5M steel-framed houses

BR 200
ISBN 0 85125 489 6

5M STEEL-FRAMED HOUSES

This report records the form of construction of 5M dwellings, identifies positions where deterioration has occurred, and highlights areas where surveyors should pay particular attention when carrying out an inspection.

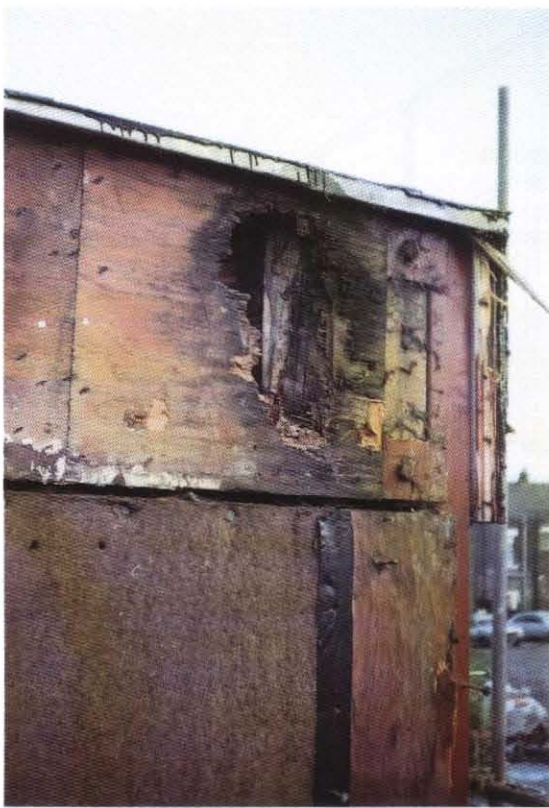
- (a) Carbonation of the concrete in the cladding panels leading to corrosion of the reinforcement and spalling of the surfaces. Horizontal cracks across the concrete cladding panels.
- (b) Broken and missing tiles in the tile hanging.
- (c) Wet rot in the plywood box beams and plywood fascia panels at roof level due to rain penetration (Figure 6).

Wet rot in the plywood box perimeter beams, door and window joinery units and lower areas of timber claddings (3.4(c) and (d)).

Rain penetration through cracks in the asphalt roof covering has led to wet rot in the plywood box perimeter beams.

Figure 6 Wet rot in the plywood box beams

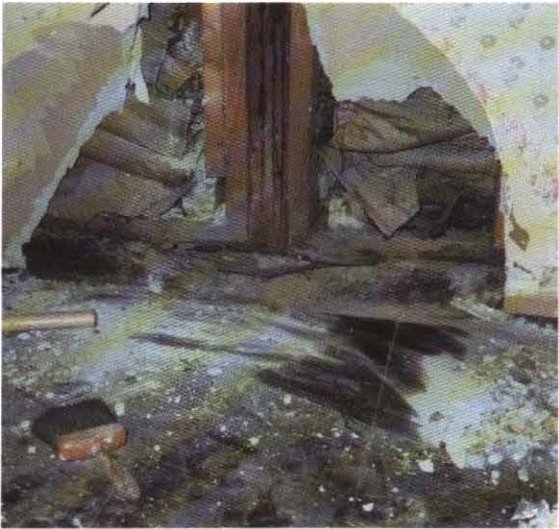
- (d) Deterioration of the external paintwork leading to wet rot in the timber joinery units, particularly at the lower joints in the opening windows and at timber sills and in the lower areas of timber claddings.
- (e) Mineral fibre insulating blankets detached from their fixings and sagging to the bottom of the cavities (Figure 7).
- (f) Severe mould growth on internal wall faces due largely to rain penetration in unoccupied dwellings and to a lesser extent to condensation in occupied dwellings.

Ineffective insulation and mould growth (3.4(e) and (f)).

Figure 7 Detached mineral fibre insulating blankets

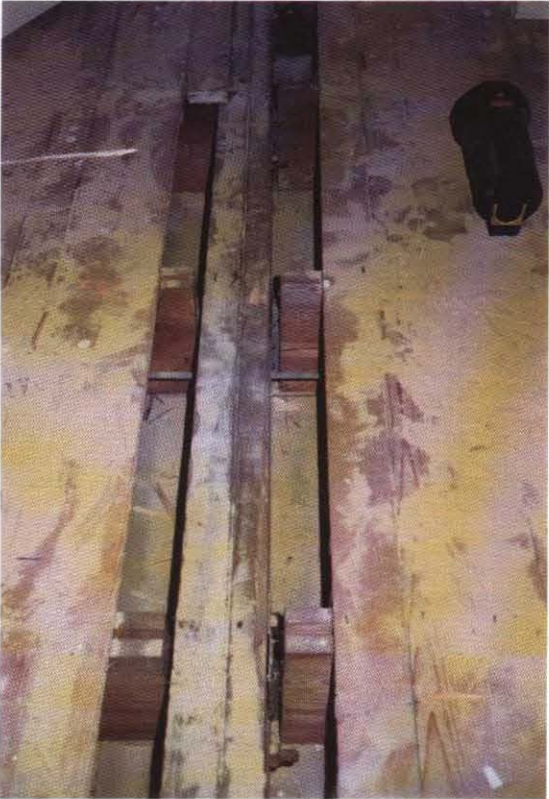
- (a) First-floor joists with wide gaps between the end of the joist and the joist hangers (Figure 8).
- (b) Large notches cut in the tops of the floor joists and composite fitch beams for central heating pipes.

Poorly fitting floor joists and large notches cut into the joists (3.5(a) and (b)).

Figure 8 Wide gaps between the ends of joists and joist hangers

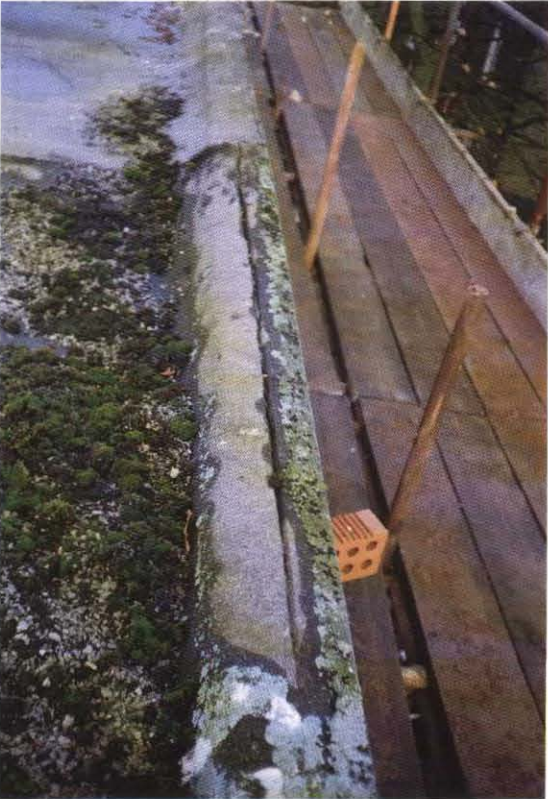
The roofs do not always slope towards the drainage outlet, creating areas of ponding. The asphalt roof covering is deteriorating and cracking allowing water to penetrate to the plywood decking and to the rooms below. Cracks along the top of the perimeter beams at the joint between the asphalt and the aluminium flashing are common and allow water to penetrate to the plywood box perimeter beams (Figure 9).

Cracks in the asphalt roof covering, allowing water to penetrate through to the structure. Poor drainage of the roof creating ponding (3.6).

Figure 9 Crack between the asphalt roof cover and aluminium flashing
