C25(88)**Level 2.5****Repair Documentation**

The C25 is the first dualband handset (GSM-900 and GSM-1800) in the C-class. The C2588 is a special version for the asian market featuring a graphic display instead of the alphanumeric C25 display.

This manual is intended to help you carry out repairs on level 2.5, meaning limited component repairs. Failure highlights are documented and should be repaired in the local workshops.

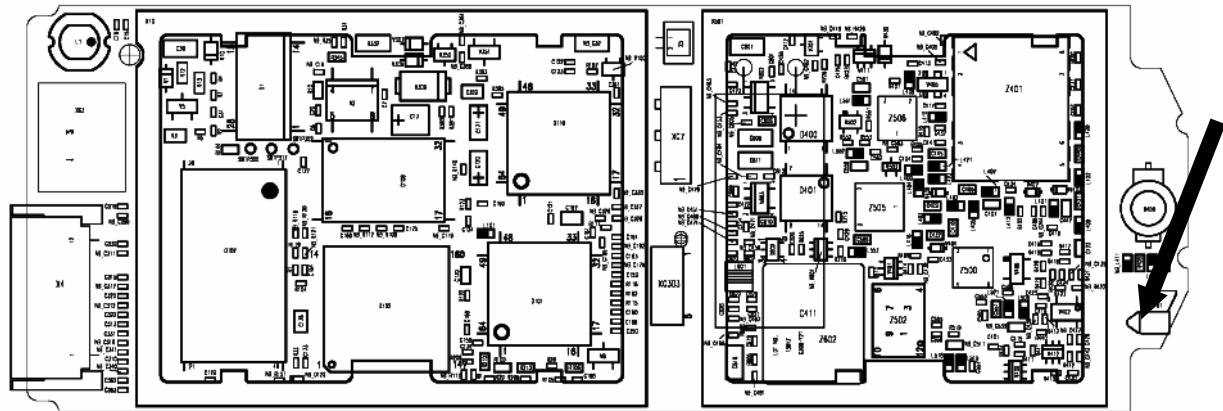
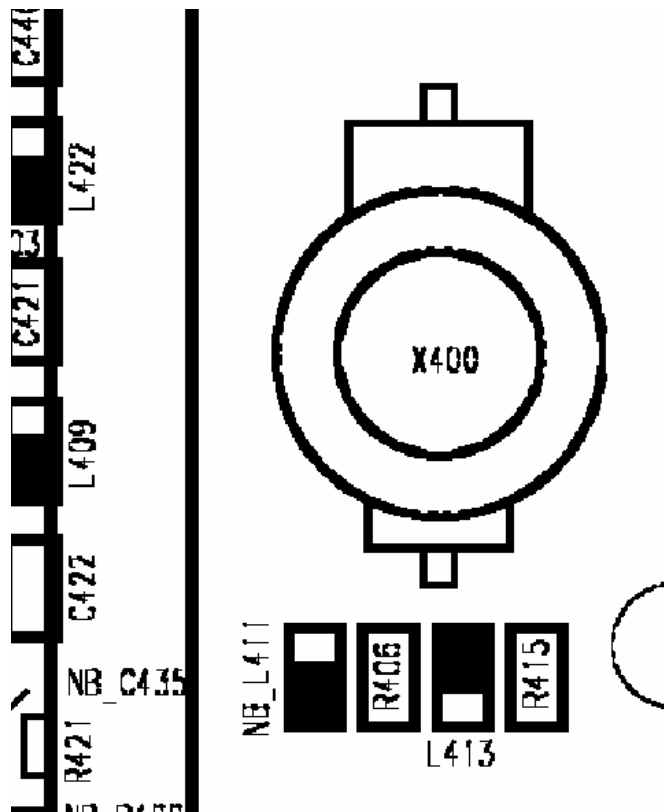
Network Search when using the external antenna
(carkit)
No location update possible on external antenna (carkit)

Output power problems on the external antenna
No location update possible

The Antenna Connector is a mechanical switch operated by the RF plug of a carkit or, for testing purposes, of an RF clip.

Use hot air blower to remove defective connector
Avoid excessive heat!
Watch surrounding components!

Resolder new connector afterwards.

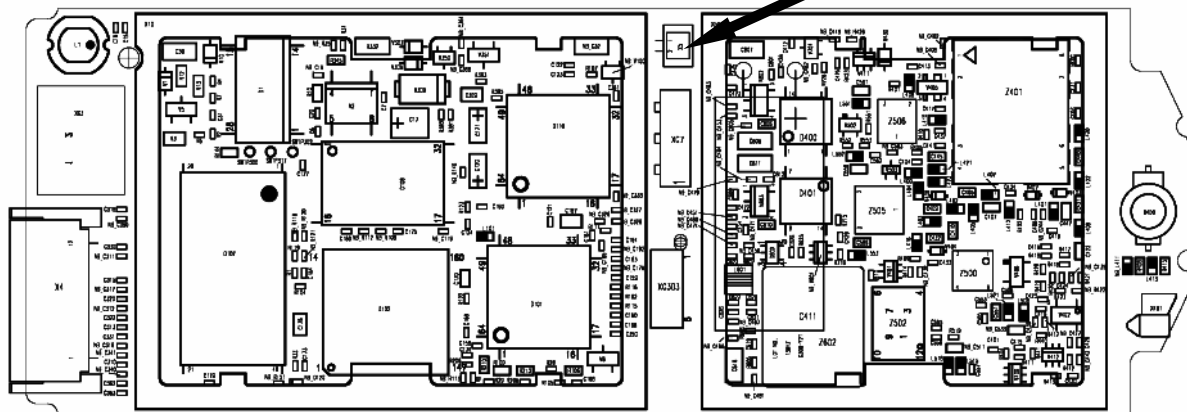
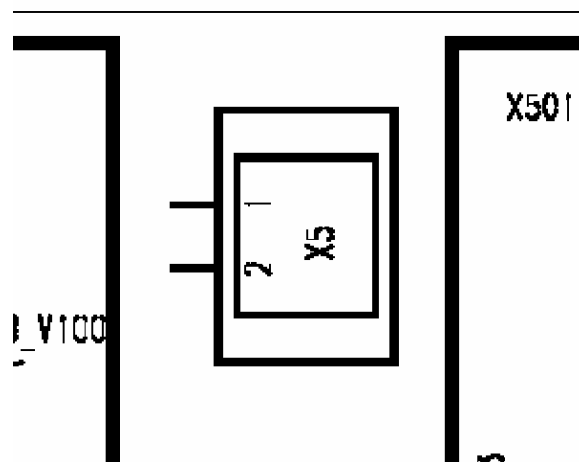
Problems with the handset ringer. No ringer tone audible.

Handset fails ringer test.

The connector X5 is connecting the main board of the C25 with the piezo ringer through a two pin cable.

Visually check the connector. Watch for bent contacts and dry joints.

Resolder dry soldering joints.
If the connector is physically damaged use hot air blower or wick to remove defective connector.
Avoid excessive heat!
Watch surrounding components!

Resolder new connector afterwards.

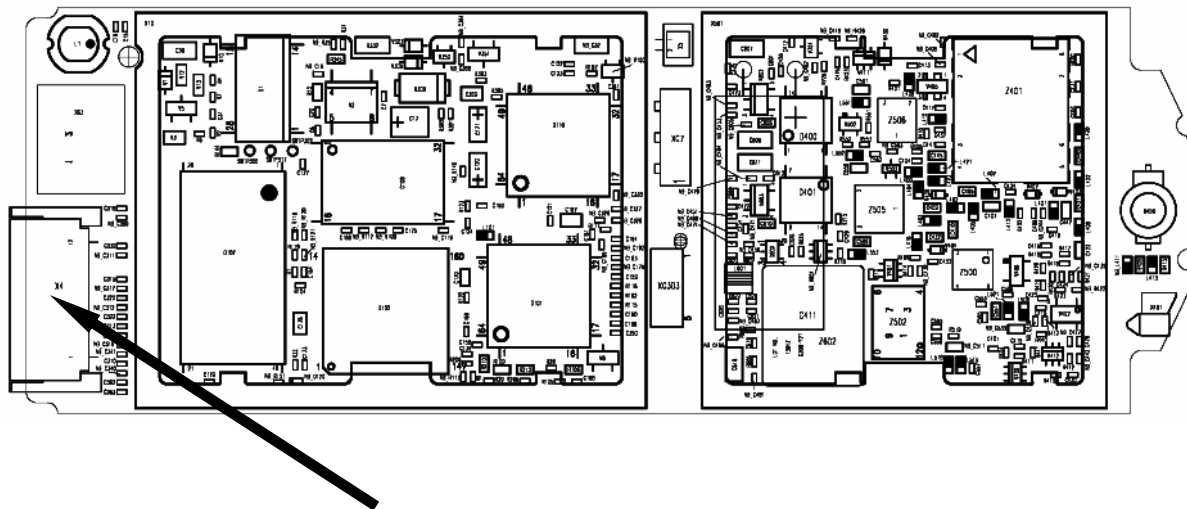
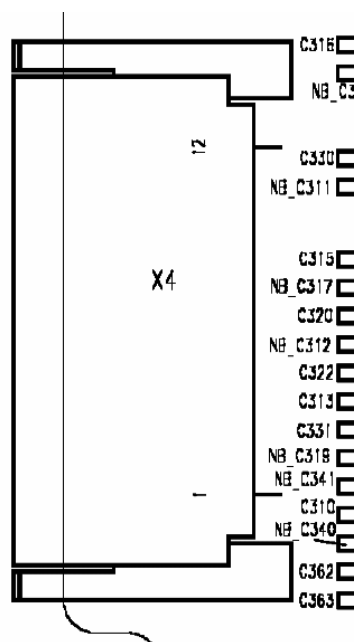
Charging problems.
Problems with external loudspeaker or microphone
when using a car kit.
Problems with accessories connected at the bottom
connector.

Testequipment cannot communicate with the handset.

Visually check the bottom connector. Watch for dry joints!

Use hot air blower remove defective bottom connector.
Avoid excessive heat!
Watch surrounding components!

Resolder new bottom connector afterwards.

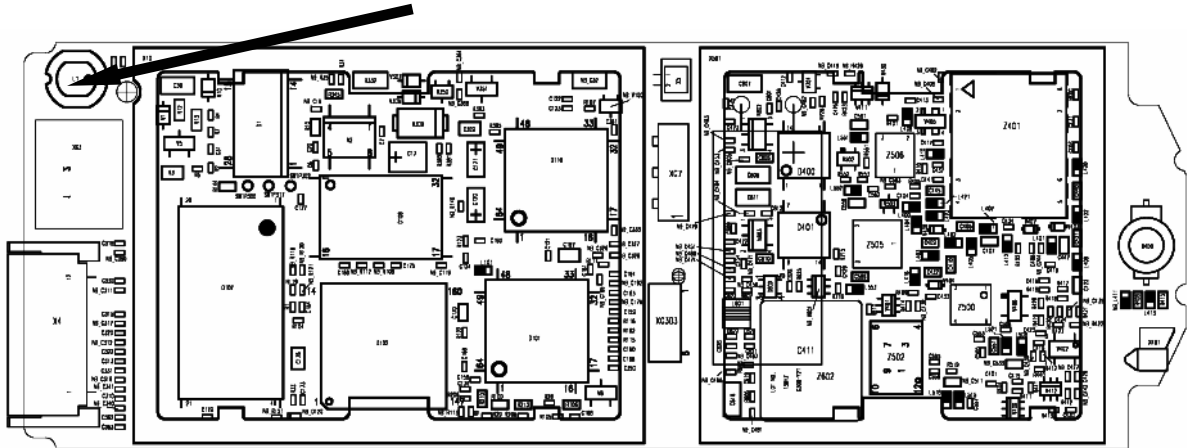
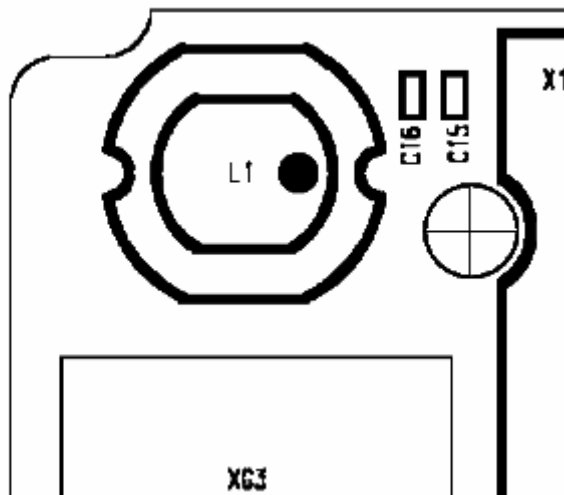
Loud humming noise in loudspeaker.

The 18 μ H coil is used in the step up converter which is generating a 5.4 V supply voltage for the power amplifier out of the 2.8V battery voltage.

If the coil is mechanically damaged (broken) it produces heavy interference with the acoustical elements of the C25 resulting in a loud humming noise in the earpiece.

A broken coil can easily be diagnosed by trying to move it with two fingers. If it moves, the core is broken and the coil has to be replaced.

Use hot air to remove defective coil.

Resolder new coil afterwards

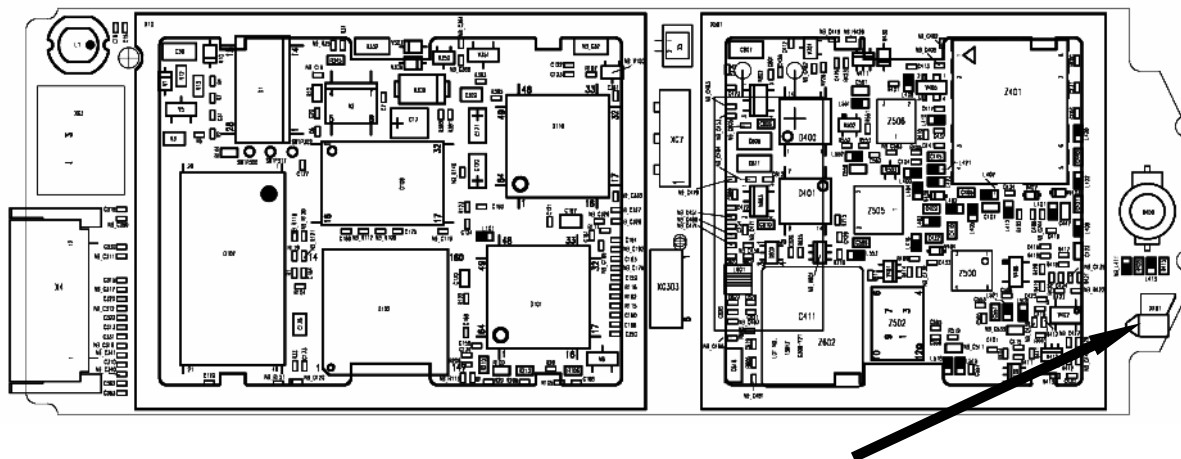
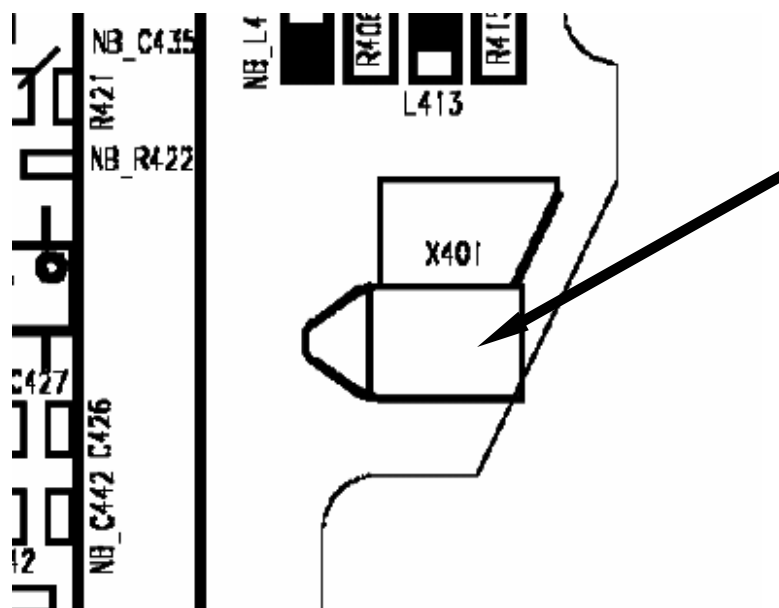
Network Search.
Handset drops calls.

Power problems on the **internal** antenna of the handset only.

Visually check the status of the spring. Bent or oxidated springs have to be replaced.

Use soldering iron to remove defective spring.
Avoid excessive heat!
Watch surrounding components!

Resolder new spring afterwards.

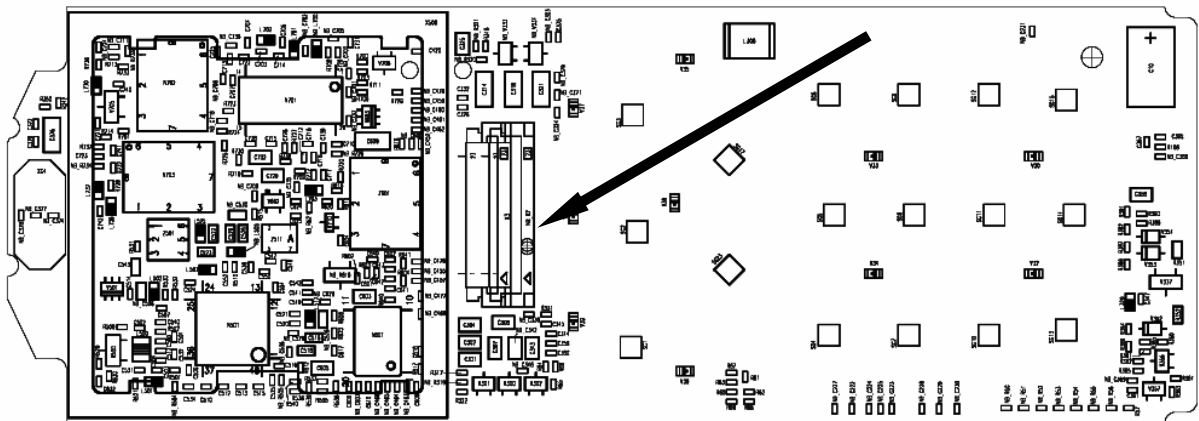
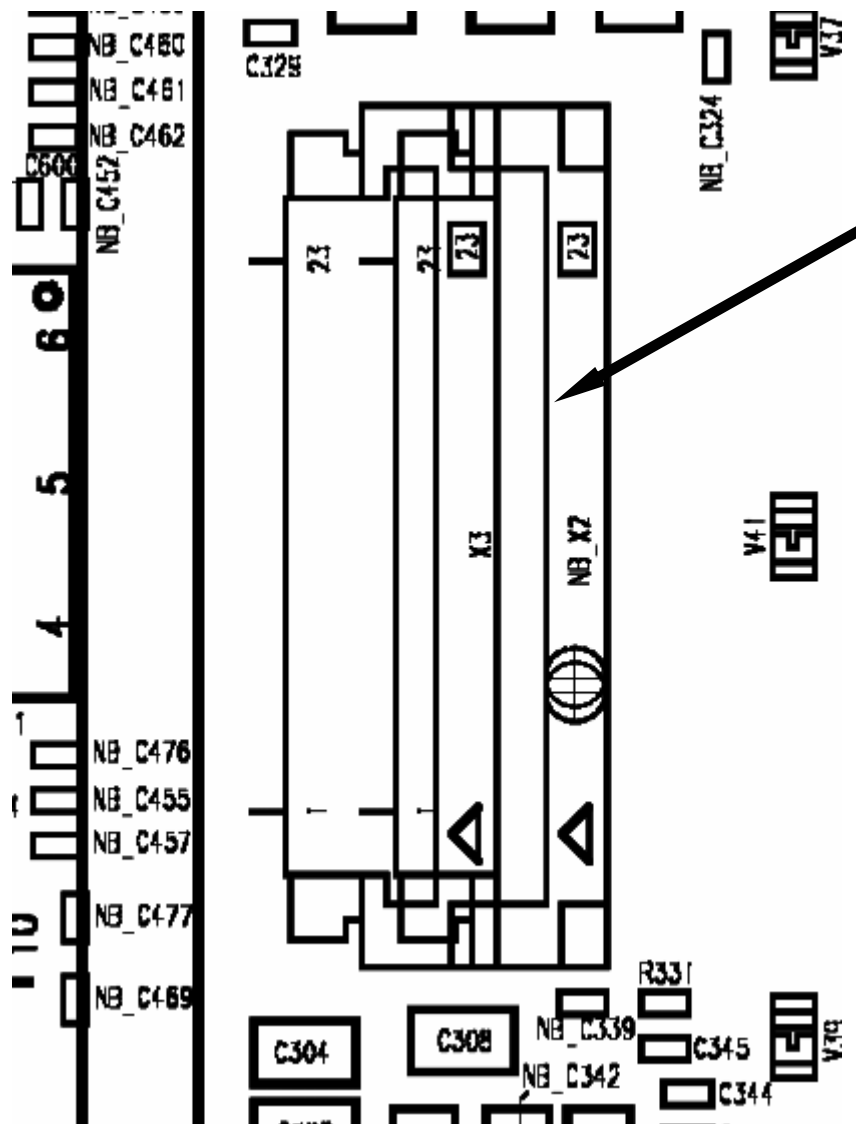
Display problems.
Missing Lines or columns on the LCD.

Visually check the status of the connector. Check the opening/closing mechanism and watch for dry joints.

Use soldering iron to resolder dry joints or use hot air blower to remove defective connector.

Resolder new connector afterwards.

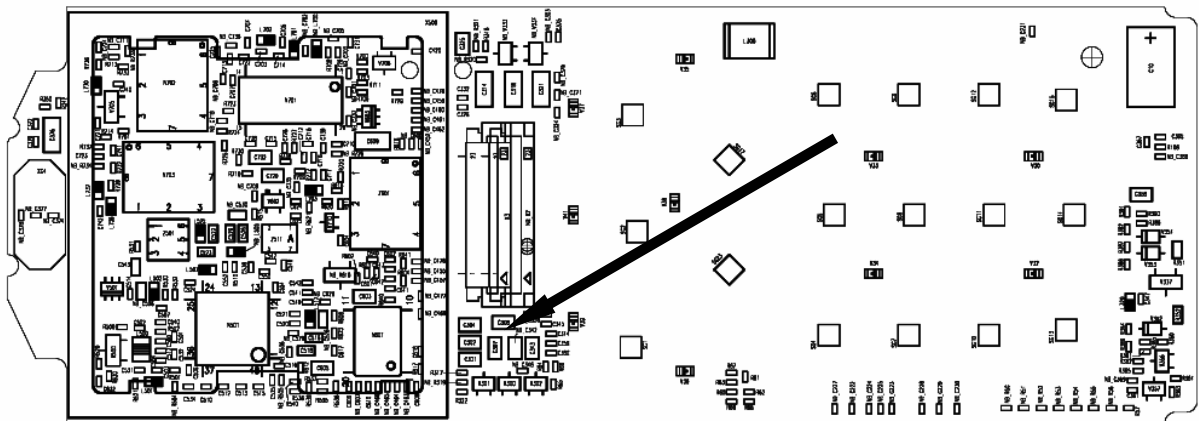
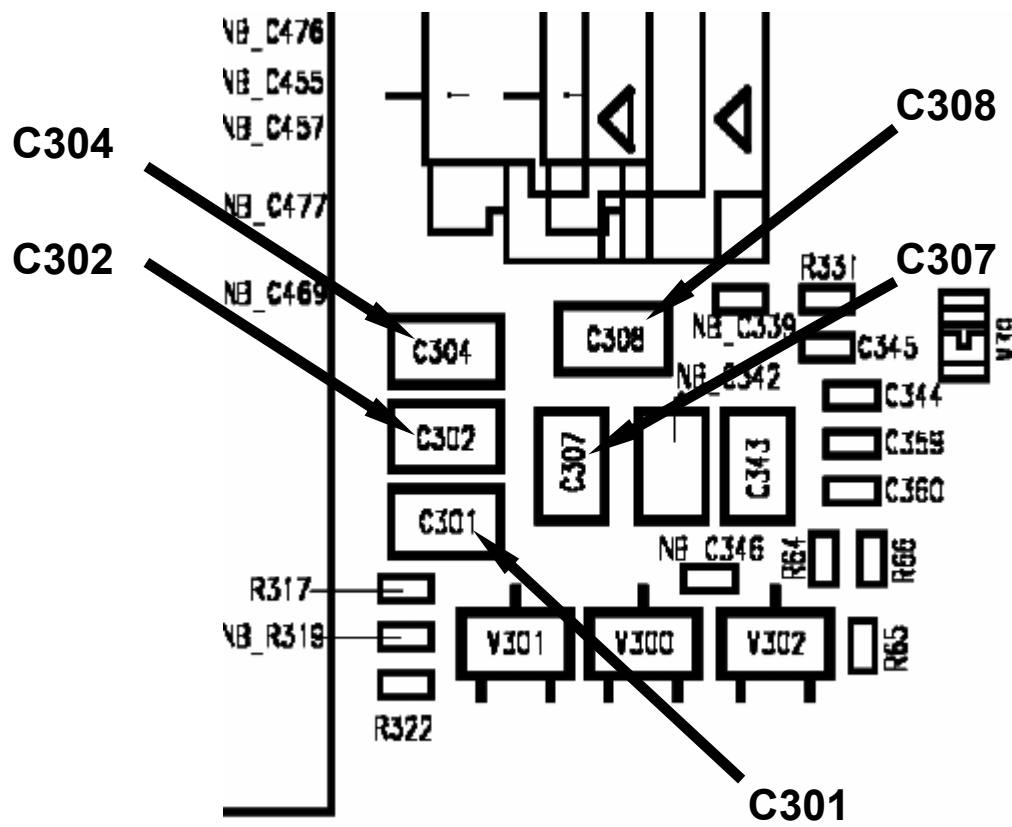
The display is not working at all or shows strange characters.

The capacitors are used to buffer the supply voltage of the display controller. Especially C308 has occasionally been found defective. Check the status of the capacitors by measuring its capacitance with an appropriate measurement device. The capacitance must be in the 220nF range. Defective caps often have a lower capacitance around 100nF.

Use hot air blower or soldering iron to remove defective capacitor.
Avoid excessive heat!
Watch surrounding components!

Resolder new capacitor afterwards.

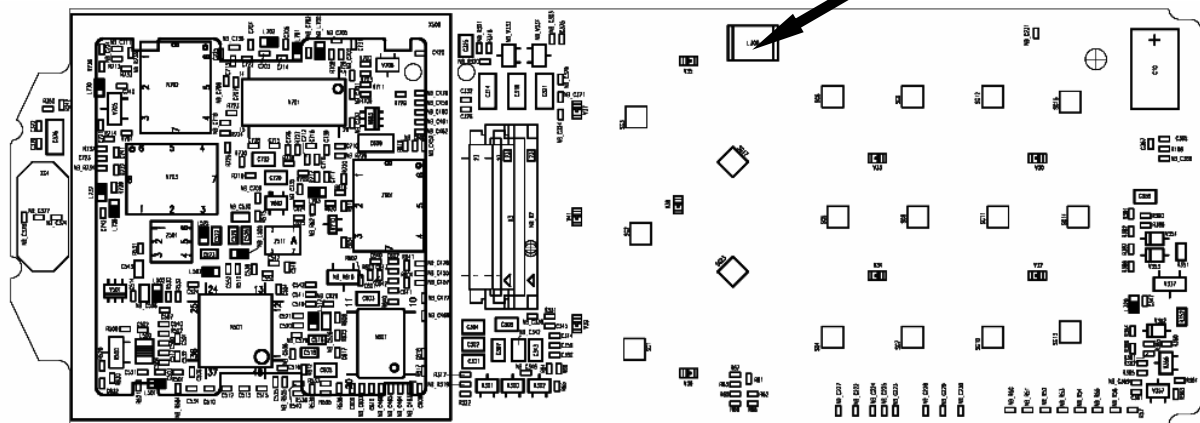
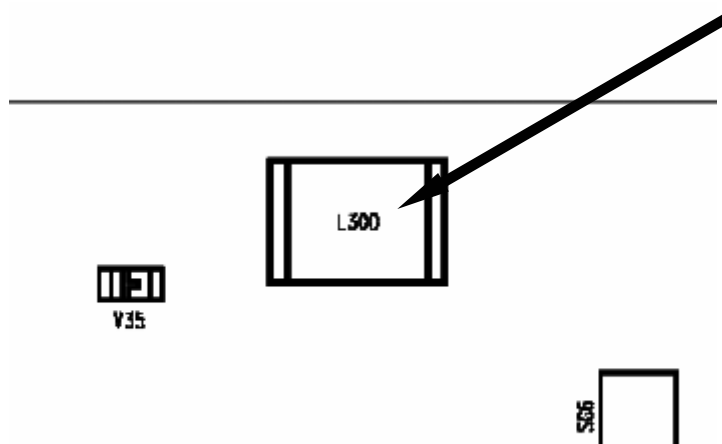
The handset ringer (buzzer) is not working or the
Ringer level is too low

The coil is used to generate the voltage to operate the piezo ringer. If it is defective, the ringer cannot work anymore.

Check the status of the coil by measuring its resistance with a multimeter. The resistance must be very low. Also broken coils have to be replaced.

Use hot air blower or soldering iron to remove defective coil.

Resolder new coil afterwards.

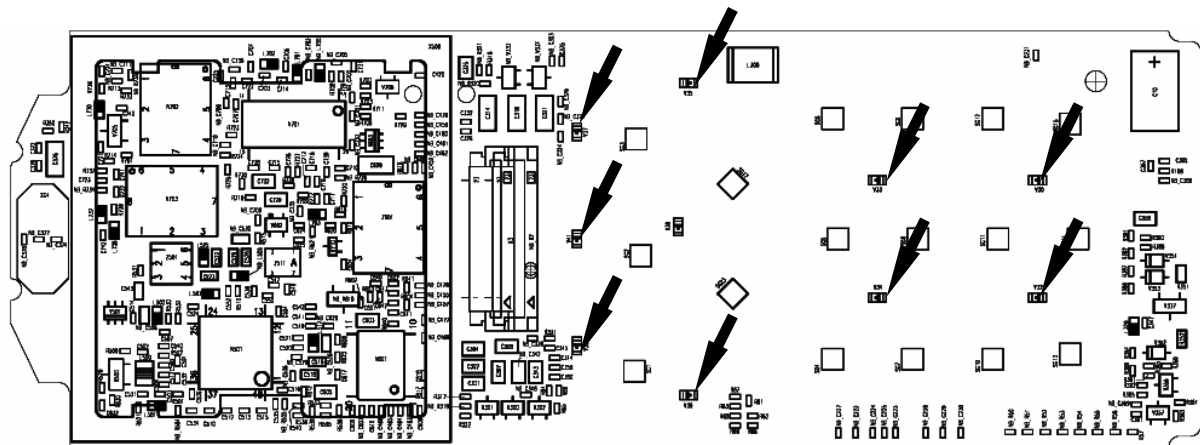
The display/keypad illumination is not working properly.

The nine LEDs are providing the illumination both for the display and for the keyboard. Just switch on the phone without upper case and remove the keyboard. Now visually check the function of the LEDs.

Use hot air blower or soldering iron to remove defective LED.

Watch the polarity of the LED!

Resolder new LED afterwards.
