INPO 11-005
November 2011

Special Report on the Nuclear Accident at the Fukushima Daiichi Nuclear Power Station

Revision 0

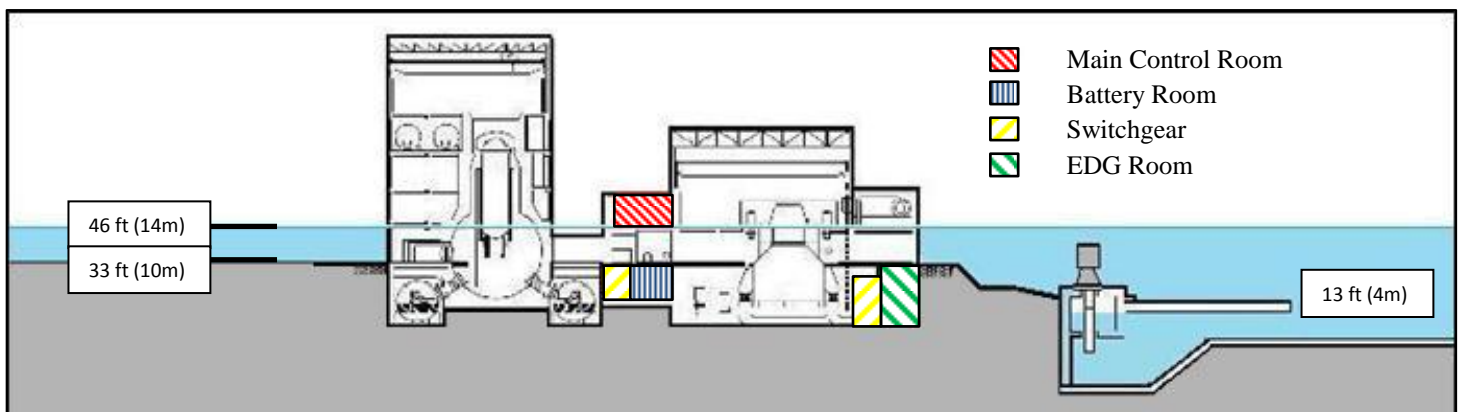
Figure 3.3-1 General Elevations and Inundation Level

The tsunami inundated the area surrounding units 1–4 to a depth of 13 to 16 feet above grade (4 to 5 meters), causing extensive damage to site buildings and flooding of the turbine and reactor buildings. Intake structures at all six units were unavailable because the tsunamis and debris heavily damaged the pumps, strainers, and equipment, and the flooding caused electrical faults. The damage resulted in a loss of the ultimate heat sink for all units. The diesel generators operated for a short time; but by 1541, the combination of a loss of cooling water, flooding of electrical switchgear, and flooding of some of the diesel generator rooms (located in the basement of the turbine buildings and not designed to withstand flooding) caused a loss of all AC power on site for units 1–5. (Refer to Figure 7.4-7.)

Figure 3.3-1 shows the general elevations (typical for units 1–4) and the approximate inundation level. The grade level of units 1–4 is 32.8 feet (10 meters) and is 42.7 feet (13 meters) at units 5 and 6 above mean sea level (commonly referred to as OP, for the level in the Onahama Port). The intake structures were at an elevation of 13.1 feet (4 meters) for all units.

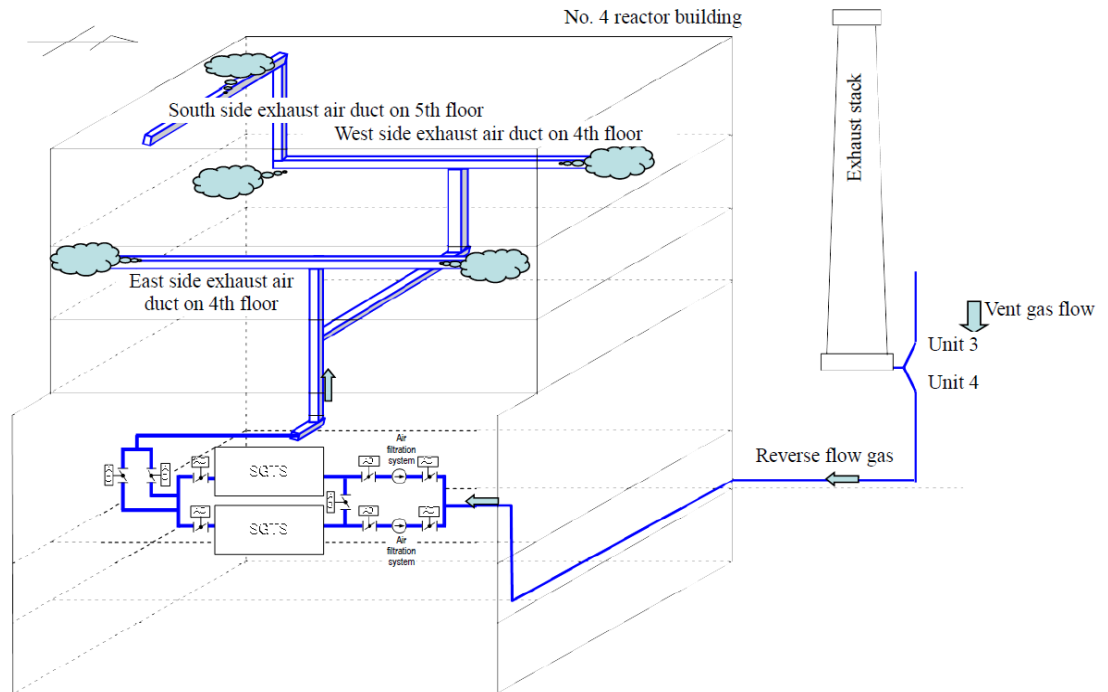
Figure 4.4-1 Unit 4 Standby Gas Treatment System Hydrogen Flow Path

The most widely accepted theory is associated with the backflow of gases from Unit 3 during venting. The containment vent exhaust piping from Unit 3 is connected to the Unit 4 exhaust piping. The dampers on the Unit 4 standby gas treatment system (SGTS) are air-operated and fail open on a loss of power or air (except the cross-connect between SGTS filter trains). Additionally, the system does not have a backflow damper installed in the piping that connects to Unit 3. With no power or air, and no fans in service to direct the gases from Unit 3 up the exhaust stack, the exhaust gases from Unit 3 would be directly aligned to the Unit 4 SGTS filters. This piping arrangement may have allowed

gases from the Unit 3 containment to be vented to the Unit 4 reactor building via reverse flow through the Unit 4 standby gas treatment system.

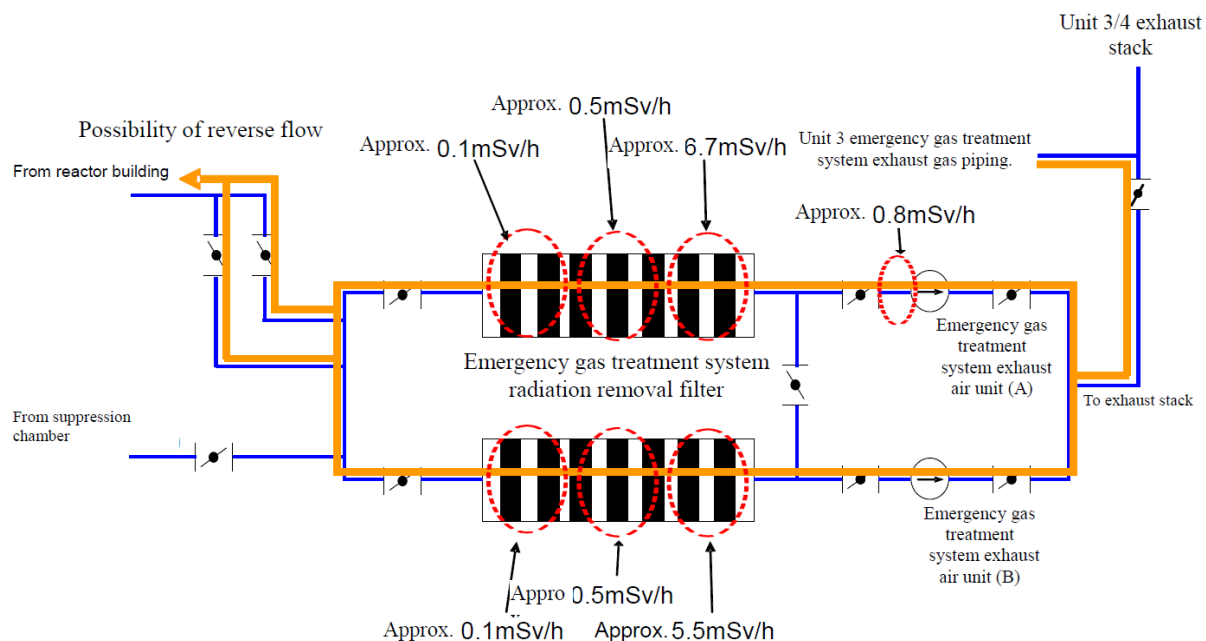
Figure 4.4-2 Unit 4 Standby Gas Treatment System Filter Survey Results

To confirm this theory, on August 25 TEPCO personnel performed radiation surveys on the Unit 4 SGTS filters. The survey results, shown in Figure 4.4-2, revealed higher radiation levels at the locations closer to Unit 3. These survey results support the conclusion that there was backflow from Unit 3 to Unit 4. Further inspections are needed to confirm this theory; but based on this information, it is postulated that the hydrogen explosion in the Unit 4 reactor building was caused by hydrogen from Unit 3.

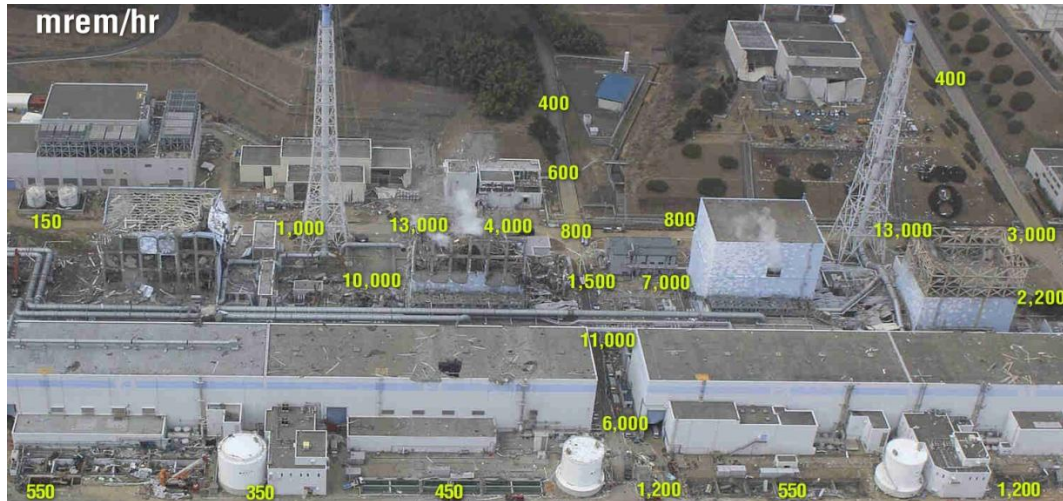
Figure 5.3-1 Site Dose Rates

On March 22 and 23, surveys of the airborne radioactivity and dose rates around the site began to be collected and documented. The dose rates are documented on Figure 5.3-1. Localized dose rates as high as 1,000 rem/hr (10 Sv/hr) were later discovered.

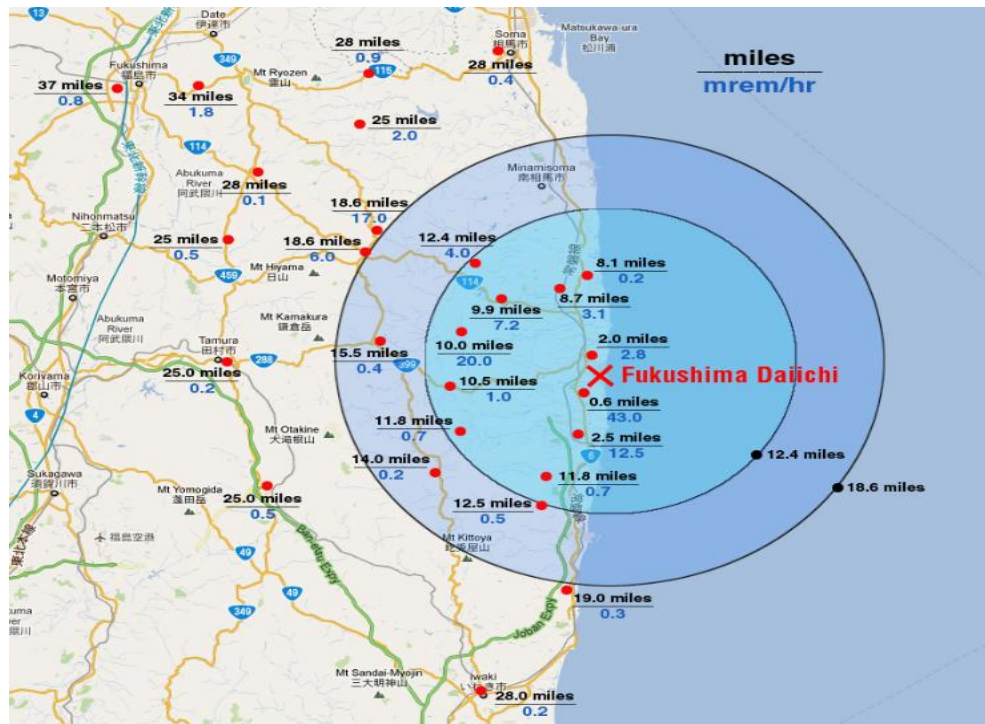
Figure 5.4-1 Initial Off-Site Survey Results

Routine dose rate surveys began to be collected in the area outside the 12.4 mile (20 km) radius of the plant on March 16. The highest dose rate of 17 mrem/hr (0.17 mSv) was measured 19 miles (30.5 km) northwest of the station. The first air samples from the site boundary, on March 22 and 23, had iodine-131 concentrations that were equivalent to approximately 80 mrem (0.8 mSv) of thyroid dose each hour if inhaled by an unprotected individual. The concentration remained between 25 and 200 percent of this value until April 18, 2011. Surveys inside 12.4 miles (20 km) began on March 30. The map shown in Figure 5.4-1, which was created based on survey results, is representative of these initial surveys.

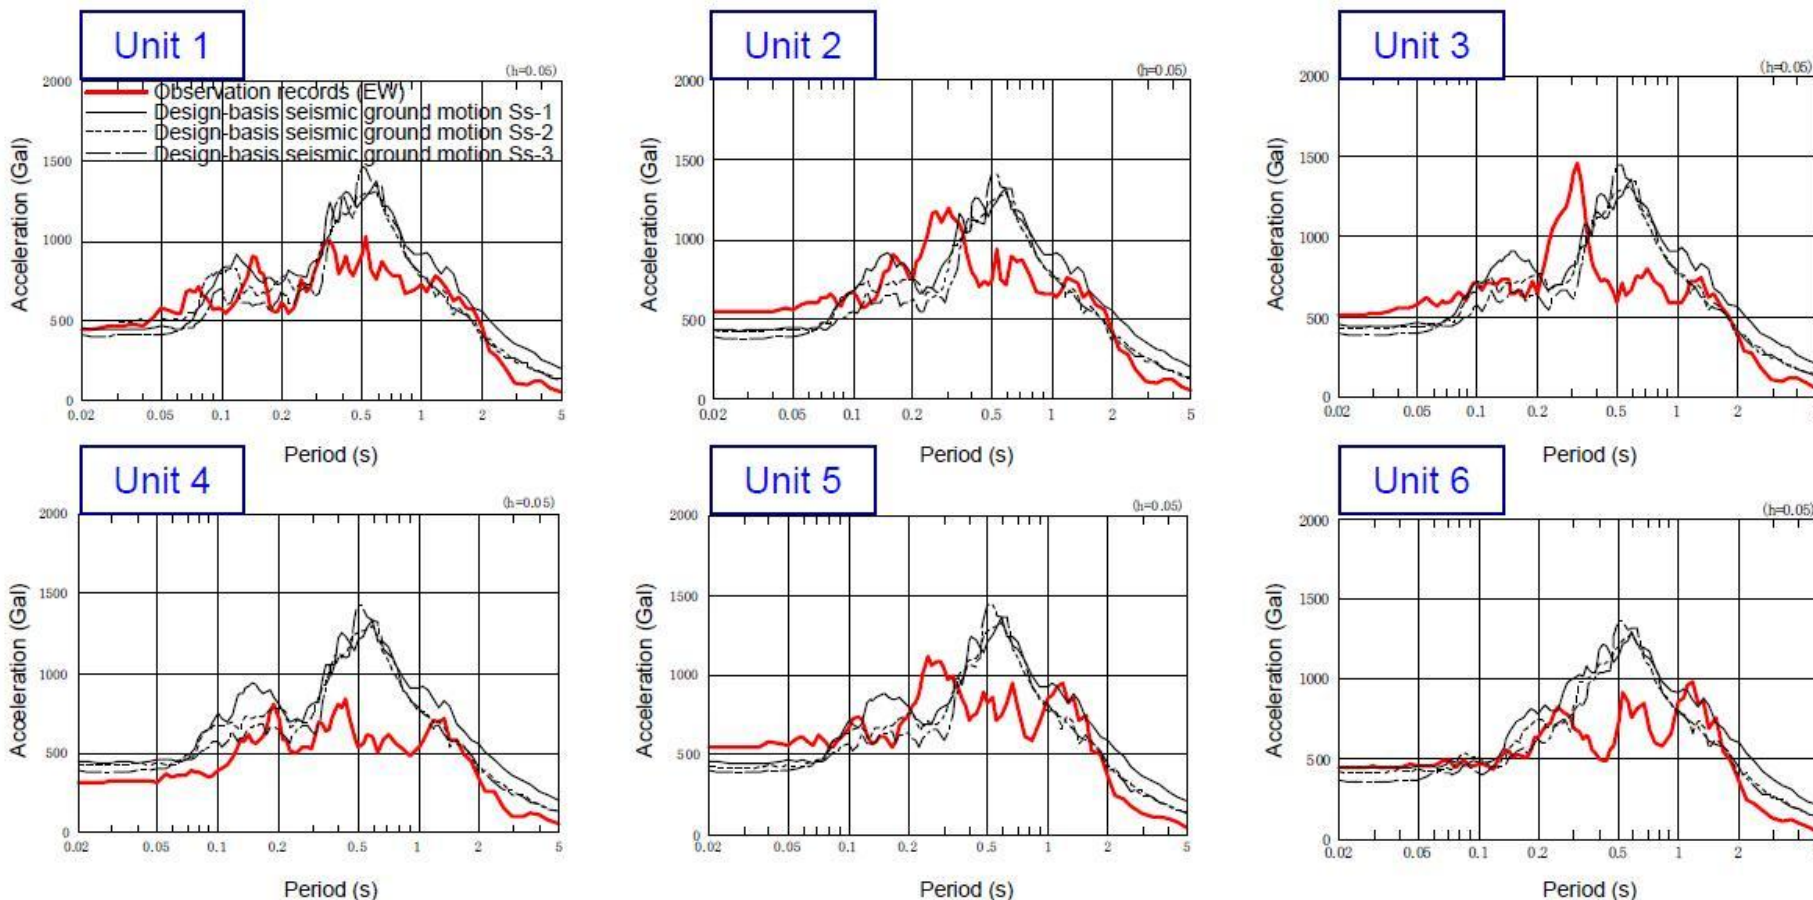
Figure 7.1-1 Preliminary Seismic Data

While no formal seismic walkdowns have been performed, a review of plant indications and operator logs does not indicate any seismic damage that affected the operator response to the earthquake. Before the tsunami, all emergency diesel generators that were operable started and loaded as expected, and each emergency core cooling system the operators used appeared to function as designed. Reactor pressure, reactor water level, and containment pressure indications for units 1, 2, and 3 appeared as expected following a scram and did not indicate any potential breach of the reactor coolant system from the earthquake.

Graphs indicate the observed values as compared to the design basis seismic criteria.

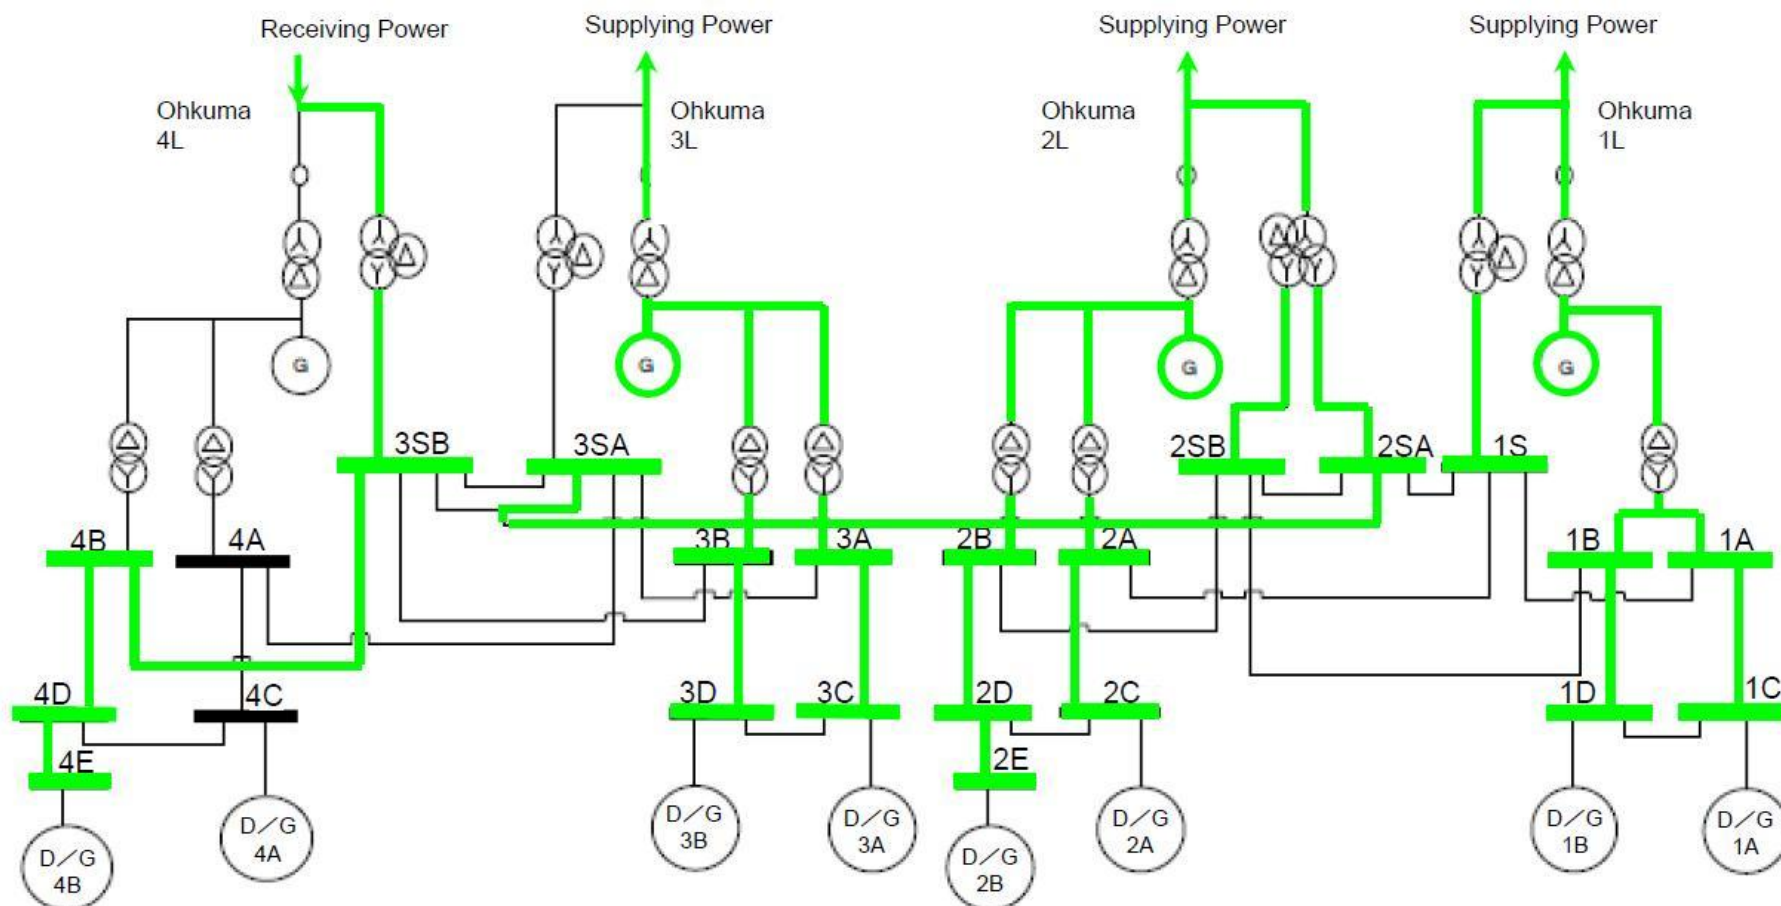
Figure 7.4-6 Simplified Electrical System¹¹

Systems highlighted in green were in service (energized). The 4A EDG and Unit 3 startup transformer were out of service for planned maintenance at the time of the event.
