MSC-PA-R-68-15

APOLLO 7 MISSION REPORT

MANNED SPACECRAFT CENTER

DECEMBER 1968

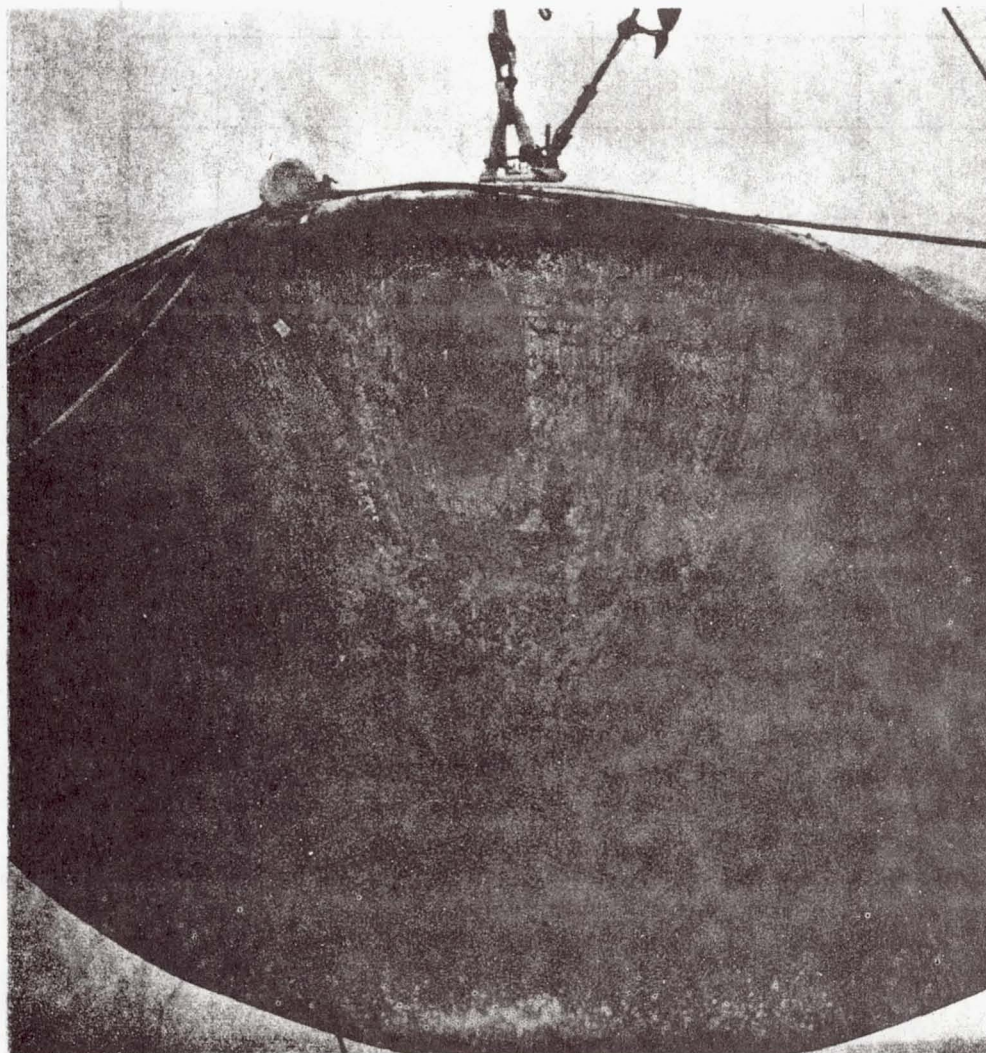
Figure 5.4-1.- Char condition of aft heat shield.

The thermal protection system performed well during the mission. The responses of the thermocouples and the calorimeters indicate a very erratic motion of the spacecraft during entry; the entry is discussed in more detail in section 3.0 and 5.16.
