GEMINI PROGRAM MISSION REPORT

GEMINI V

MANNED SPACECRAFT CENTER
HOUSTON, TEXAS

AUGUST 1965

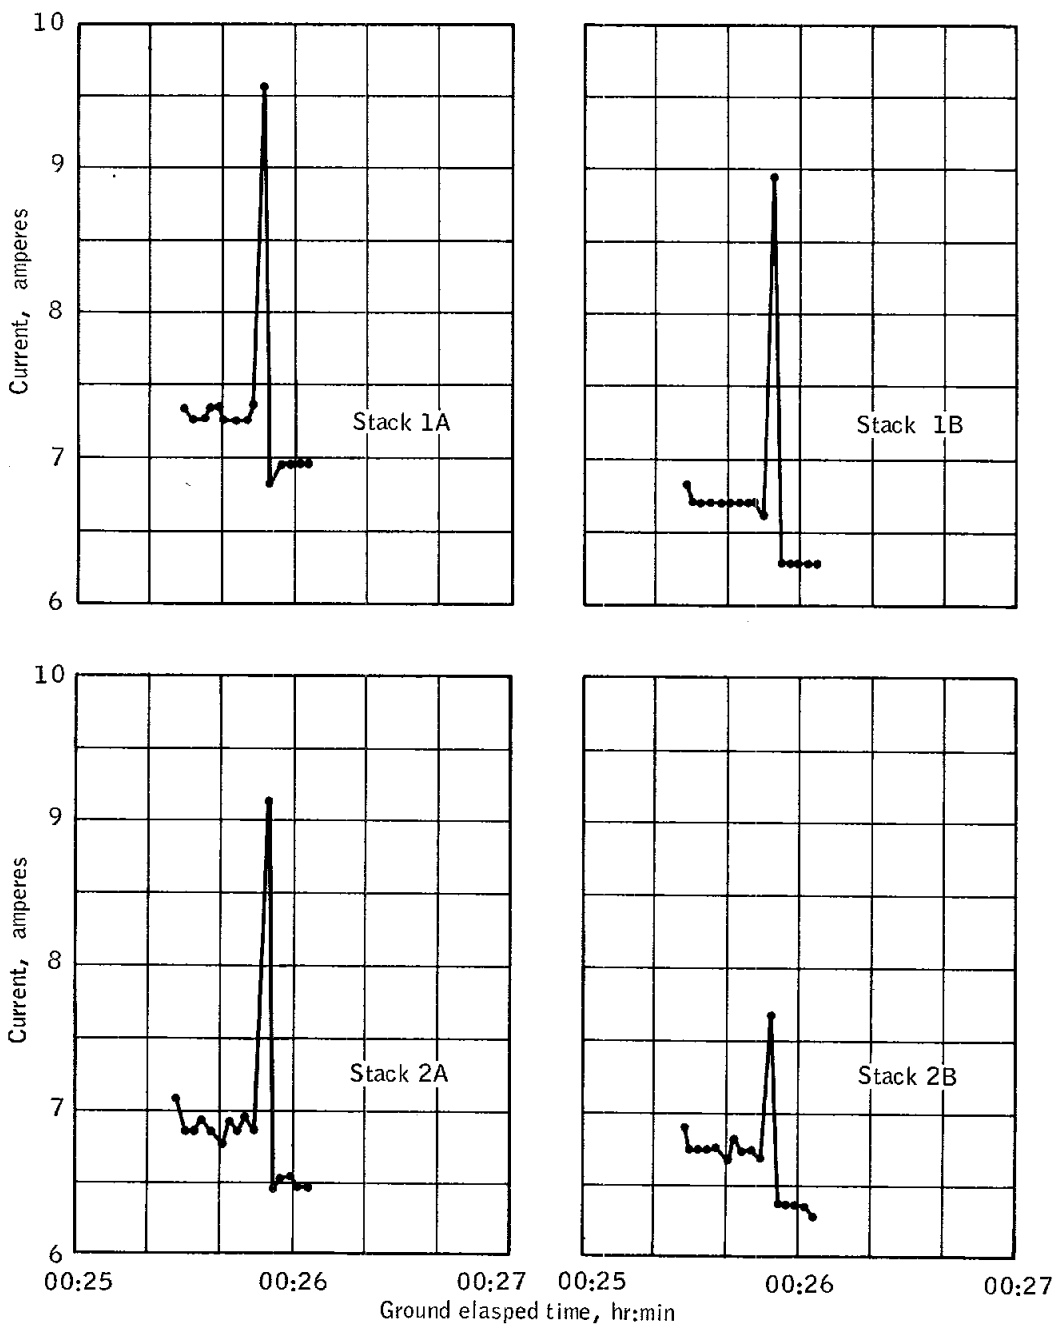
Figure 5.1.7-4: - Stack currents during time of RSS oxygen heater failure at 00:25:51 g.e.t.

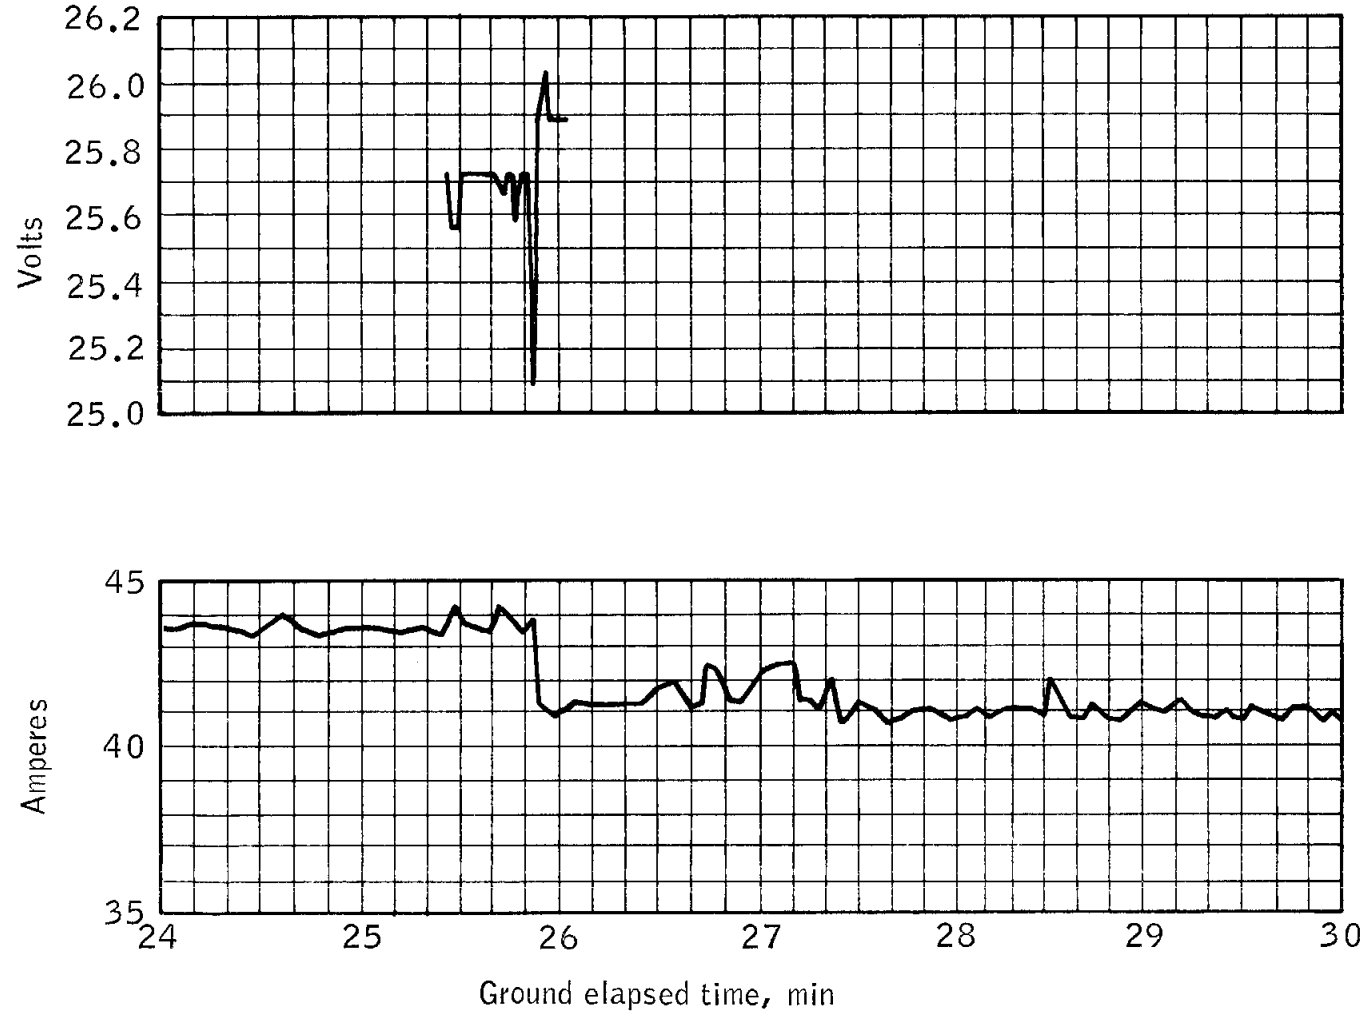
Figure 5.1.7-5. - Main bus voltage and current during time of RSS oxygen heater failure at 00:25:51 g.e.t.

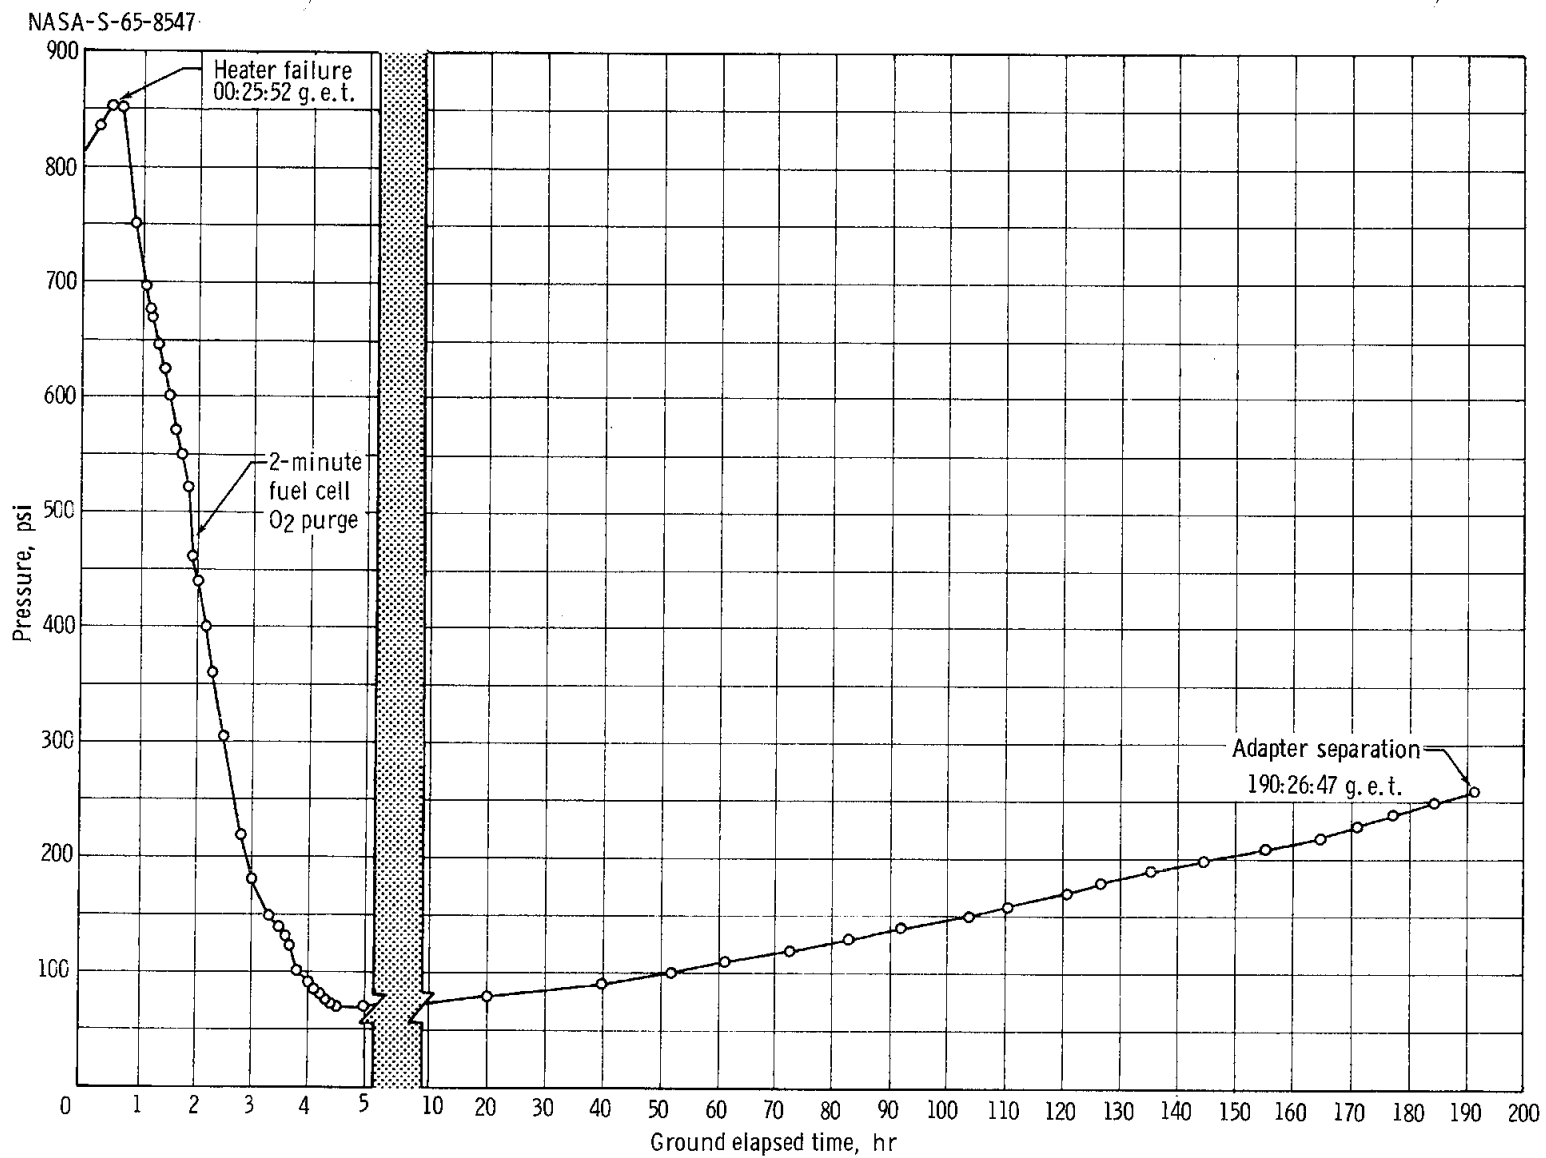
Figure 5. 1. 7-6. - RSS oxygen supply pressure.

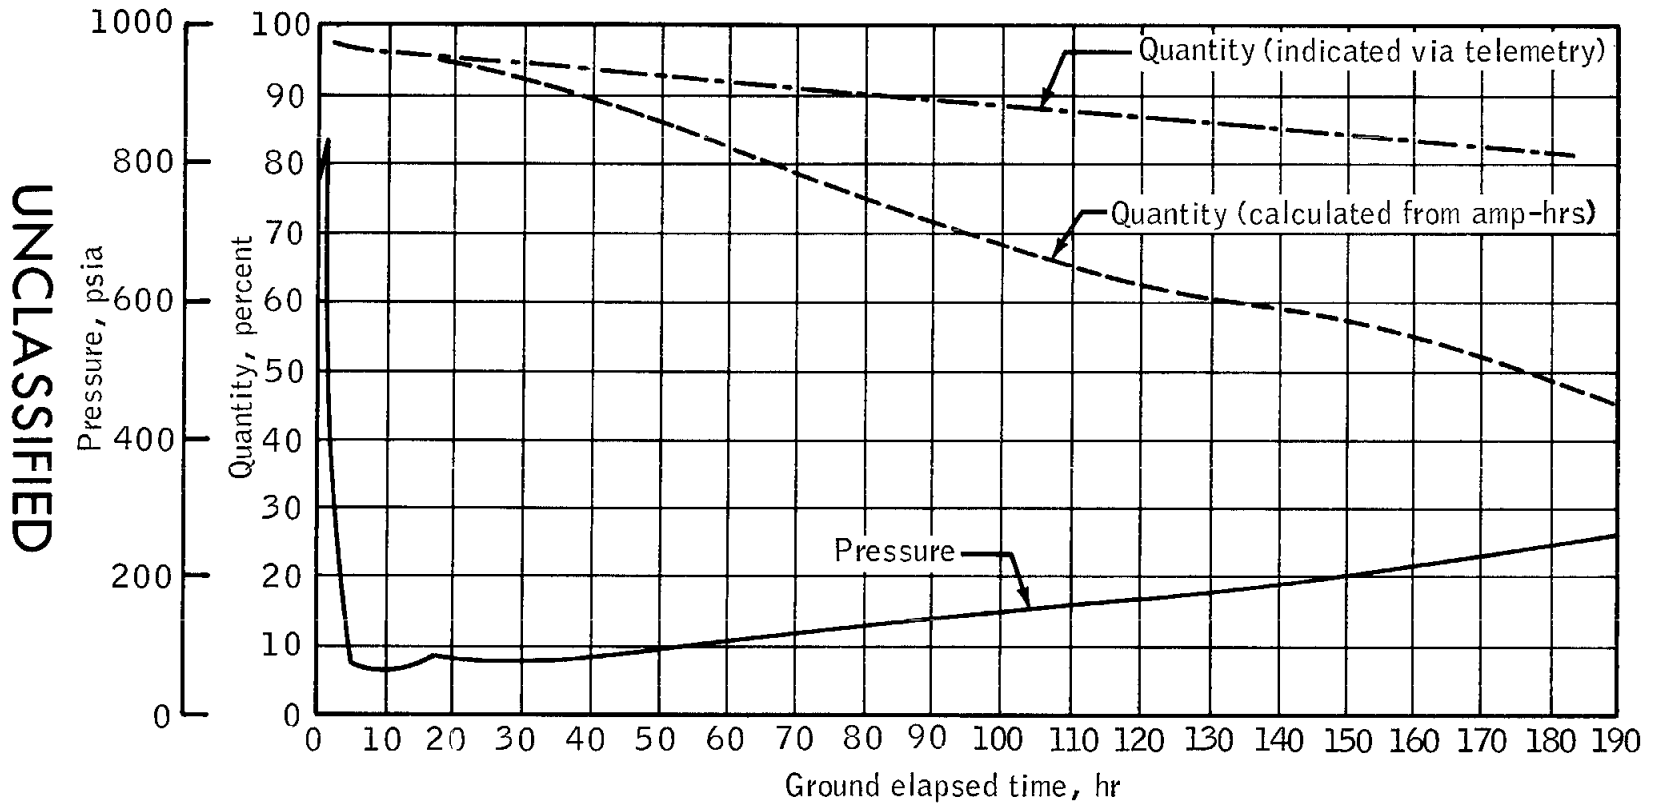
Figure 6.1-1.- Real - time data concerning the fuel-cell oxygen supply.
