# The Locomotive

THE HARTFORD STEAM BOILER  
INSPECTION AND INSURANCE CO.

**VOL. XXXVI.**

HARTFORD, CONN.,  
1926-1927.

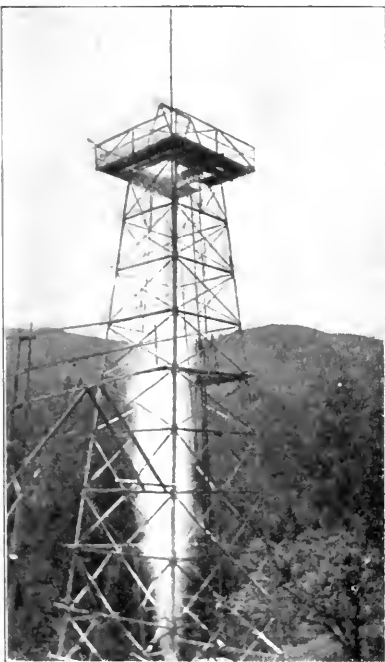
FIG. 1.

During the past year four new experimental wells have been drilled by means of a rotary drill similar to the tool used in the oil fields. The last well opened up, No. 7, just before it was capped projected a jet of steam from an 8 inch diameter pipe fully 75 ft. into the air, as shown in Fig. 1.

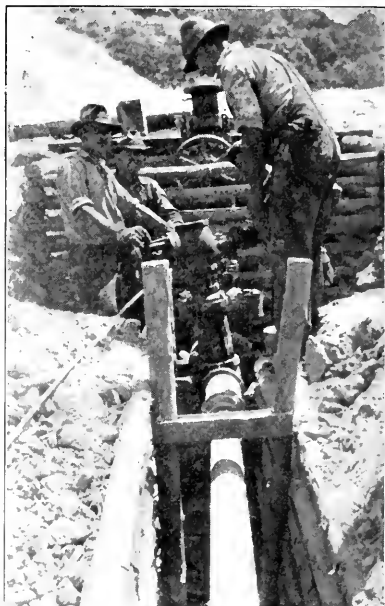
FIG. 2.

When capped it showed a pressure of 220 lbs. Well No. 6 only a hundred feet away developed a pressure in excess of 300 lbs. In order to limit it to this pressure, the safe working pressure for the casing valves and fittings, a 4 inch diameter escape pipe is provided as shown in Fig. 2. Well No. 5 showed a pressure of 250 lbs.

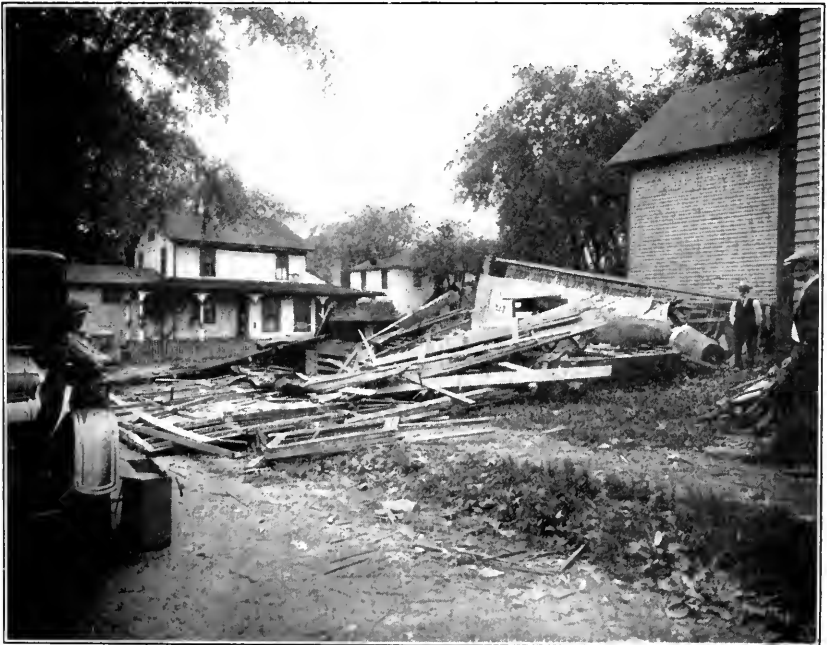
HOT WATER SUPPLY TANK EXPLOSION AT WATERVILLE, CONN.

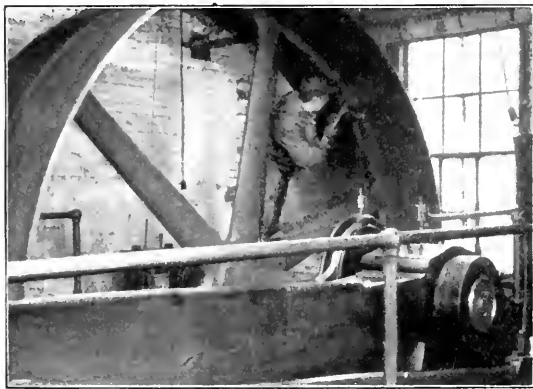
INSPECTING A FLYWHEEL.

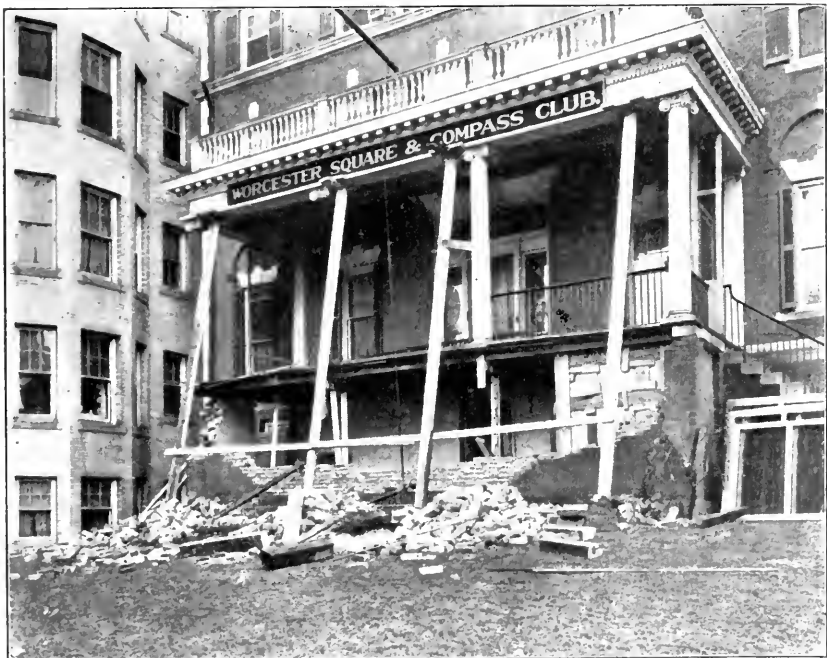
HOT WATER SUPPLY TANK EXPLOSION AT WORCESTER, MASSACHUSETTS

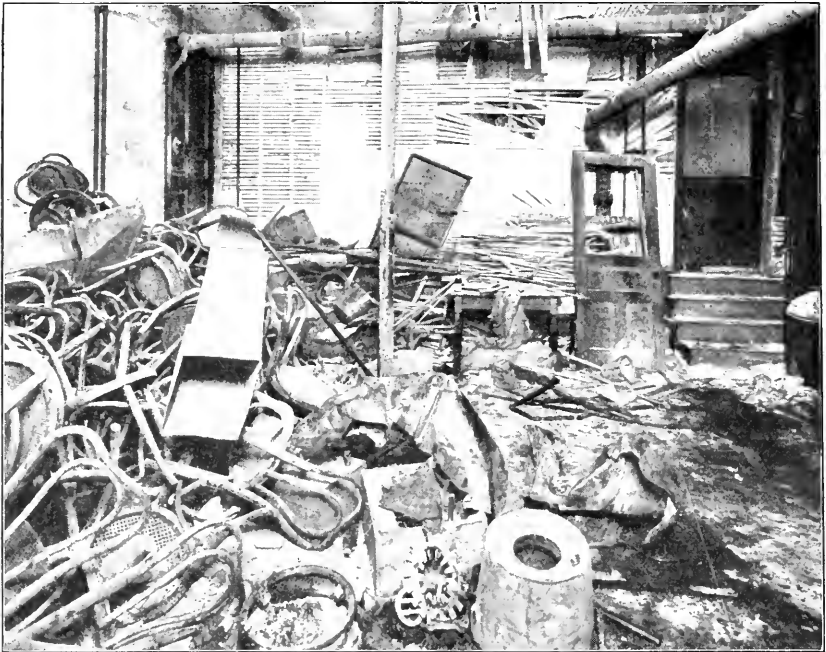
FIG. 1.

**A**N explosion of terrific violence occurred early in the morning of March 30th, 1925 at the Worcester Square and Compass Club, Worcester, Mass. when the hot water supply boiler exploded. No one was injured, due to the early hour of the explosion, but considerable property damage was done in the basement and on

the first floor, as indicated by Fig. 1 and the picture on the front cover. The boiler was located in the front part of the basement and the explosion blew down a brick wall that supported the large front porch. Doors and windows, including several decorative leaded glass windows, in the basement and on the first floor were blown out and the floor was raised several inches. Windows in neighboring buildings were also blown out. The property loss was estimated to be \$10,000.

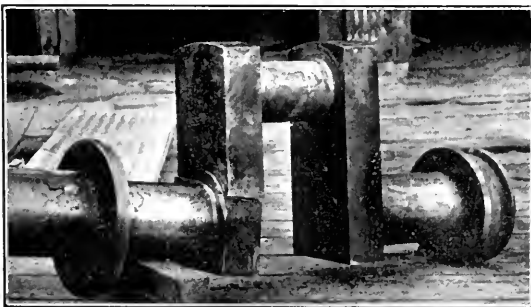
When under these conditions the distance between the crank webs is measured by means of a micrometer in four different positions of the crank, an appreciable difference is found between the measurements

in these four crank positions. If the engine is operated with this condition existing, it is reasonably certain that the shaft will develop surface cracks in the critical areas shown in Fig. 2. If the misalignment of the bearings is serious enough, failure of the

FIG. 5. BROKEN CRANK WEB.

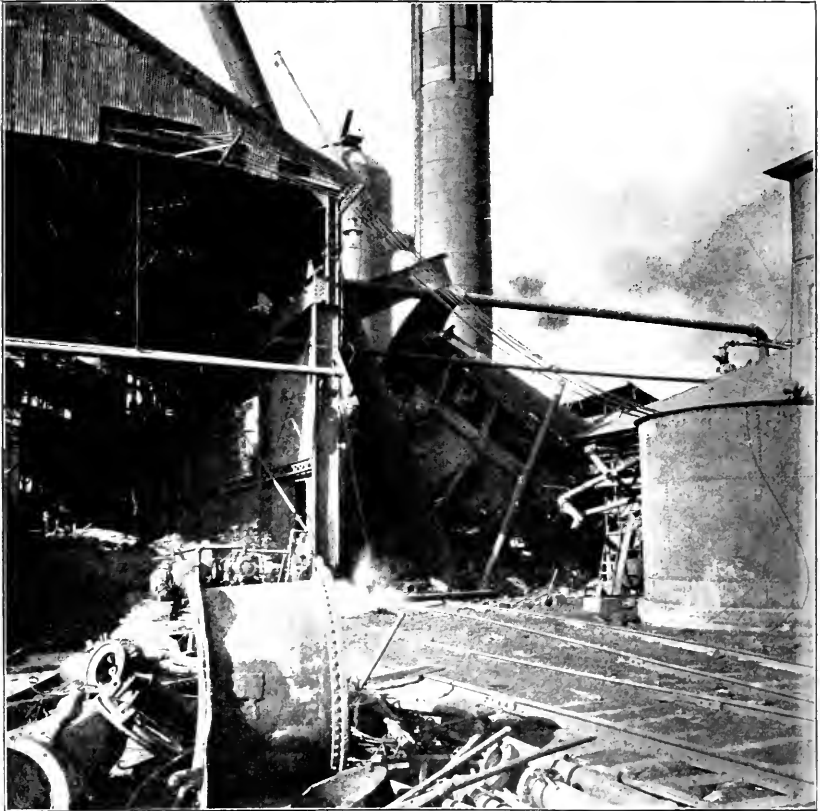
FIG. 1.

**T**HE explosion of an 8 inch steam pipe might not ordinarily be thought of as a very devastating type of accident but the accompanying pictures show that such an accident may at times approach a boiler explosion in destructiveness. The explosion illustrated occurred July 25, 1926. The property loss amounted to \$17,-

860. That no one was killed or seriously injured seems miraculous.

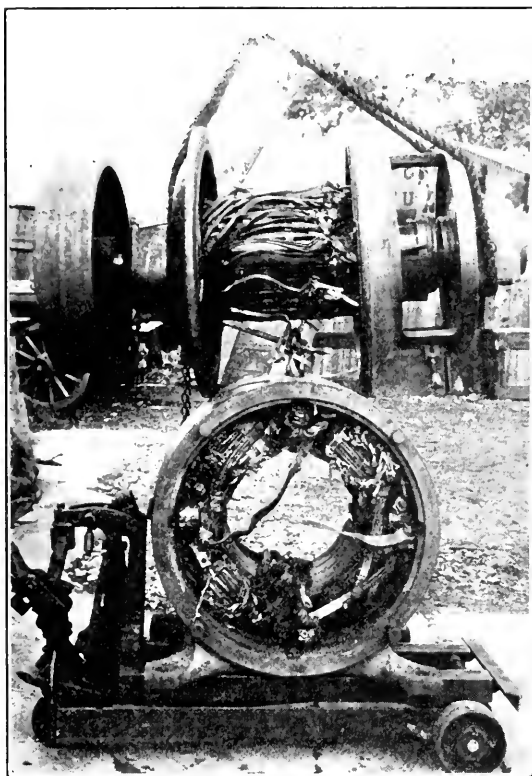
FIG. 1.

Direct current motors are divided into three general classes — series, shunt and compound wound — each of which has characteristics particularly adapting it to certain kinds of work. The series motor for instance, is almost invariably used for traction and hoisting work where frequent starting under heavy loads is the rule, because it can exert a maximum torque or turning effort when starting. There is only one circuit to such motors, as the armature and field windings are connected in series. All of the armature current therefore passes through the field,

and as the torque or turning effort in a motor is proportional to the armature current multiplied by the field current, the torque in the series motor is approximately proportional to the square of the current — within certain limits. When starting or when the motor is slowed down due to load, less counter-voltage — or counter-electromotive force\* as it is usually called — is generated and hence more current is drawn from

the line. The torque therefore increases with the load. On the other hand, as the load falls off, the motor speeds up due to the decrease in the field current, and if the speed is not checked it will race to destruction. Series motors ought, on this account, to be hand controlled.

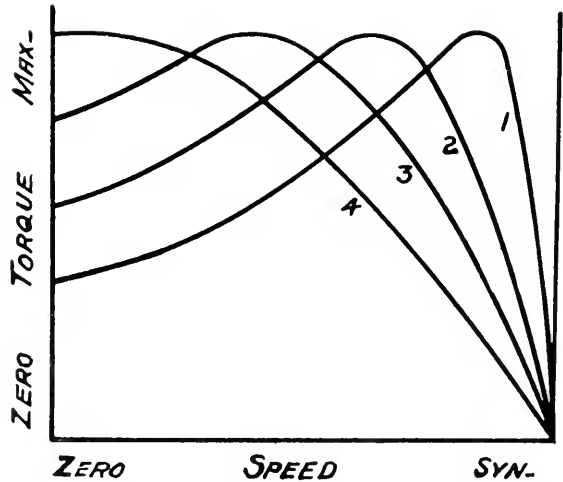
FIG. 2. CURVES SHOWING EFFECT ON LOAD OF EXTERNAL RESISTANCE IN ROTOR CIRCUIT OF WOUND ROTOR MOTORS.

There is one other interesting point that is well shown by this diagram and which applies either to a squirrel cage motor or to the wound rotor motor with resistance short circuited. Imagine the motor running idle. This condition is represented by the right hand end of curve 1. If a load is gradually placed on the machine, we would be traveling

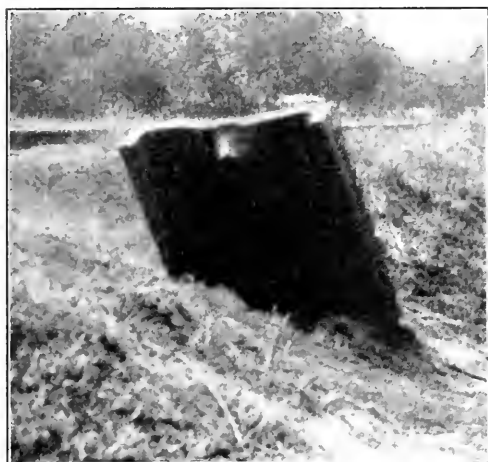
FIG. 2.

Fig. 2 shows a piece of the rim of the wheel as it landed near the Pennsylvania Railroad tracks 700 feet west of the engine room. This piece was estimated to weigh 2100 lbs. Fig. 3 shows portions of the rims of both wheels just as they landed on the right-of-way of the Grand Truck Railway approximately 800 feet east of the plant; and it is interesting to note that these portions of the two wheels are still joined by a small bolt, which would indicate that the wheels failed simultaneously. It is also to be noted that the flange joints shown are still intact.

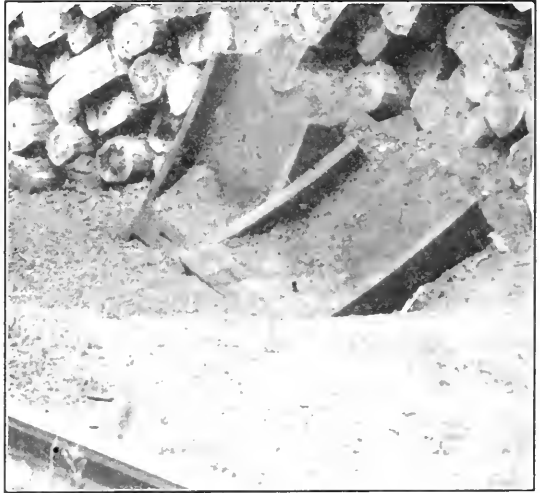
FIG. 3.

The distances which pieces of the wheel traveled afford an opportunity to calculate the minimum speed of the engine at the instant of the explosion. The formula used is the usual projectile formula:—

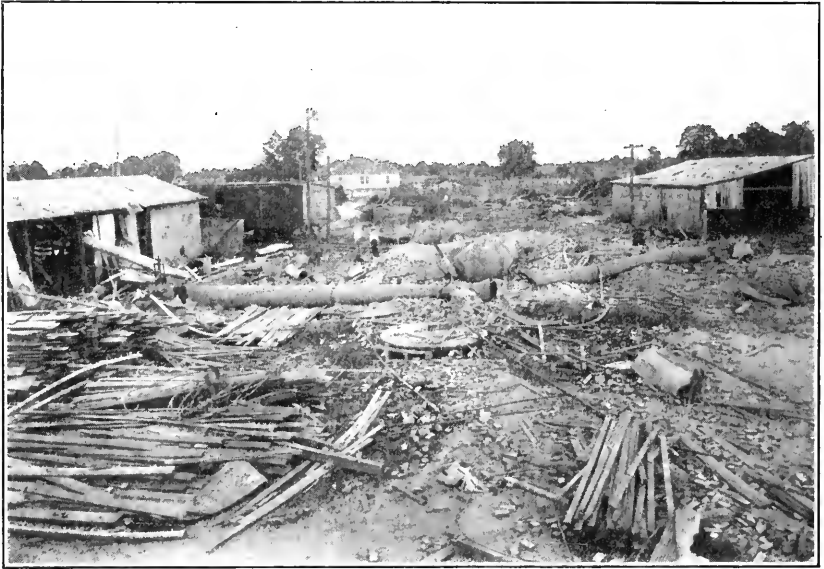
FIG. 1.

**T**HE approximately simultaneous explosion of two boilers occurred August 14, 1926, at the plant of the J. H. Self Lumber Company, Ninety Six, S. C. Seven persons were killed and three were injured. The property loss was estimated to be \$15,000. A general view of the scene is given in Fig. 1.

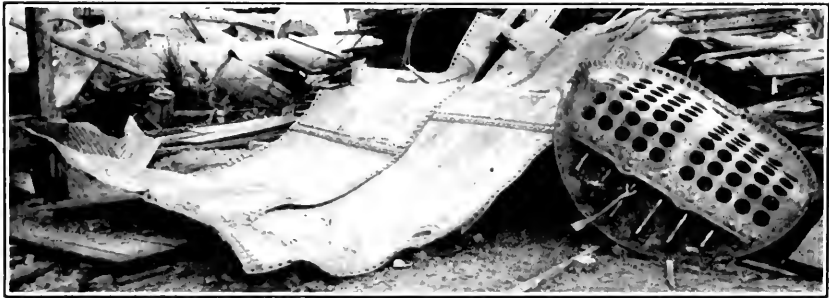
FIG. 2.

The boilers that exploded were of the horizontal return tubular type, 60 inches in diameter and, respectively, 14 and 16 ft. long, of

double riveted lap seam construction. One of them was said to have been 43 years old and the other one 25 years old, although they had been in the present location but three years. The 43 years boiler failed along a row of rivets in the longitudinal seams of the rear and middle courses, much the same as in the case of a lap seam crack failure. In this instance, however, there was no sign of a crack, the entire break being fresh. These two courses opened out flat and, together with the rear head, moved only a few feet from the site of the boiler room. They are shown in Fig. 2. The rear course and head, intact, traveled about 100 feet in the opposite direction. The dome of this boiler was blown a distance of approximately one-half mile.

Boiler number 2, said to have been 25 years old, failed by shearing all of the rivets in the girth seam between the middle and rear courses. The front and middle courses and front head, with most of the tubes, moved about 100 feet forward, while the rear course and head were blown about 600 feet to the rear. There was no dome on this boiler, and the boiler itself did not suffer general disruption. The boiler room, of course, was leveled, but the nearby engine room fortunately suffered little damage. The property loss might very easily have reached a far greater figure had any of the projected parts of these boilers gone in the direction of a nearby cotton mill, as the machinery of such mills is delicate and expensive. So far as could be learned, there was no insurance on this installation.

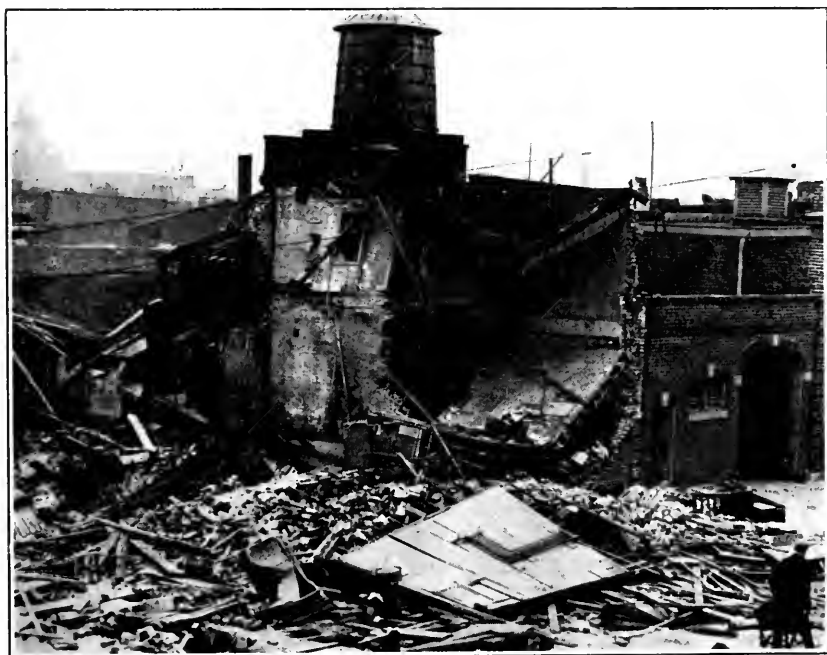
AMMONIA GENERATOR EXPLOSION AT PHILADELPHIA, PA.

**A**N autogenously welded generator in the absorption refrigerating system at the Stenton Park branch of the Scott-Powell Dairies, Philadelphia, Pennsylvania, exploded July 29, 1926. Four persons were injured, one of them fatally, and the portion of the building that had housed the refrigerating plant was razed. The property loss was estimated at \$15,000. A general view of the scene shortly after the accident is shown on the front cover.

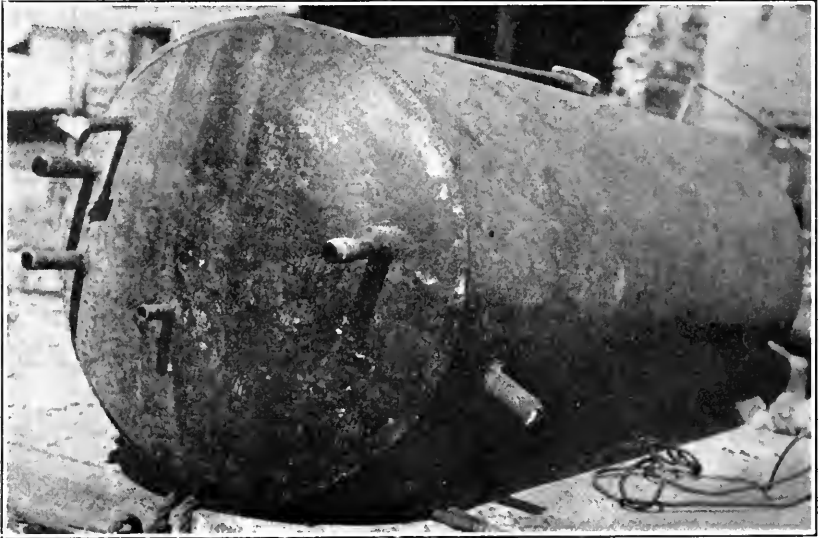
FIG. 1.

The tank that exploded was 43 inches in diameter by 10 ft. long, and was  $7/16$  inch thick. The heads were of the convex, or plus, type, approximately  $17/32$  inch thick. They were flanged and fitted inside of the shell, the turn of the flange being then welded to the end of the shell. Figure 1 shows a duplicate of the exploded vessel that was part of a standby unit. The exploded vessel was of autogenously welded construction throughout, all longitudinal and girth seams having been made by that process. It had been installed about five years previously. It was equipped with a safety valve. The operating pressure varied from 150 to 225 lbs.

The cause of the accident is not known, but it is believed to have been due to failure of a welded seam at ordinary working pressure. One head blew out, the separation taking place entirely in the weld.

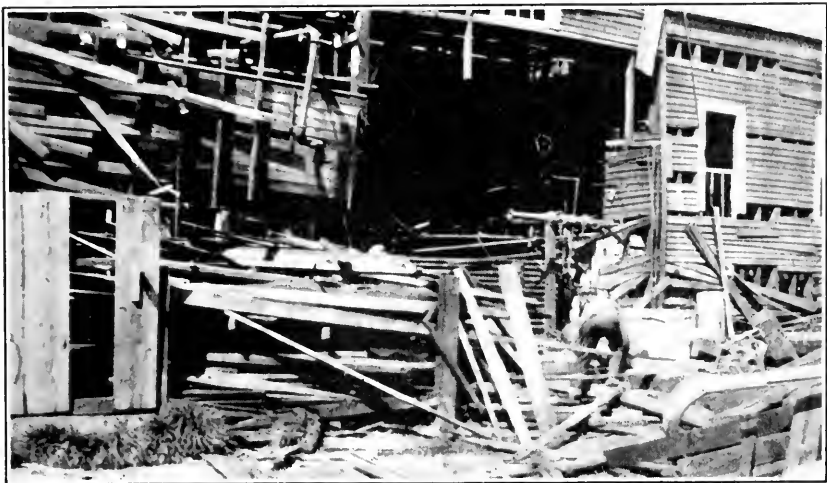
FIG. 2.

The explosion occurred about 4:50 A. M., approximately half an hour after twenty-five or thirty drivers had loaded their milk wagons and left the plant with the morning delivery. Because of this, the refrigerator was empty, and the plant was not operating at its full capacity. Yet the explosion was extremely violent, as can be observed from the picture. The refrigerating machinery was located in the basement at the left-center of the picture, under the debris at the edge of the partition which is lying flat in the foreground with pipe coils attached. The building was completely destroyed, and the 500 gallon water tank on the roof of the adjacent building was left in a pre-

carious position such that it had to be immediately removed to overcome the danger of its falling. Heavy steel beams were blown 200 ft. away, into the park across the street, and telephone and electric wires in the adjoining streets were carried away. The shell of the generator was driven through an 18 inch stone basement wall and into the earth embankment beyond.

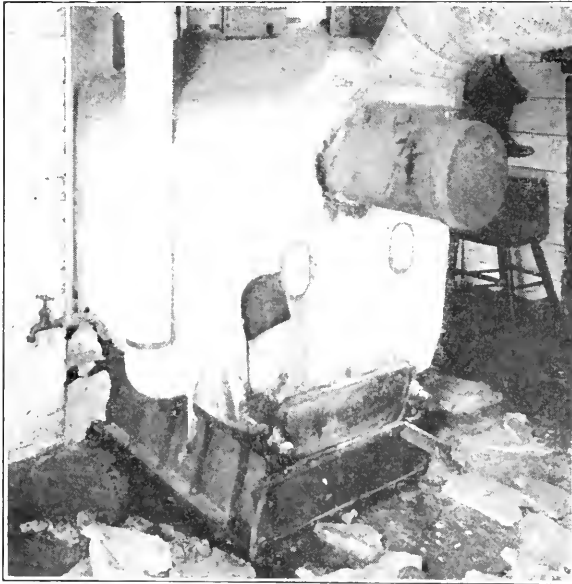
**N**OT only was a residence in Fremont, Ohio, deprived of heat at a cold season of the year, but the cellar walls and furnishings of the first floor were damaged by steam and dust when over-pressure blew a piece out of a cast iron hot water boiler, on December 8. The accompanying photograph gives an idea of the destructive force exerted by water when an attempt is made to constrain its natural expansion while it is being heated.

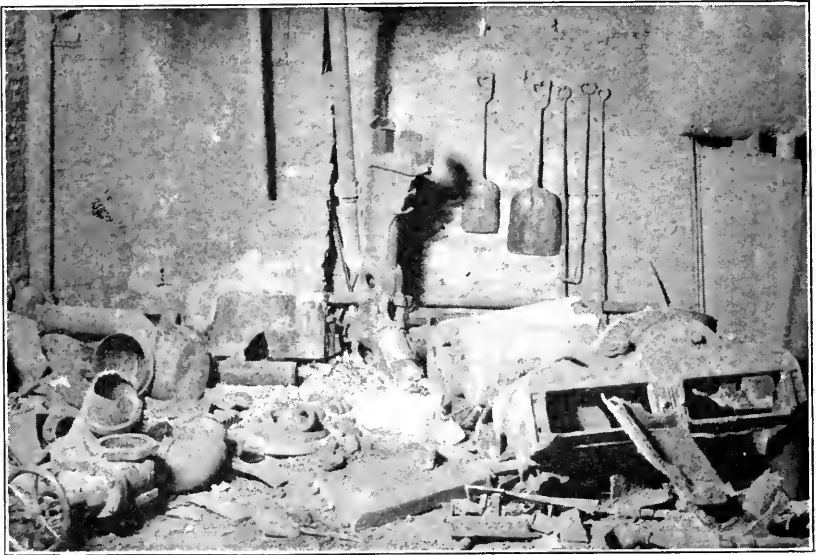
*Figure 2*

At the Y. W. C. A. in York, Pa., a hot water supply boiler was used to heat water for the swimming pool. Feed and discharge connections led directly to the pool, the boiler taking cold water from the bottom of the pool and delivering hot water near the top. Operating thus as an open system, there appeared to be little prospect of danger arising from over-pressure. Yet on April 9th this boiler blew up with

considerable violence, as may be seen from the accompanying illustration.

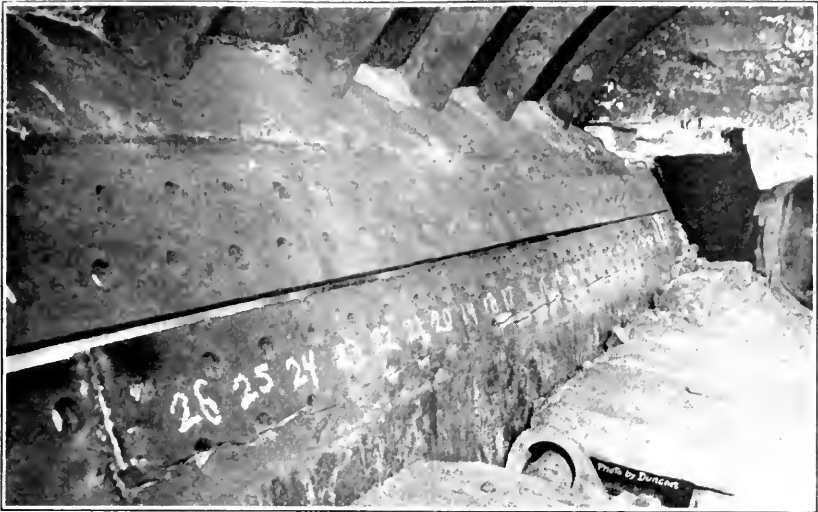
*The destructive work of caustic embrittlement is plainly evident in this steam drum of a water tube boiler. Removal of the strap after a Hartford inspector had discovered symptoms of embrittlement disclosed a crack extending through 27 rivet holes. Two other boilers in the plant were found similarly affected.*

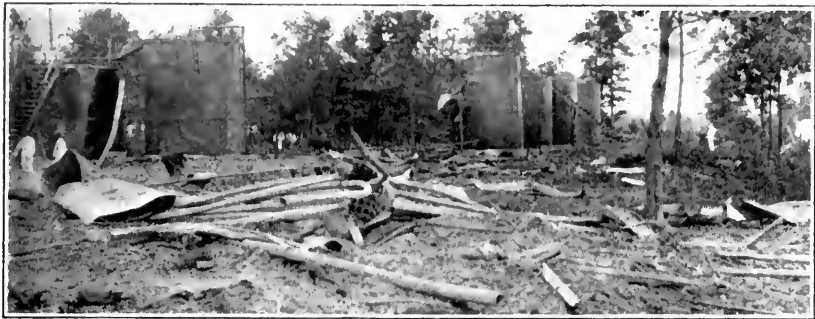
The exploded boiler was of the locomotive two-course type with safety valve set to relieve at 150 pounds. It was blown into four parts, the smoke box end, consisting of one course and tube sheet, being torn loose at the girth seam and hurled about 325 feet. During the course of its flight it tore away the side of a large tank.

Parting from the wrapper sheet, the first course was ripped through its entire length parallel to and on the opposite side from the butt strap seam. This sheet crushed the side of another tank 300 feet away.

Overpressure seems to have caused the explosion, though failure to find the safety valve after the accident prevented investigation of the supposition that it had stuck.

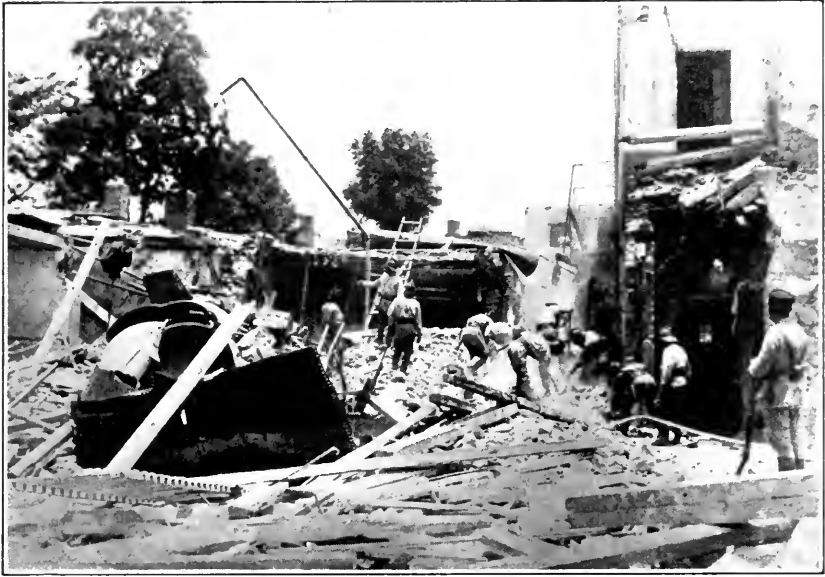
proved fruitless because the engineer, as well as his wife and son who had brought his lunch and eaten with him, was killed instantly. A bath house attendant told police that, while the engineer was eating, the boiler ran low in water and became overheated. He said the explosion followed an attempt to feed in cold water. This explanation scarcely seems plausible, however, in view of the great amount of

energy that must have been required to wreak the havoc indicated by the photograph.

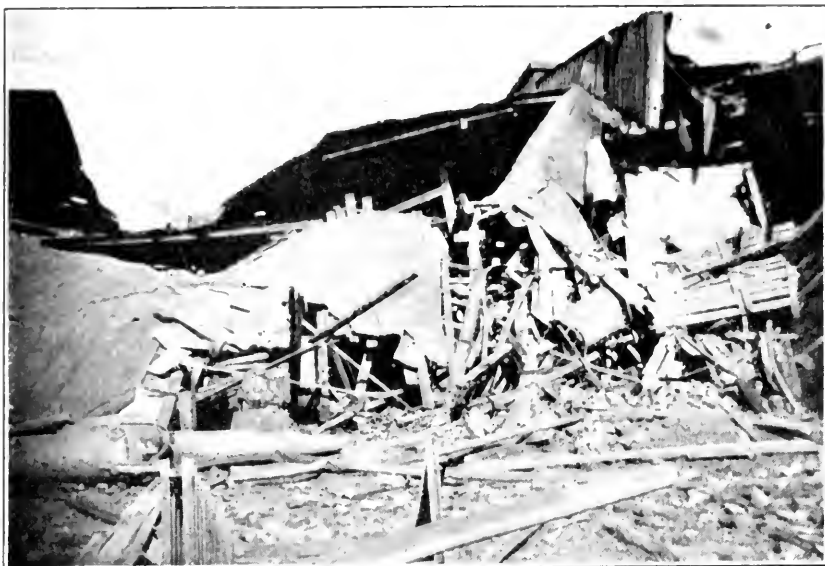
*Excessive internal corrosion in a horizontal tubular boiler at a brick yard in Richmond, Va., caused the explosion shown above. The accident demolished the building and wrecked an engine, causing property damage of almost \$10,000.*

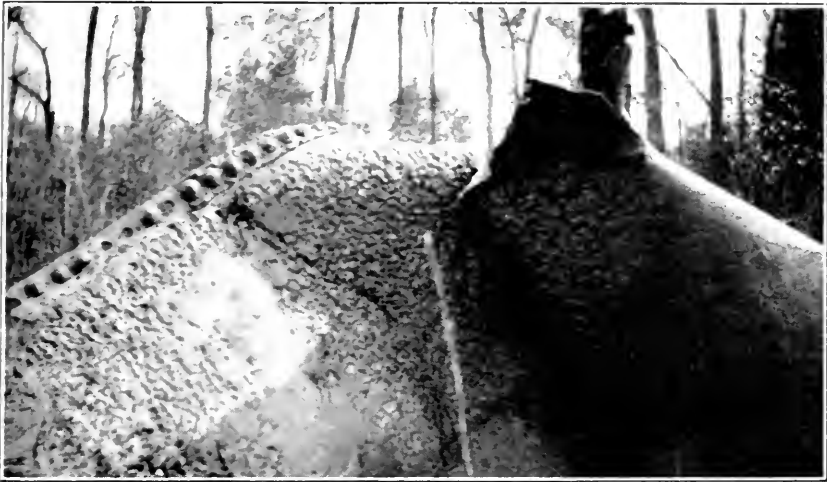
The boiler was fired up next morning, and a moment after the safety valve popped the boiler ruptured from end to end through the bottom of all three courses. At the same time the courses were separated at the girth seams, the solid plate tearing circumferentially parallel to the seams rather than through the rivet holes. A part of the

boiler was blown a distance of 225 yards, landing within a few feet of the owner's residence. Another large piece, consisting of most of the front head, was hurled over the mill and a railroad siding, coming to rest 190 yards from the point where it started. Four persons were

killed outright; two others died in the hospital. Property damage alone was approximately \$10,000.

The owner carried no boiler insurance, so it is not probable that the boiler was examined by a competent inspector when it was brought to the sawmill and set up. An inspector would surely have noted the dangerous extent to which the shell had deteriorated, for even in the accompanying photograph it can readily be seen that corrosion and pitting had eaten down the metal alarmingly.

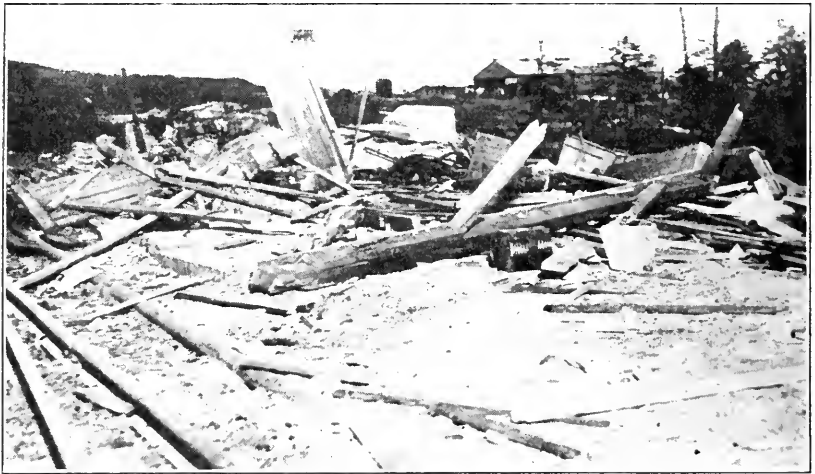
**S**EVEN men were killed and ten were seriously injured at the quarry of Stone Mountain Granite Corporation near Atlanta, Georgia, on February 22, when an air tank head blew out and crashed through the timekeeper's crowded office. Four of the victims were dead when fellow workmen pulled them from beneath the wreckage; three died on the way to a hospital. The photograph shows the remains of the small wooden building which was demolished as completely as though it had

been bombed. The tank was located about 20 feet away and was pointed directly at it.

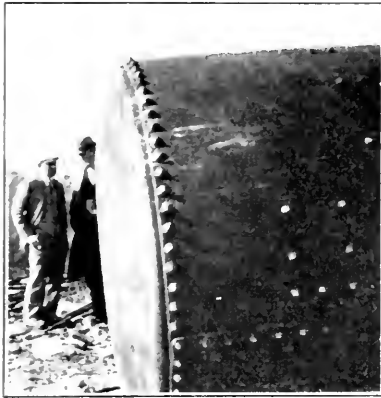
An examination of the head revealed that, with the exception of the place where the welding was applied, the flange showed no evidence of the existence of an old crack. From all appearances the metal gave way simultaneously around the entire circumference of

the head. Apparently lack of sufficient thickness and depth in the bumped head allowed bending at the flange as the head "breathed" in and out with the variations in pressure. Eventually this flexing weakened the flange to the point where it gave way.

On the morning of the accident a short crack appeared at the knuckle of a head flange. Pressure was taken off immediately and the repair gang set to work welding the crack. After a test for tightness pressure was again turned on and the tank lasted throughout the after-

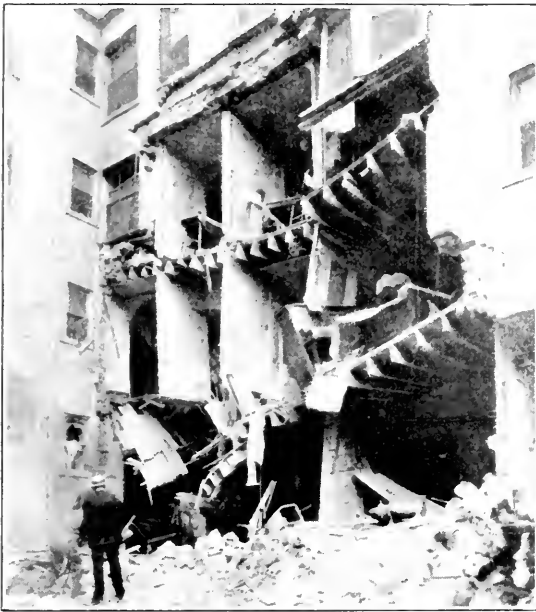
*Figure 1*

Those who examined the wreckage of the boiler believe that over-pressure caused the accident. The evidence pointed to the sudden release of a tremendous amount of energy, for the wrapper sheet unwound completely by bursting the welded seams and pulling away from the staybolts. There were no signs that the metal had been previously weakened by over-heating, and the fusible plug was found to be unaffected. It seems probable that the fault lay in the safety valve, although the valve was so badly damaged in the accident that this supposition could not be verified.

Thus it is evident that the only safeguard against over-pressure was the safety valve, for during hours when the demand for hot water was least the fire would put heat into the boiler water faster than the heating coils could extract it.

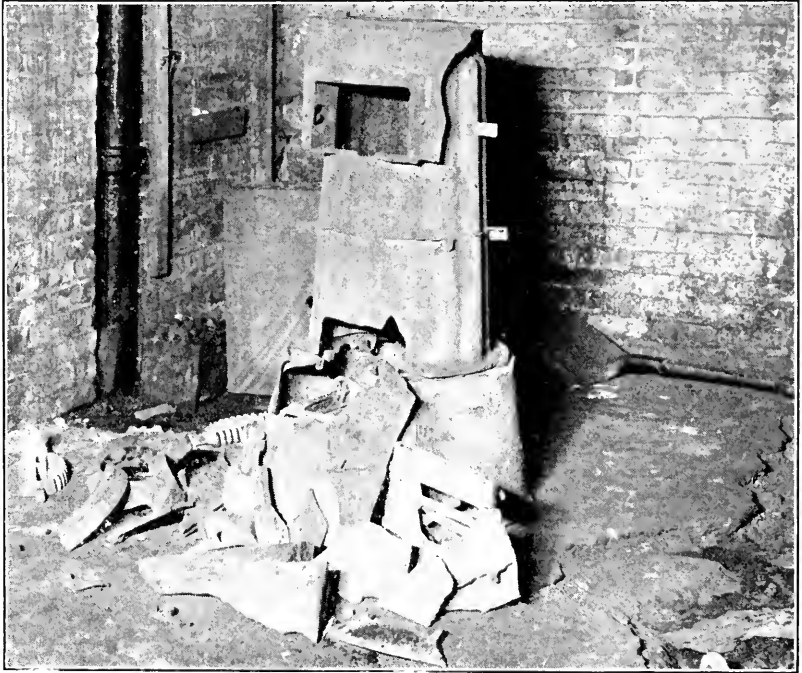
*Figure 2*

On the morning of the accident the janitor instructed the fireman to shut off the hot water supply so as to give him an opportunity to repair a leaky faucet. The fireman followed instructions to the letter, closing off, among others, the valves between the boiler and the hot

water supply tank. As the boiler had not been provided with a relief valve, it took but very few minutes for the rapidly accumulated pressure to exceed the strength of the cast iron. A severe explosion was the result.

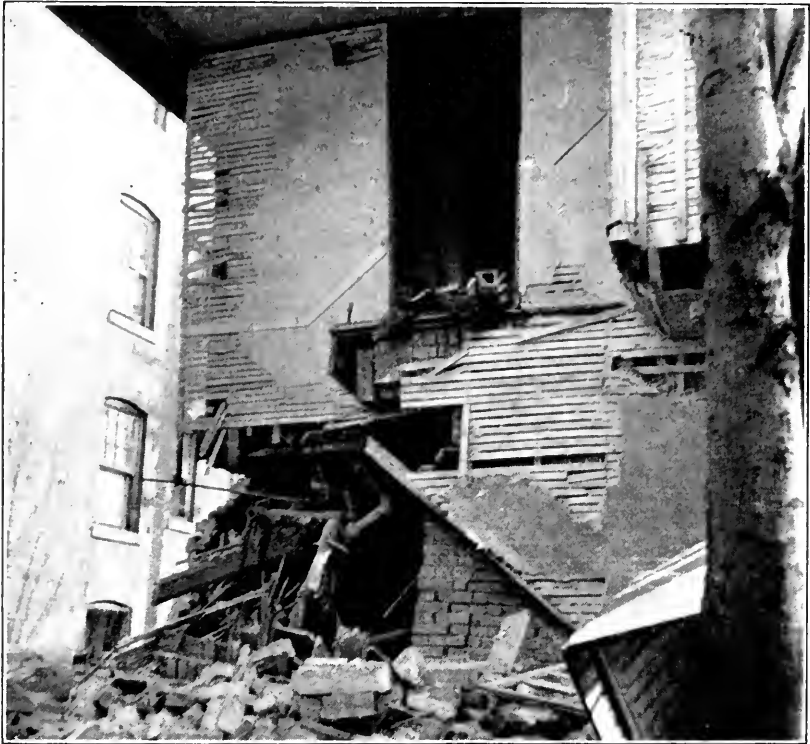
*Figure 3*

extent of about \$10,000 by the explosion of an oil-fired cast iron hot water supply boiler, on June 12th. This blast was so violent that it raised the first floor of the building more than an inch, wrecking equipment in the basement and damaging foundation walls severely.

A two-inch relief valve on a hot water supply tank directly connected to the boiler was depended on to prevent over-pressure but,

as has happened in many other instances, the valve disc had stuck to the seat and the valve was unable to open. Moreover, a check-valve in the supply line prevented such relief as would have been obtained had the pressure been able to back water out into the city mains.
