LAUNCH VEHICLE FLIGHT REPORT

NASA PROJECT APOLLO
LITTLE JOE II QUALIFICATION TEST VEHICLE 12-50-1

27 September 1963

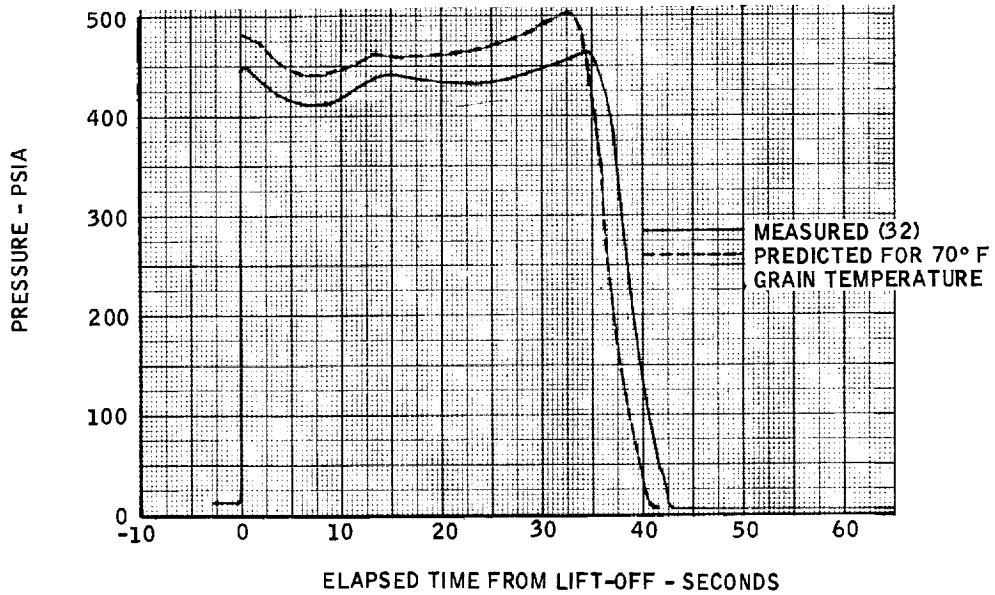
Figure 4-2. Algol 1D, Mod 2, LJ-6 Chamber Pressure

The Algol rocket motor operation was normal. Chamber pressure and burning time are shown in Figure 4-2. Predicted web burning time of this motor, with a propellant grain temperature of 70° F, was 33 seconds at an average chamber pressure of 465 psi. Actual web burning time was 35 seconds with an average chamber pressure of 436 psi.
