GEMINI PROGRAM MISSION REPORT

GEMINI VII

JANUARY 1966

NATIONAL AERONAUTICS AND SPACE ADMINISTRATION MANNED SPACECRAFT CENTER

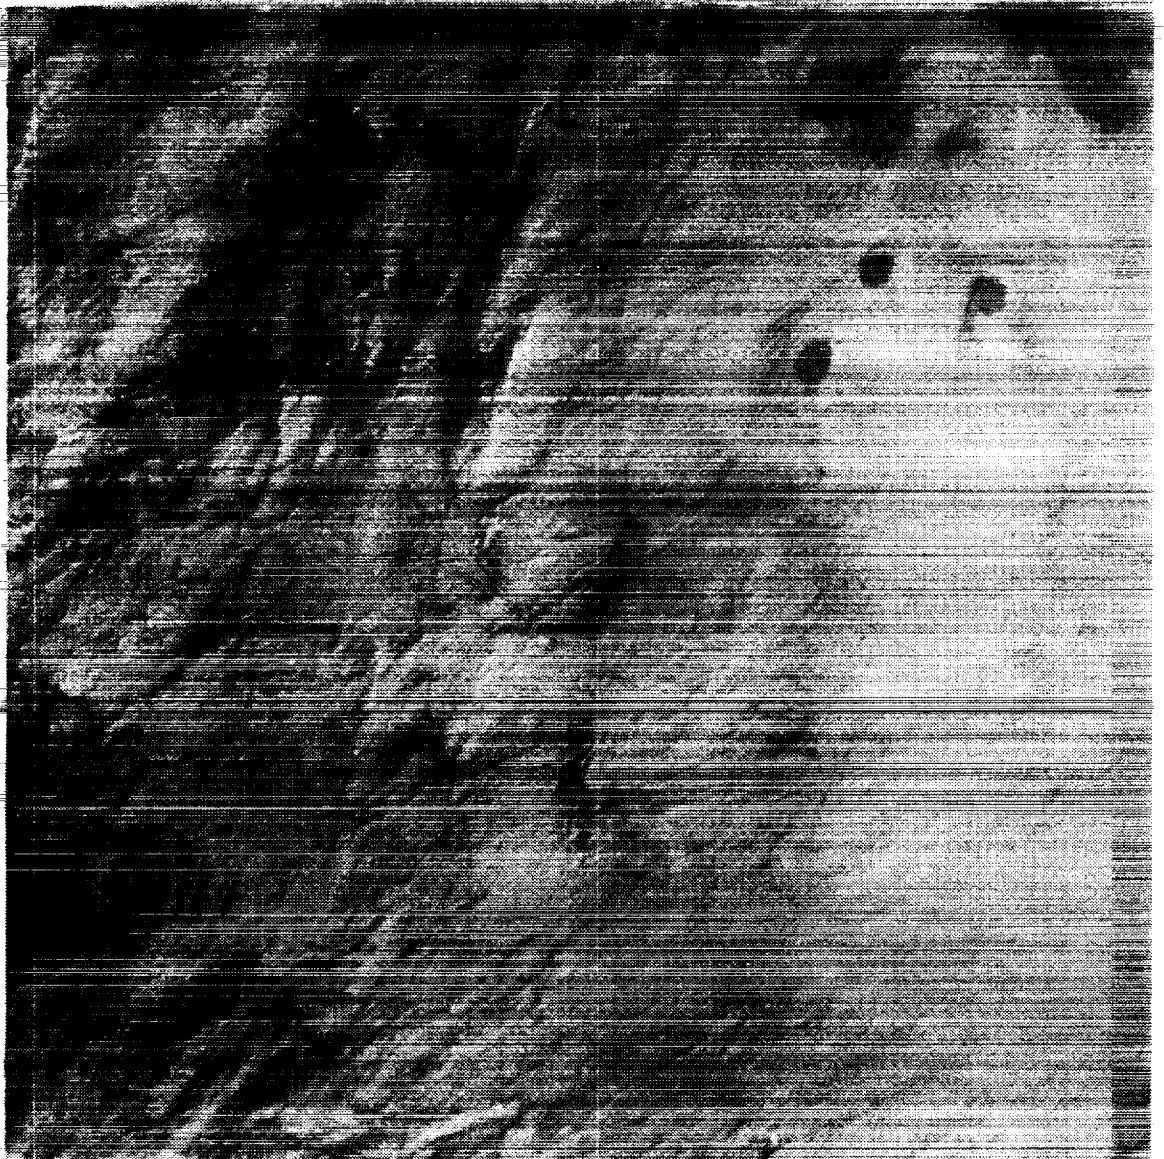
(a) View taken at approximately 12:56 G.m.t. on December 8, 1965 during revolution 57 north of Venezuela over the Caribbean Sea. The three distinct holes in the cloud deck are likely caused by small islands influencing the stability and motion of the atmosphere in their vicinity.

Figure 8.17-1. - Experiment S-6, a series of three typical synoptic weather photographs.
