MSC-01855

APOLLO 12 MISSION REPORT

MARCH 1970

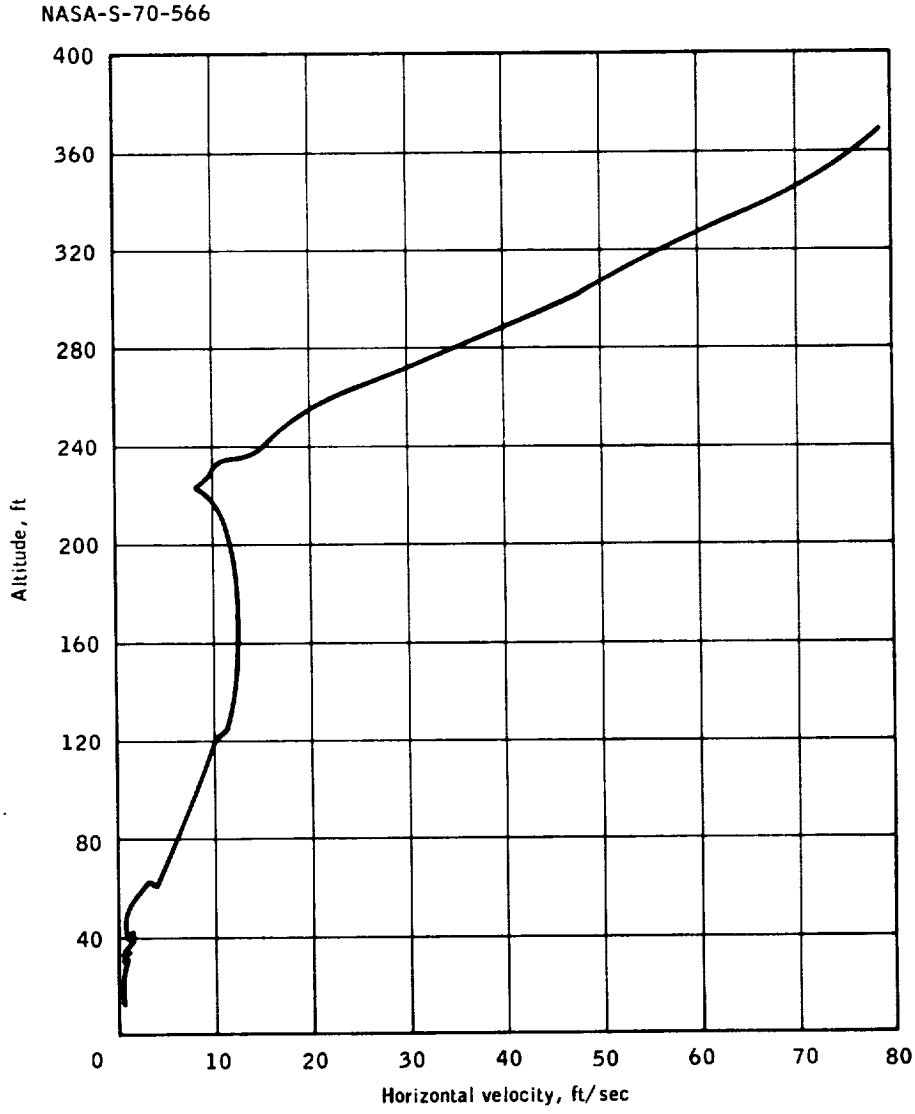
Figure 4-12.- Altitude and velocity calculated onboard during the final descent phase.

altitude in figure 4-12, which indicates the descent was essentially vertical from the 50-foot altitude and that the horizontal velocity displayed was less than 1 ft/sec at times. The display is serviced by the computer every 0.25-second in 0.55-ft/sec steps. If the Commander's observation was made with an actual velocity of less than 1 ft/sec, it is possible that a near-zero reading could have existed. There are no data indications of abnormal hardware or software performance associated with the cross-pointers, and the pointers operated properly during ascent.

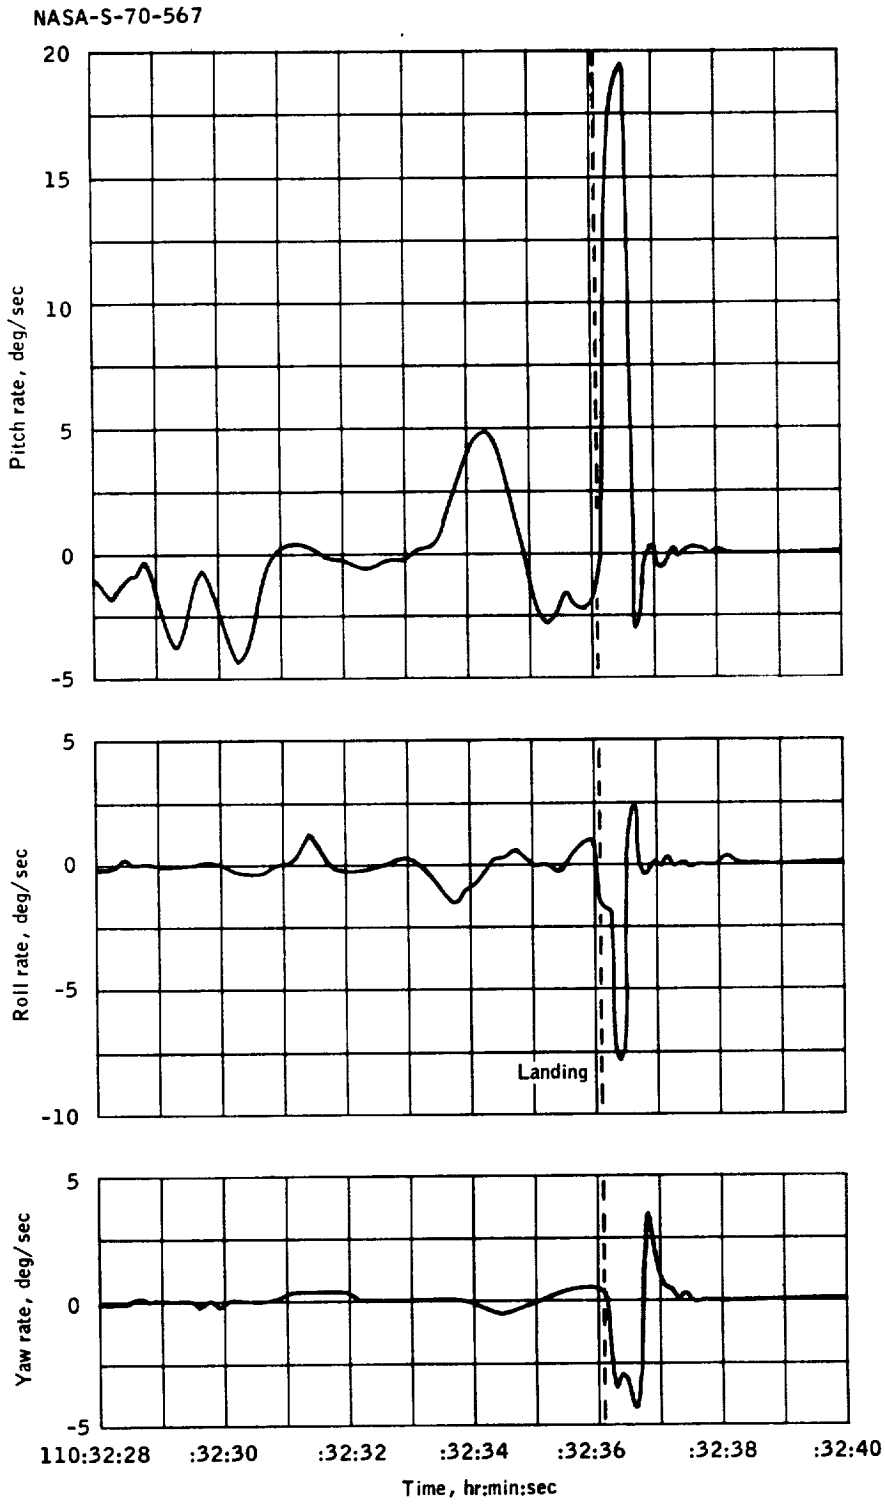
Figure 4-13.- Expanded plot of attitude rates during landing.

Figure 4-13 contains a time history of attitude rates near lunar touchdown, which occurred with first footpad contact at 110:32:36. The vehicle came to a stable rest within 1.5 seconds of this time. The descent engine stop button was activated approximately 1.3 seconds prior to first pad contact, and the engine thrust was consequently in a transient decay at the time surface contact occurred. The vertical velocity at the time the engine stop button was activated was approximately 0.4 ft/sec downward and increased to about 3.2 to 3.5 ft/sec before first footpad contact. At the time of contact, the forward velocity was approximately 1.7 ft/sec, with a lateral velocity to the crew's left of about 0.4 ft/sec. The final resting attitude, as viewed by the crew, was 3 degrees up in pitch and a 3.8-degree roll left, which indicates a surface slope of about 4 or 5 degrees downward to the left and rear of the crew. Pitch and roll attitudes at contact were approximately 3 degrees down and 1.4 degrees left, respectively. The primary spacecraft motion during landing was a pitching motion from the 3-degree pitch-down attitude to the final 3-degree pitch-up attitude, with a maximum pitch rate during this period of 19.5 deg/sec. This pitching motion was accompanied by a slight left roll and right yaw motion, with maximum rates on these axes of 7.8 and 4.2 degrees per second, respectively.

Digital computer simulations of the touchdown indicate that all primary strut strokes were less than 2.5 inches and secondary strut strokes were less than 4.5 inches. Maximum vertical and lateral accelerations during touchdown were less than 1 and 0.2 g, respectively. The coefficient of friction between the footpad and the lunar surface was approximately 0.4. The landing was very stable from a tipover standpoint, since the maximum angle between the spacecraft vertical axis and the local gravity vector did not exceed 4 degrees. The conclusions from the computer simulations of the landing dynamics are substantiated by crew comments and photographs of the landing gear and local surface.

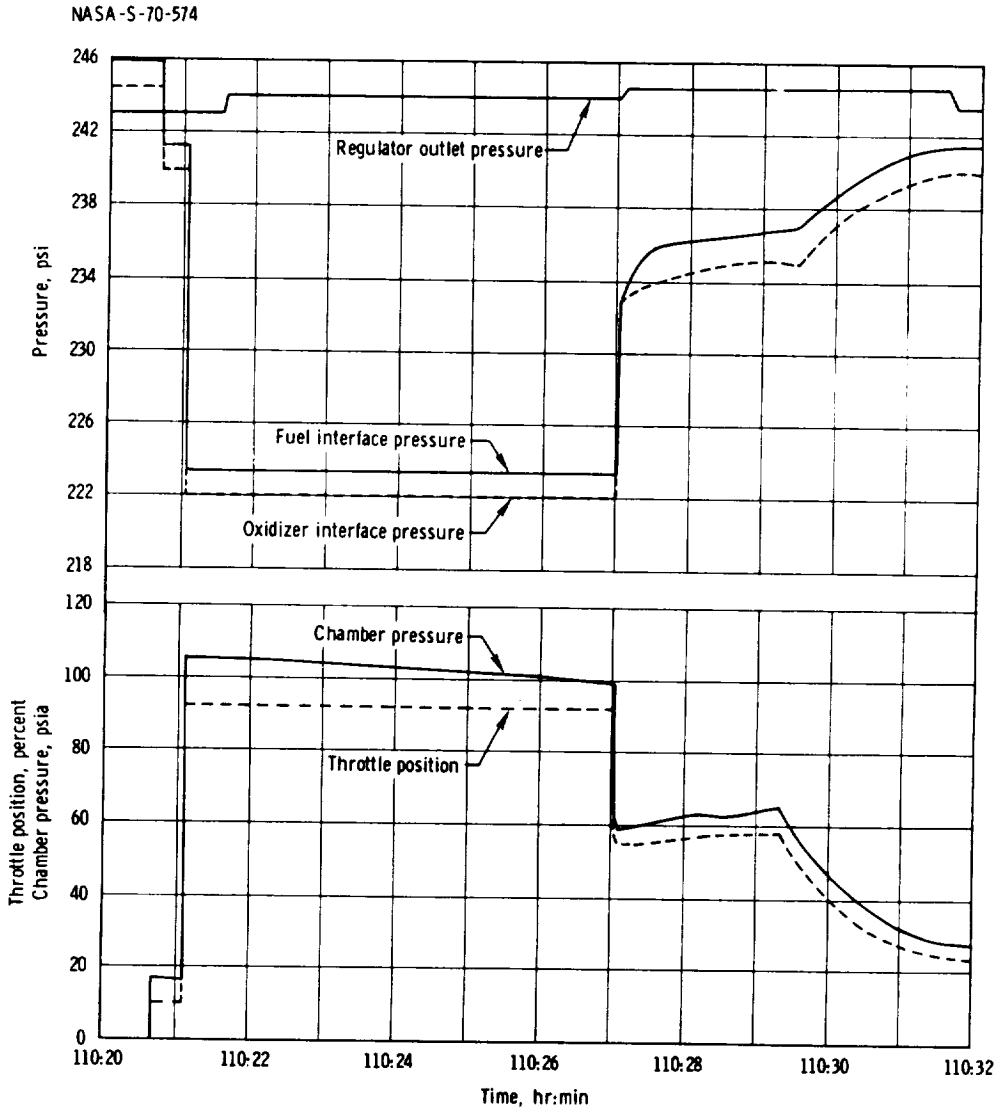
Figure 8.8-1. - Descent propulsion system performance.

The descent propulsion system performed normally during the 29-second descent orbit insertion maneuver. The powered descent firing lasted 717 seconds, and the system pressures and throttle settings are presented in figure 8.8-1. The data curve has been smoothed and does not reflect the numerous throttle changes made during the final descent. During powered descent, the oxidizer interface pressure appeared to be oscillating as much as 59 psi peak to peak. These oscillations were evident throughout the firing but were most prominent at about 55- to 60-percent throttle.

Oscillations of this type were also observed during the Apollo 11 descent. After the Apollo 11 flight, it was determined that the oscillations resulted from the instrumentation configuration and were not inherent in the system. Engine performance and operation were not affected in either flight.

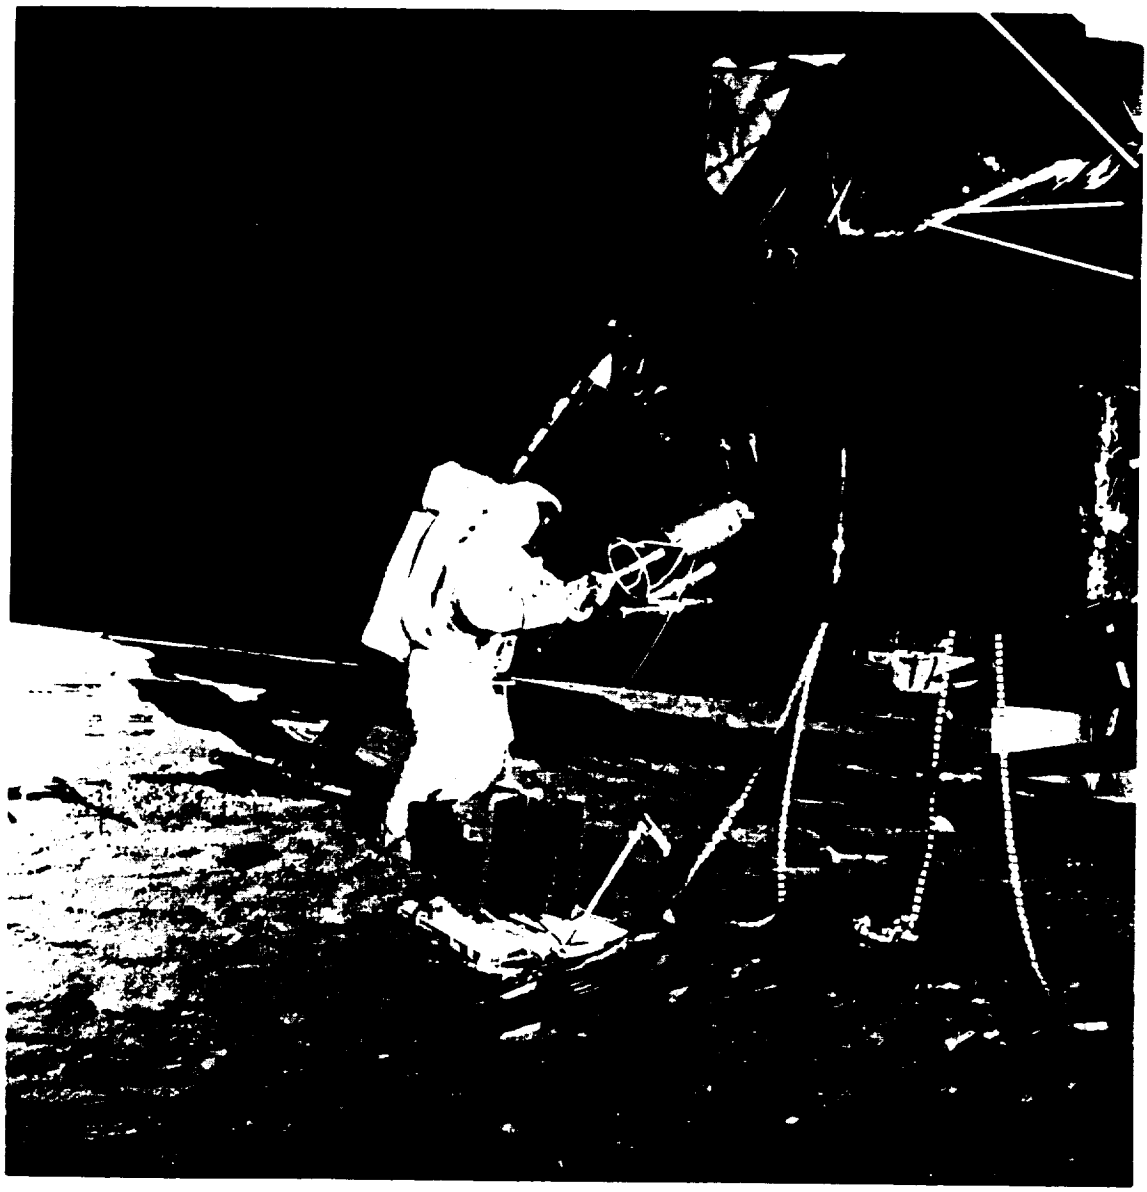
Figure 9-3.- Lunar Module Pilot extracting the fuel cask. The radioisotope thermoelectric generator is shown near the crewman.

The fuel element stuck in the cask (fig. 9-3) and could not be removed with normal force. By striking the side of the cask with a hammer

and exerting a positive pull on the element, it was possible to extend the element an additional 1/8 inch or so for each hammer blow. After the element had been extended about an inch, it became free and was removed and placed in the radioisotope thermal generator. The thermal generator was easy to fuel. Heat radiating from the fuel element was noticeable through the gloves and during the walk to the deployment site but was never objectionable.

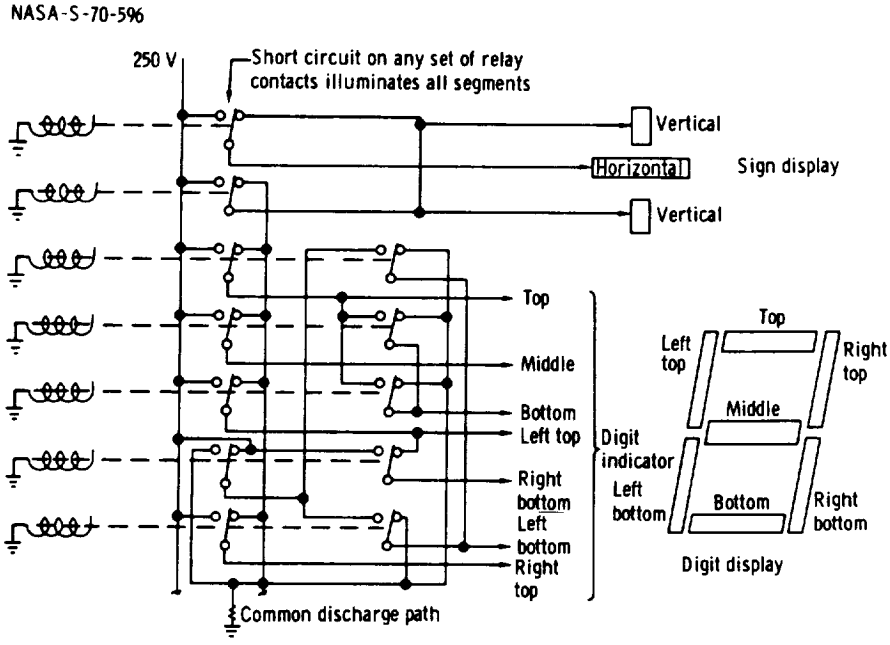
The crew reported several intermittent, all-"8's" displays on the main display and keyboard assembly approximately 1-1/2 hours before launch, but no display malfunction occurred in flight. The display segments are illuminated by applying 250 V ac through the contacts of miniature relays, as shown in figure 14-1. When a segment is off, it is grounded through a resistor and the normally closed contacts of a relay to avoid residual illumination. The normally closed contacts of all relays are tied together; consequently, a short across the contacts of any one relay will apply the voltage to all segments of each display. The effect of the short in conjunction with the common discharge path is shown in figure 14-1 for a typical character and one sign. A short across the relay contacts will affect only the display function of the unit.

Figure 14-1. - Simplified schematic diagram of relay matrix.

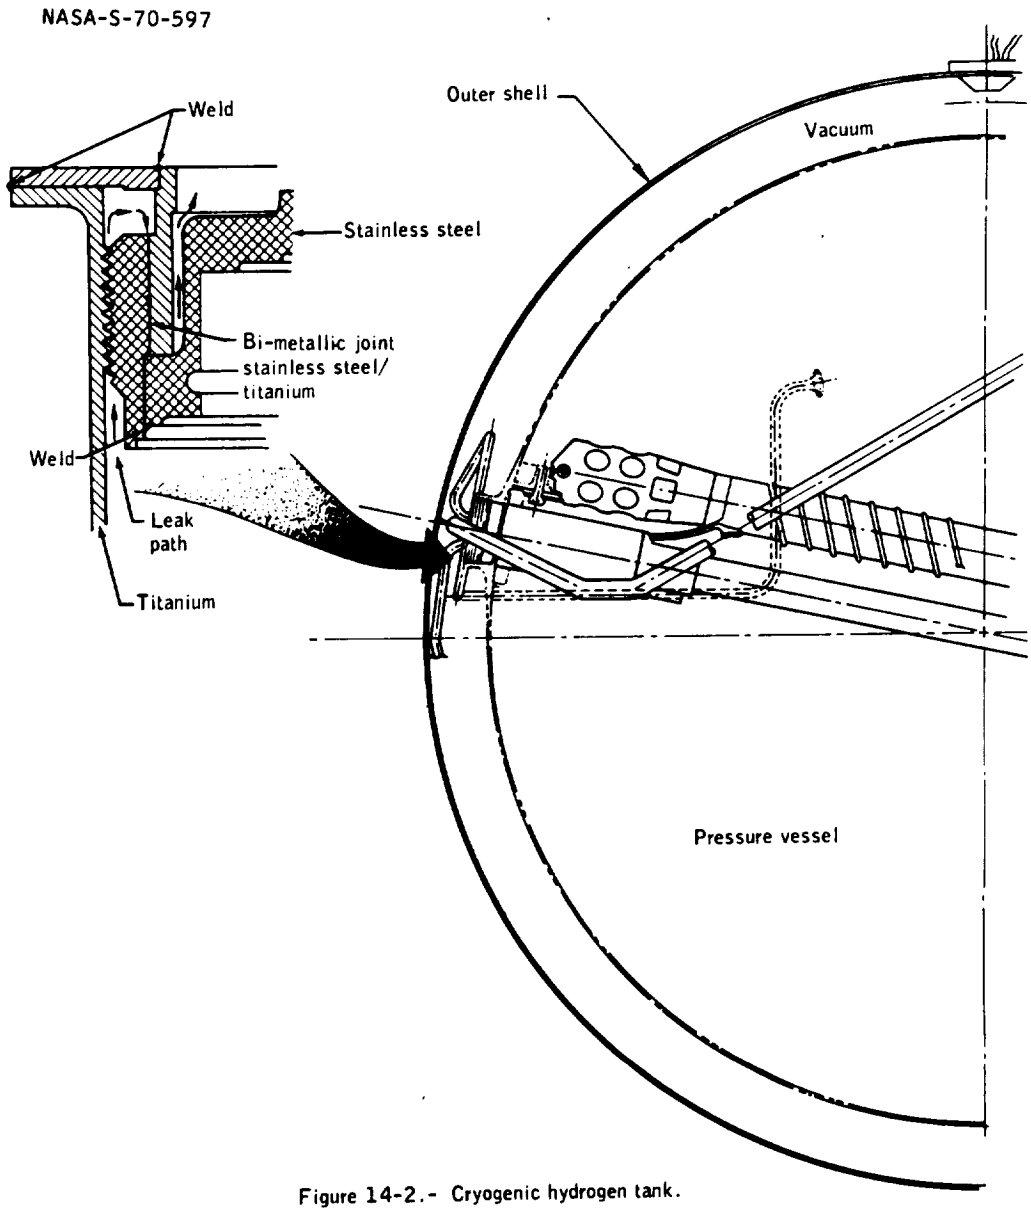
Figure 14-2.- Cryogenic hydrogen tank.

During cryogenic loading about 51 hours before launch, the heat leak of hydrogen tank 2 was unacceptable. Visual checks showed a thick layer of frost on the tank exterior, verifying an inadequate vacuum in the insulating annulus. The tank was removed and replaced. A failure analysis performed before launch identified the cause of the vacuum loss as an incomplete bond in the stainless steel/titanium bimetal joint, which permitted hydrogen to leak from the inner tank into the annulus (fig. 14-2). The bimetallic joint provides a seal between the two metals, which are not compatible for welding to each other. The joint is made from a billet such that the two metals are extruded together and machined. The machined fitting is welded in place, as shown in figure 14-2.

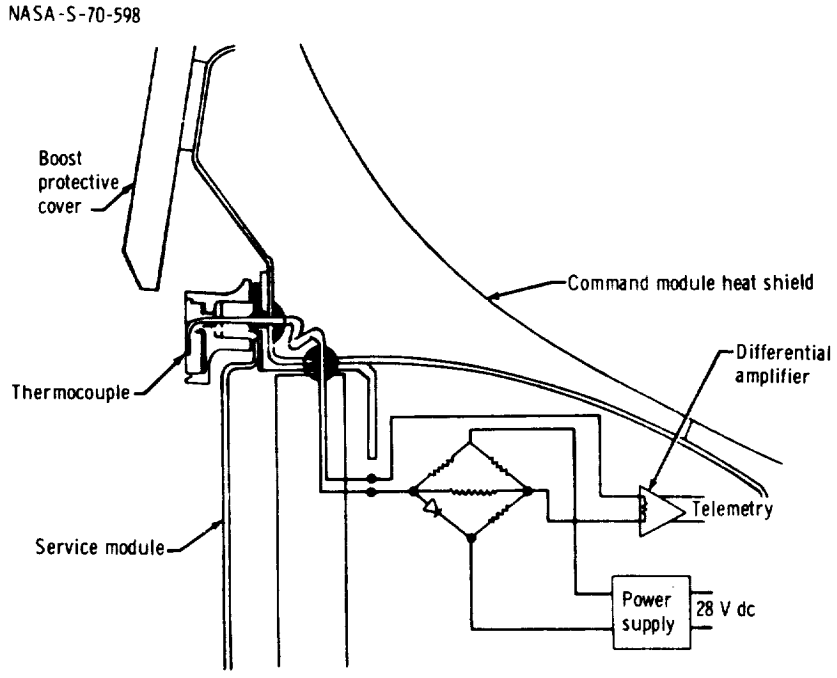
The service module outer surface temperature measurements use a chromel-constantan thermocouple and a reference junction. The reference junction is a bridge made up of three resistors and a temperature-sensitive diode (fig. 14-3). The resistors normally operate at about 0.020 ampere and will open in the region of 0.100 ampere. An open bridge resistor would drive the signal output off-scale high or low depending upon which resistor fails.

Figure 14-3. - Simplified schematic and location of a typical outer skin temperature sensor.

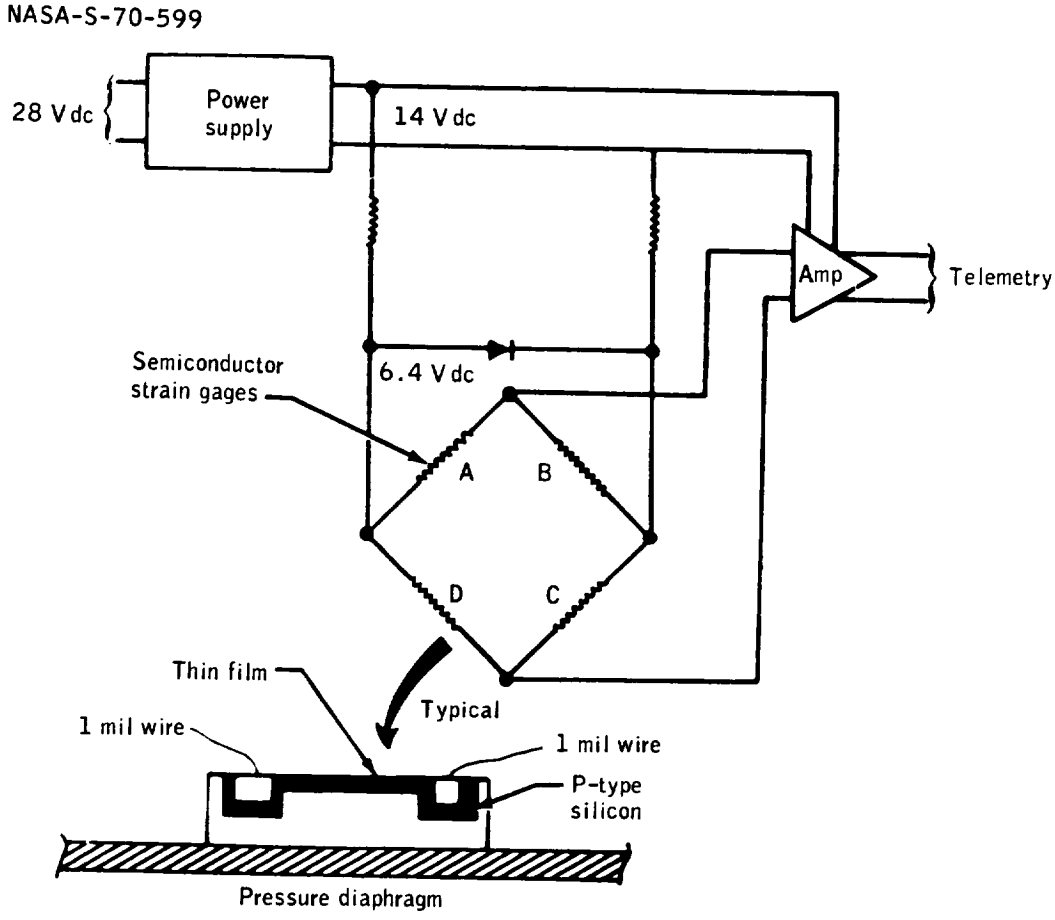
The reaction control propellant quantity measurements use semiconductor strain gages on a pressure-sensitive diaphragm (fig. 14-4). The semiconductors are a thin film type, and excessive current would probably damage their capability to operate as pressure-sensitive resistors. An alternate possibility is that the Zener diode, used to regulate the 14-volt supply to 6.4 volts, was burned out. Loss of this diode would explain the instrumentation symptom, which in all four cases was full-scale and unchanging.

Figure 14-4.- Propellant quantity transducer schematic.

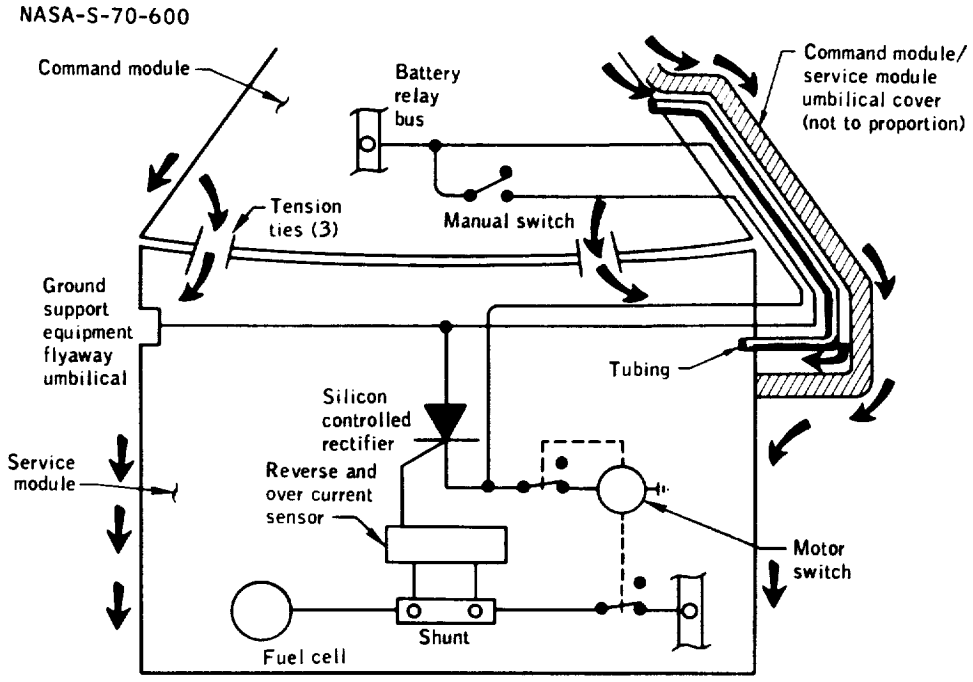
The voltage transient that was induced on the battery relay bus by the static discharge exceeded the current rate-of-change characteristics of the silicon controlled rectifiers in the fuel cell overload sensors and disconnected the fuel cells from the bus (fig. 14-5). As a result, the main bus loads of 75 amperes were being supplied totally by entry batteries A and B, and the main bus voltages dropped momentarily to approximately 18 or 19 volts, but recovered to 23 or 24 volts within a few milliseconds. The low dc voltage on the main buses resulted in the illumination of undervoltage warning lights, a drop out of the signal conditioning equipment, and a lower voltage input to the inverters. The momentary low-voltage input to the inverters resulted in a low output voltage which tripped the ac undervoltage sensor causing the ac bus 1 fail light to illuminate. The transient that disconnected the fuel cells from the buses also caused the silicon controlled rectifier in the overload circuits to indicate an ac overload. At 2 minutes 22 seconds into the flight, the crew restored fuel cell power to the buses. All bus voltages remained normal throughout the remainder of the flight.

Figure 14-5.- Fuel cell disconnection circuitry.

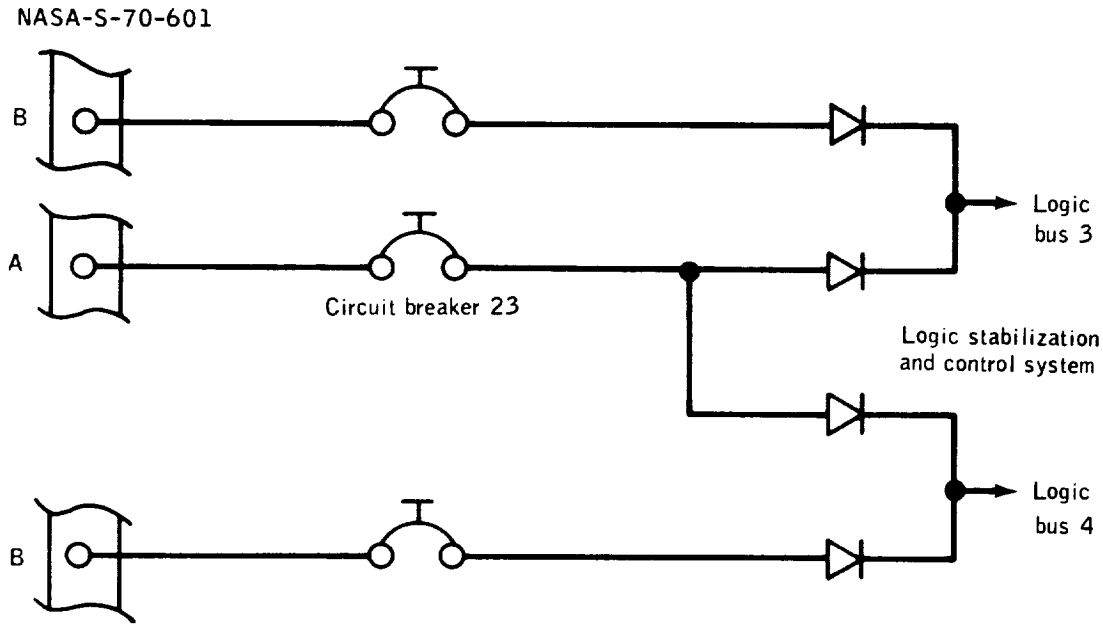
it remained closed throughout the rest of the mission. Complete electrical and mechanical tests were performed and the results were normal. The circuit breaker and associated circuitry showed no cause for the breaker to have opened either because of launch vibrations or an electrical fault.

Figure 14-6.- Stabilization and control circuit breaker schematic.

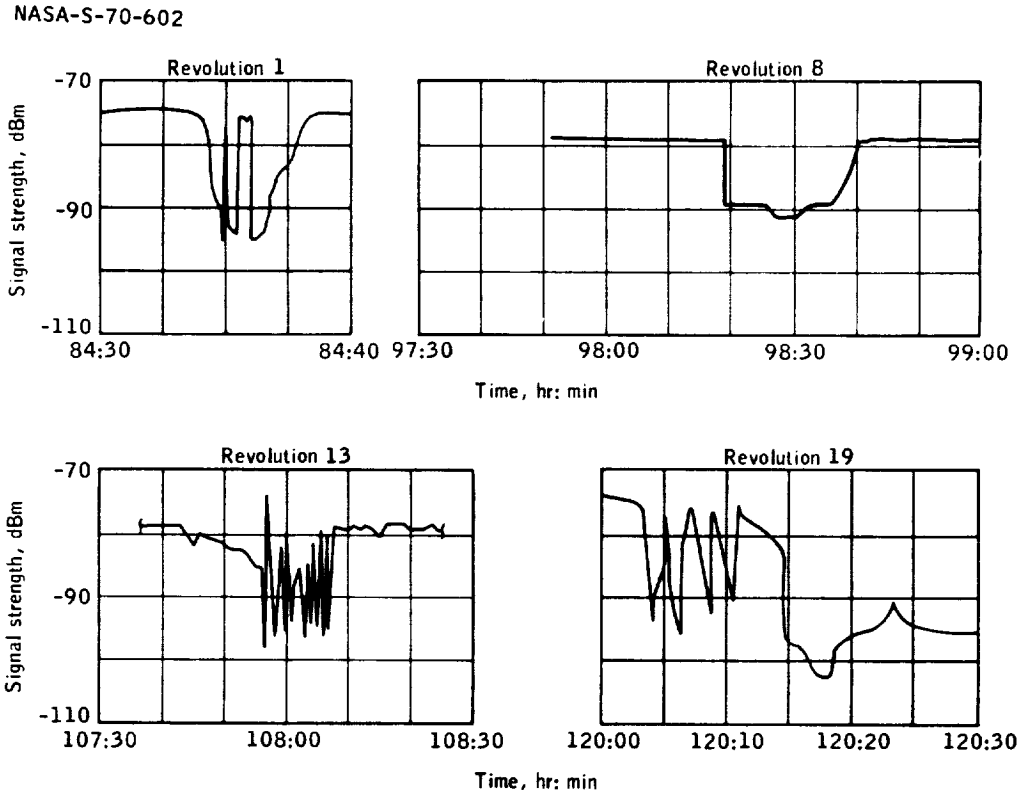
Operation of the S-band high gain antenna in the narrow beam mode resulted in a decrease of approximately 10 to 12 dB in both uplink and downlink signal strength on several occasions. Illustrations of the first and other unexpected signal-strength variations are shown in figure 14-7. The first decrease occurred in lunar orbit revolution 1.

Figure 14-7.- Typical high gain antenna uplink signal strengths during abnormal operations.

Two special tests were conducted during transearth coast with the spacecraft in attitude hold to isolate the malfunction. The sun angle was within approximately a 12-degree cone about the minus X axis to induce thermal stress on the antenna. In both tests, the narrow-beam and reacquisition modes were maintained until fluctuations in the uplink and

downlink signal strengths were observed. When a dropout appeared during the first test, the mode was changed to wide beam and the signal strength became normal. The second test included acquisition in the wide beam mode after signal-strength fluctuations had been observed in narrow beam, and normal signal levels were restored after acquisition.

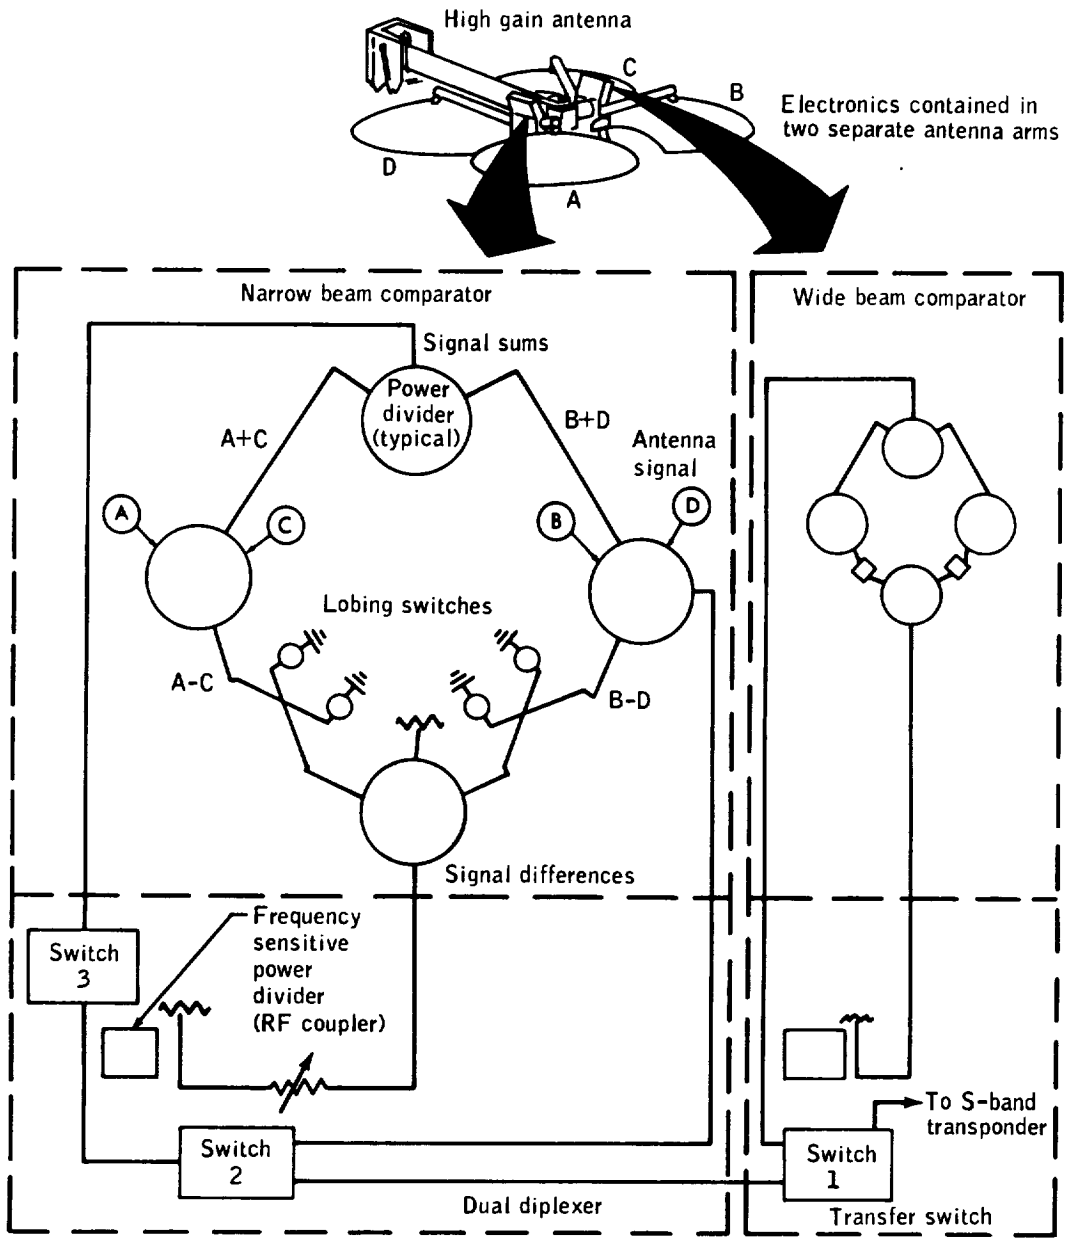
Figure 14-8.- S-band high gain antenna electronics.

There is a total of four stripline units with one contained in each of the following antenna components: narrow-beam comparator, transfer switch, and dual diplexer, as shown in figure 14-8. Based on the inflight tests, the wide beam comparator has been eliminated as a cause of the anomaly. Also, investigation of the circuitry and correlation of data has ruled out the transfer switch as being the anomaly cause. Therefore, the malfunction could only have been in the narrow beam comparator or the dual diplexer.

The narrow beam comparator combines the patterns of four dish antennas to provide the sum and difference patterns which provide the angle pointing information. Two malfunctions that could produce boresight shifts have been identified in the narrow beam comparator. Under normal operating conditions, the lobing switches function as digital phase shifters and provide either a zero or 180-degree phase shift. If a diode fault occurs that changes the phase or amplitude characteristics of either switch, tracking errors can be produced. The opening of one set of diodes would have to be intermittent to produce the observed flight anomaly, thus suggesting the presence of temperature or pressure sensitive connections in the traces that connect the diode switches. Another diode fault which can occur is a loss of the drive voltage to one of the lobing switches. In this case, the switch will provide a constant phase shift. The multiplexed difference signal for the case when the phase shift of switch 1 (fig. 14-8) is constant at 180 degrees results in unsymmetrical lobing. The antenna, in this case, will seek those pointing angles that make the elevation and azimuth angles equal in magnitude, thus suggesting that the resultant tracking error could be large and not repeatable. This condition would give the observed antenna performance characteristics. Therefore, a malfunction in the diode wiring or circuit connections is suggested. The intermittence associated with this malfunction could be explained by a temperature sensitive circuit connection (solder crack or wire break).

The major components of the dual diplexer are switches 2 and 3 and the frequency-selective power divider. The power divider is the most susceptible component for generating tracking errors. If the difference signal is attenuated by a high impedance feed-through or by incorrect phasing between the sum and difference signals, the slope of the antenna index-of-modulation curve is reduced. This decrease, in effect, reduces the total loop gain and results in an overdamped tracking system. In this case, large tracking errors would result and an antenna drift would be observed; these were the observed symptoms. Attenuation of the multiplexed difference signal can result from a trace crack or intermittent feed-through between the narrow beam comparator and the dual diplexer. Both types of failures tend to be temperature sensitive.

Malfunctions in the dual diplexer or narrow beam comparator are considered to have the highest probability as causes of the anomaly. New phase-III striplines, which should eliminate the problem, will be used on Apollo 13 and subsequent spacecraft.

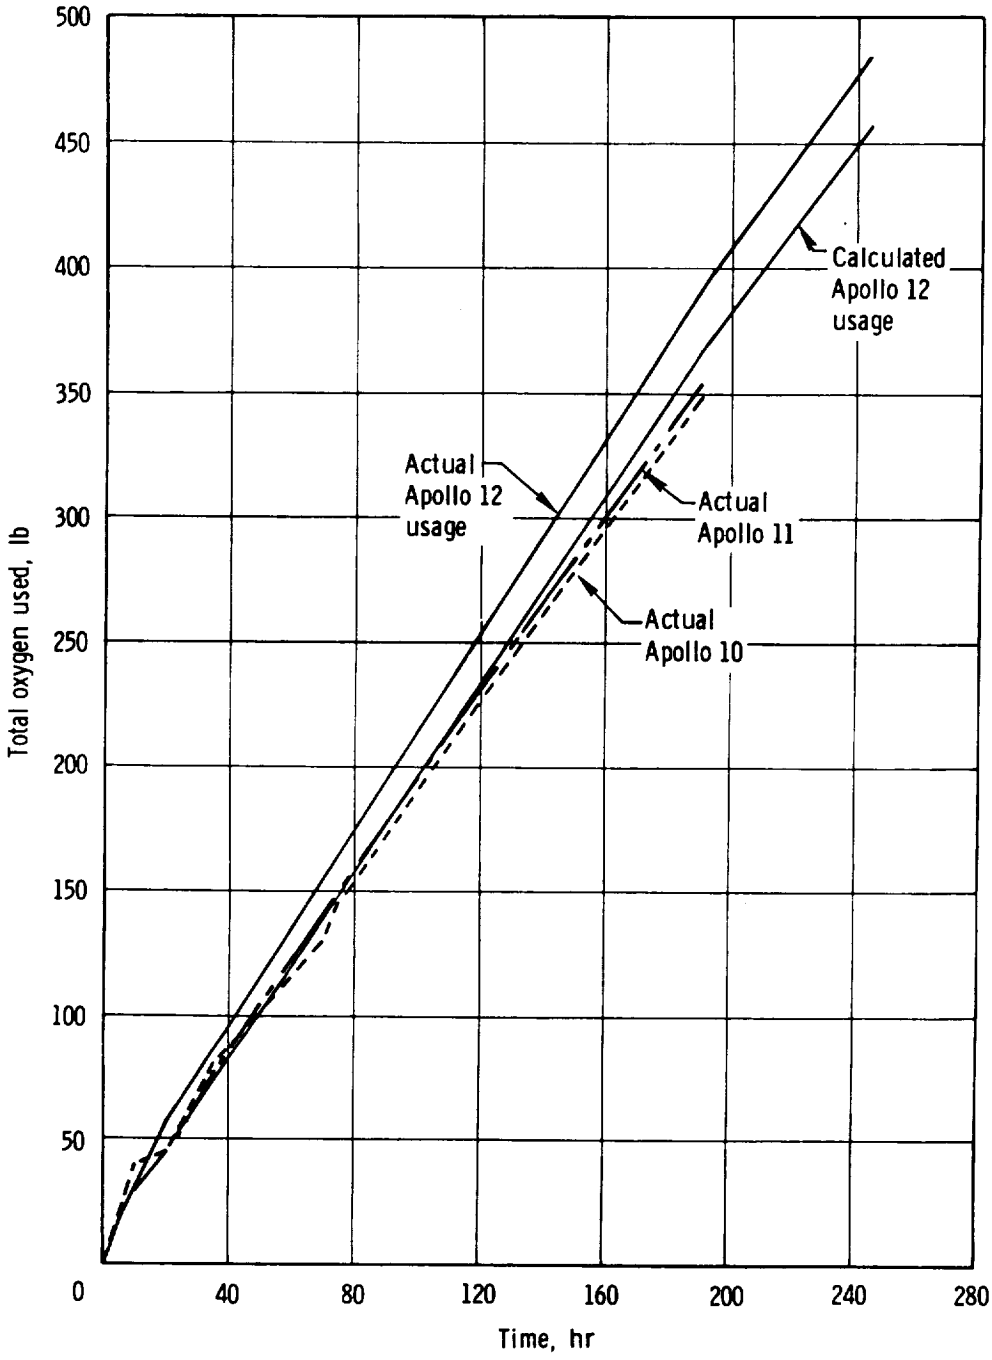
At the end of the mission there was a discrepancy of approximately 27 pounds of oxygen between the measured total cryogenic oxygen usage and the calculated combined environmental control system and fuel cell oxygen usage, as shown in figure 14-9.

Fuel cell oxygen usage was calculated from the produced electrical current and then verified by comparison with hydrogen consumption data. Environmental control system usage is measured on a flowmeter and compared with calculated usage based on purge rates, cabin leakage rates, metabolic consumption and urine dump losses. Cabin leak rates are determined by ground tests in conjunction with flight pressure decay rates. Purge rates are calculated based on ground tests and known times for purges. Oxygen losses during urine dump operations can only be estimated. Since no excessive flow was detected downstream of the flowmeter, the source of any command module environmental control system leakage is therefore limited to the 900-psi system upstream of the meter. Figure 14-10 shows the 900-psi oxygen system and that portion of the system outside the command module that could have leaked.

Postflight leak tests were conducted on the command module 900-psi system, including all check valves. These tests indicated that system leakages were within specification limits. It is therefore concluded that the 27 pounds of oxygen must have leaked from those portions of the 900-psi system within the service module. Tests of these systems prior to flight are considered adequate, and no corrective action is required.

Figure 14-9. - Comparison of oxygen consumption for Apollo 10, 11, and 12.

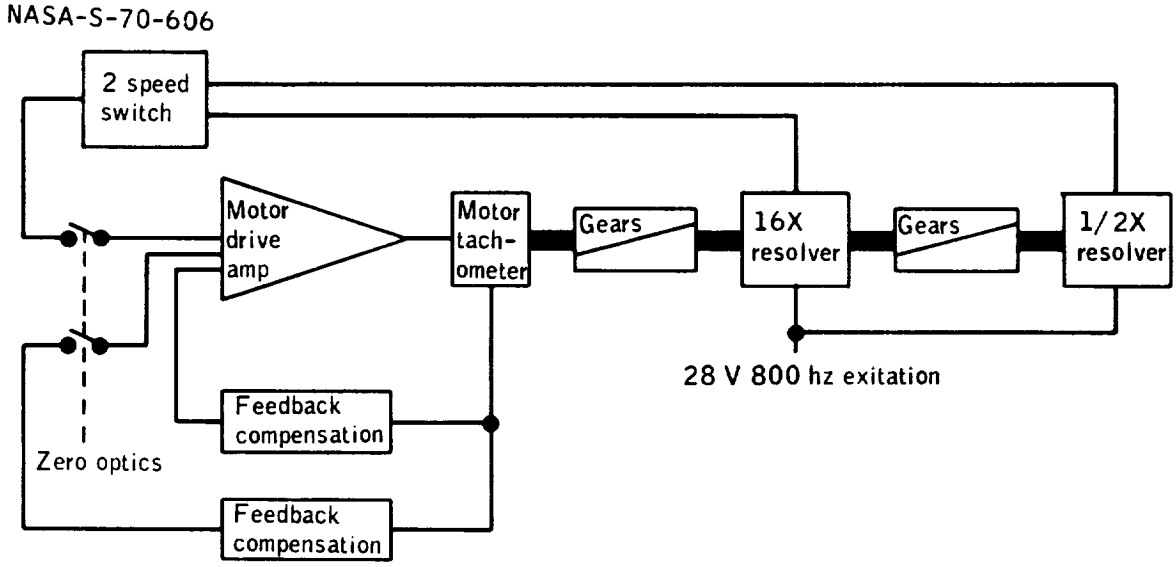
Figure 14-11.- Zero optics mode circuitry.

A number of components in the optics drive servomechanism (fig. 14-11) are used only in the zero optics mode. The optical unit and the power-and-servo assembly were removed from the spacecraft, and the servo assembly was subjected to thorough testing. The flight symptoms, however, could not be reproduced. Because of extensive sea-water corrosion, the optical unit could not be tested, but an analysis and testing of a similar unit demonstrated the cause of the zero optics anomaly to be within the power-and-servo assembly. The flight assembly was installed in a working system and has operated properly under a variety of thermal conditions. The modules associated with the optics servo were also thermally cycled in an oven, operated in a vacuum, and subjected to acceptance test vibration levels with no degradation of their performance. The modules were depotted and examined, but no cause of the anomaly could be isolated.

Analysis of the circuitry involved in the zero optics mode has isolated the problem to either a relay module, a two-speed switch module, or the motor drive amplifier module. Of these, the motor drive amplifier module is the most likely cause of the anomaly observed, since it contains the only active signal-shaping network. The inflight symptoms have been reproduced on a breadboard mockup of the system by introducing a noise of from 600 to 800 millivolts into the in-phase carrier. A number

of component malfunctions and shielding failures could combine to provide the avenue for introducing this level of noise. However, no evidence of a generic problem or design deficiency has been isolated; nor has system performance or component operation been affected. Therefore, no system changes are planned.

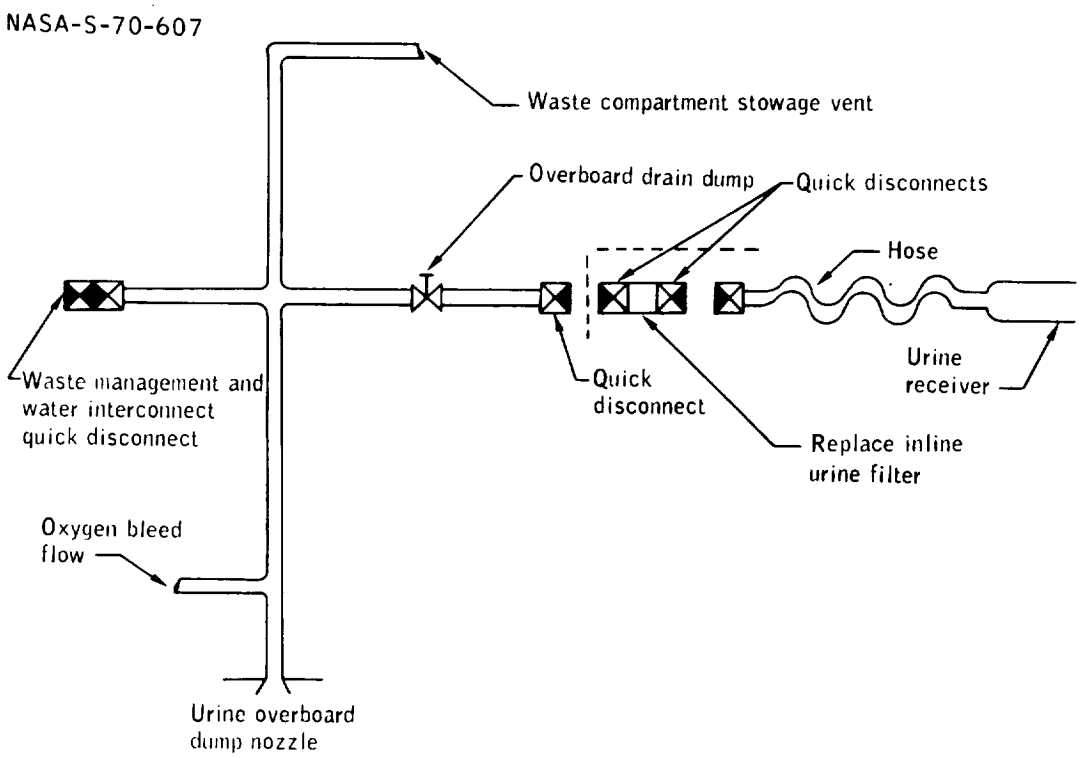
By about 215 hours, the crew reported that both urine filters had clogged and that the urine overboard dump system was being operated without a filter. The inline filter (fig. 14-12) clogged the day after the Commander and the Lunar Module Pilot returned to the command module from the lunar surface activity (day 7). The filter was then replaced by a spare unit which also clogged 2 days later. The urine dumping system operated satisfactorily without a filter for the remainder of the mission (approximately 30 hours).

Figure 14-12.- Urine dump system flow schematic.

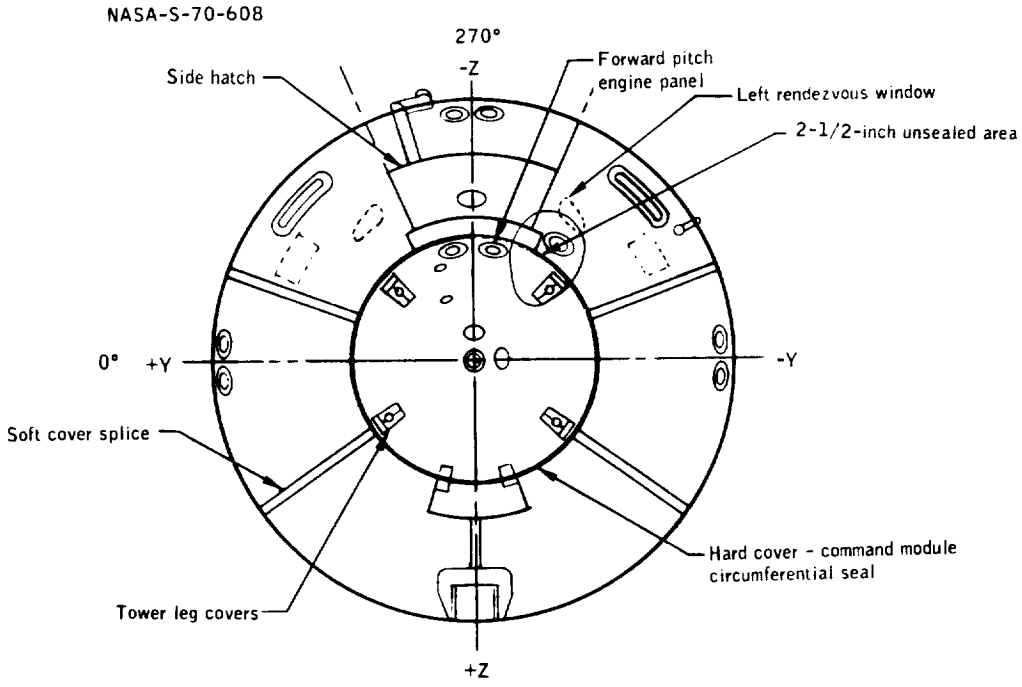
The hatch, left-hand side, and both rendezvous windows of the command module had considerable amounts of contamination appearing as vertical streaks on the exterior surfaces. Before flight, gaps in the boost protective cover were noted in the hard-to-soft transition region over the left rendezvous window (fig. 14-13). A procedure requires that these gaps be sealed with a composition sealant on final installation of the boost protective cover; however, some gaps were not sealed. The crew reported that during the heavy rain just prior to launch they saw water on the exterior window surfaces and also observed water flowing over the windows at tower jettison. The water rivulets acted as collection sites for the exhaust residue during escape motor firing. After the water evaporated, the residue deposits remained on the surfaces of the windows.

Figure 14-13.- Boost protective cover view looking aft.

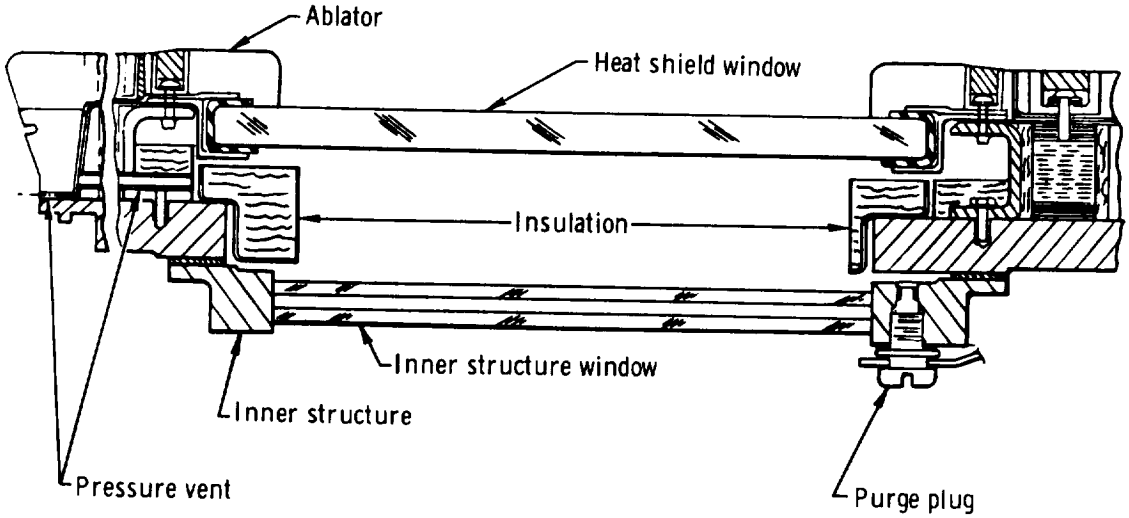
Figure 14-14. - Cross section of hatch window.

Contamination was also noted on the inside surface of the heat-shield panes on the left-hand side and hatch windows. The contamination, which disappeared on the left-hand side window after the first day, probably resulted from water entrapped between the heat shield and pressure structure in the general area of this window. The contamination on the inside surface of the hatch heat shield window remained throughout the flight and varied in size with the thermal cycles of the spacecraft. This contamination could have resulted from either entrapped moisture in the hatch area between the heat shield and the pressure structure or from outgassing of sealant materials in this area (fig. 14-14). Such outgassing has been minimal in the past three flights because the curing processes were changed to alleviate this problem. However, a chemical analysis of the contamination on the inside surface of the hatch window has shown the concentration of silicone oils to be higher than expected. These oils are the outgassed products from the material used to seal the thermal blankets near the window.

For Apollo 13 and subsequent spacecraft, seals will be added to the boost protective cover to prevent leakage of rain water. Prior to flight, the hatch window cavity will be purged with a 35/65-percent mixture of dry nitrogen and oxygen to remove entrapped moisture. To further alleviate the outgassing of silicone oils, the insulation material will be removed from between the outer and inner hatch windows on future spacecraft.

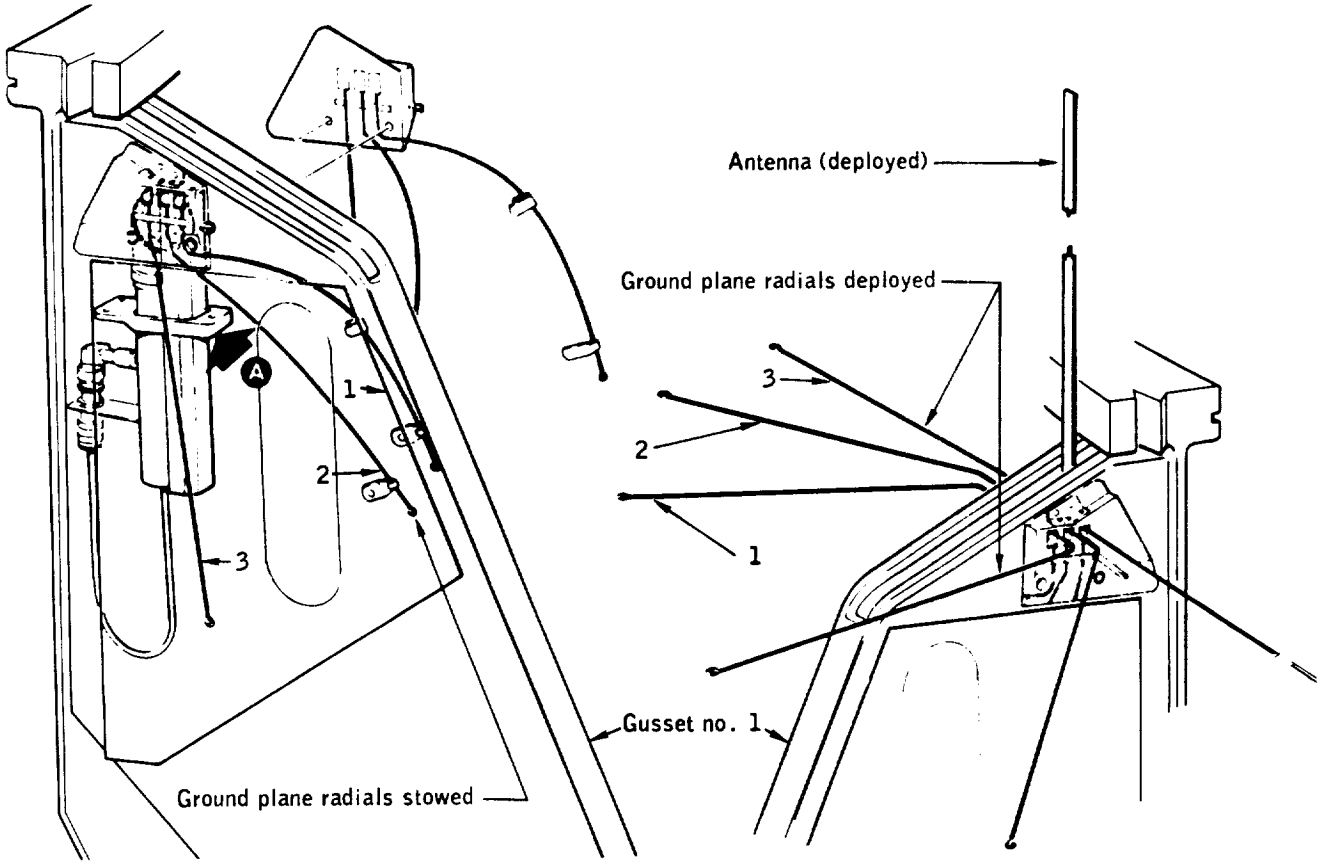
Figure 14-15.- VHF recovery antenna configuration.

During the command module descent on the main parachutes, ground plane radials 1 and 3 of VHF recovery antenna 2 (fig. 14-15) did not properly deploy. However, voice communications with the recovery forces while using this antenna were not significantly affected. Postflight examination of the antenna revealed that the cloth flap which normally covers the radials to prevent entanglement with the parachutes could be made to stick to the gusset by an adhesive substance which was inadvertently present on both the flap and the gusset. The radials would not deploy when the flap had stuck to the gusset; however, radial 1 would not always deploy, even when the flap was not stuck. A slight binding at the spring end or at the retaining clip has been experienced on radial 1.

For Apollo 13 and subsequent missions, recovery antenna 2 will be used for recovery beacon transmissions instead of voice. However, even
