MSC-01855

APOLLO 12 MISSION REPORT

MARCH 1970

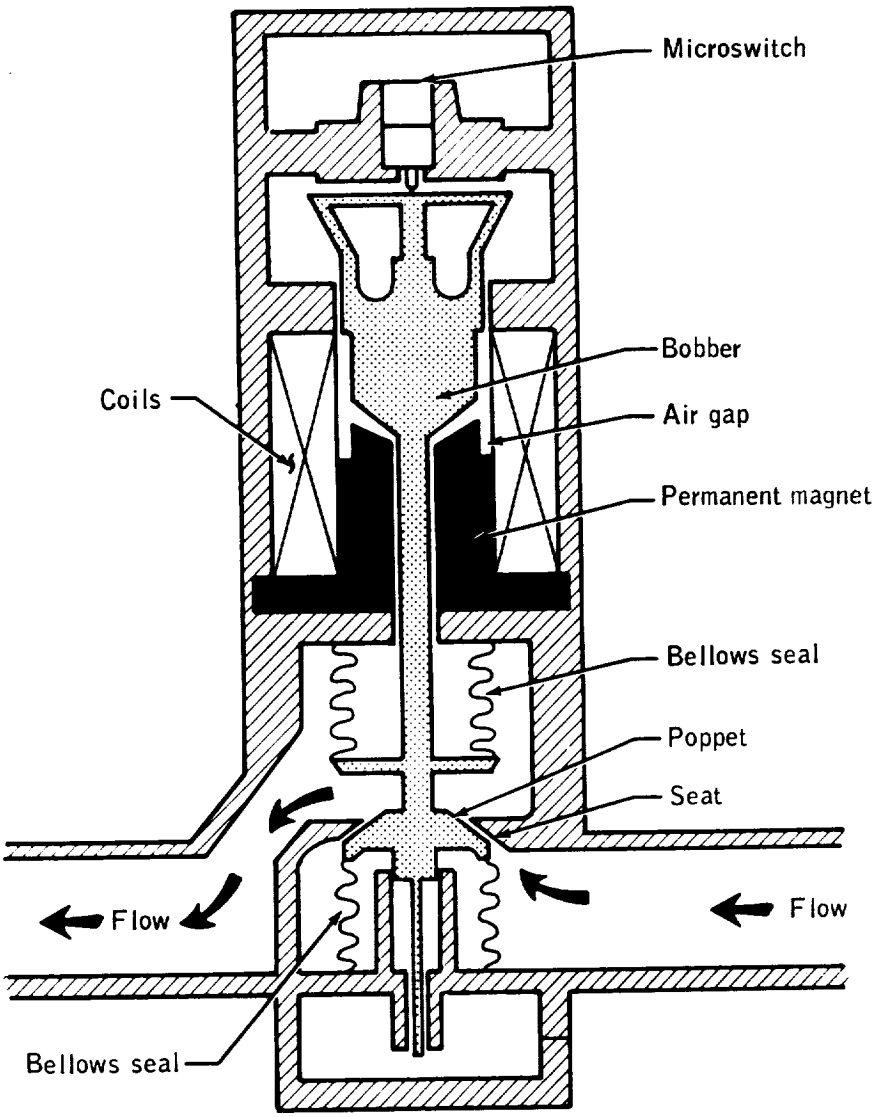
Figure 14-16.- Cross sectional view of reaction control system isolation valve.

During the postflight decontamination of the command module reaction control system, the system 1 oxidizer isolation valve would not remain in the closed position; however, the valve responded normally to open and close commands. This failure to remain in the closed position has been experienced when the valve bellows are distorted or damaged. The bellows hold the valve poppet in the closed position against the pull of a permanent magnet, which is used to hold the valve poppet in the open position (fig. 14-16). A damaged bellows cannot exert enough force to hold the poppet closed. Note that the valve can be held closed by applying power to the closing electromagnetic coil.

When the oxidizer isolation valve was disassembled after flight, the inlet-side bellows had been deformed enough to prevent the valve from staying in the closed position. The bellows in the system 1 propellant

isolation valve had also been deformed, but not enough to prevent the valve from staying closed. A review of the test and checkout history, as well as inspection records, for the Apollo 12 isolation valves indicates the valves were not degraded prior to flight. The necessity for having the valves open prior to system activation and purging will be emphasized to future crews.

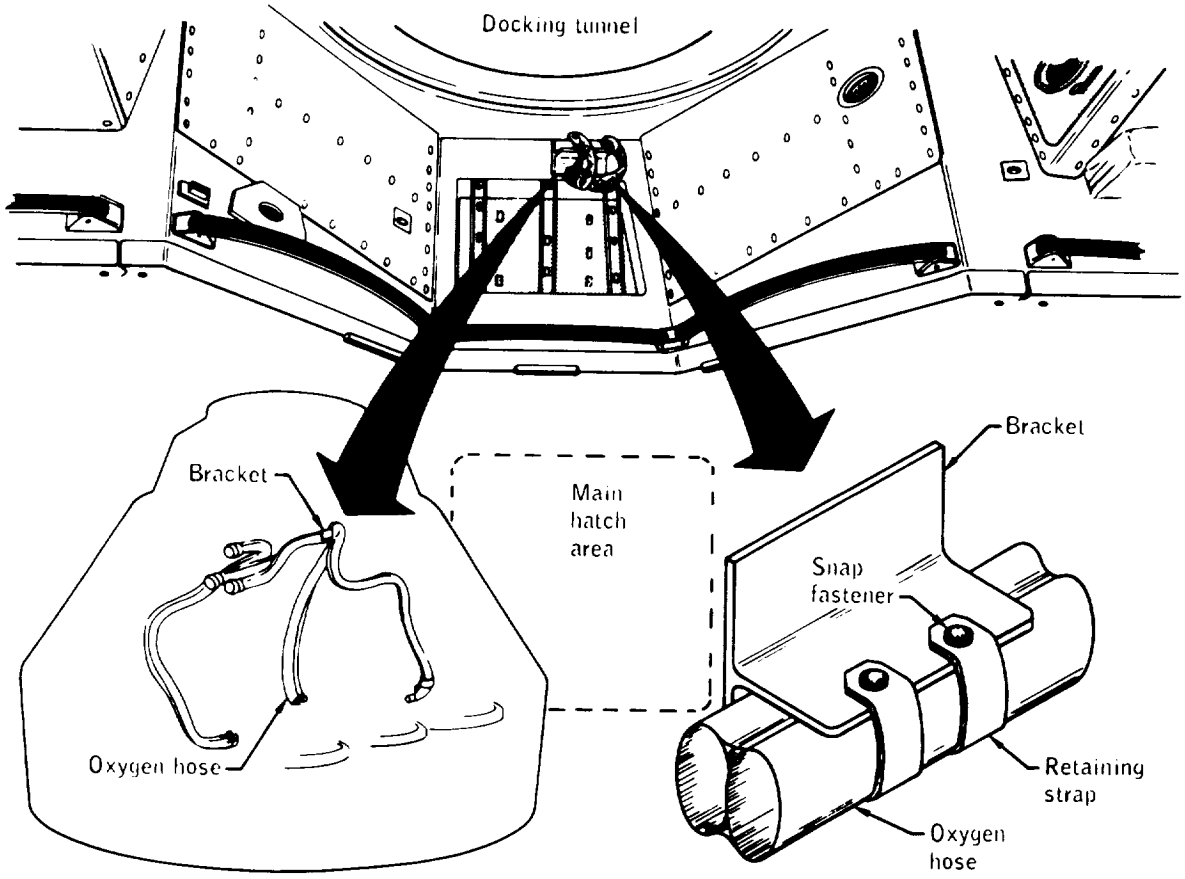
Figure 14-17.- Oxygen hose retention bracket.

At earth landing, an aluminum retention bracket for the oxygen hoses pulled loose from the main display panel (fig. 14-17). The bracket is bonded to the panel and supports four oxygen hoses, which are attached to the bracket by Beta cloth straps that snap to the panel.

Postflight inspection of the bracket revealed an inadequate adhesion area between the bracket and the panel. The adhesive material was not uniformly spread under the bracket, thereby creating large voids. A non-uniform application of pressure during the cure cycle is the most probable cause of this condition. Manufacturing requirements have been changed to include torque testing of the bracket to assure that a proper bond has been achieved.

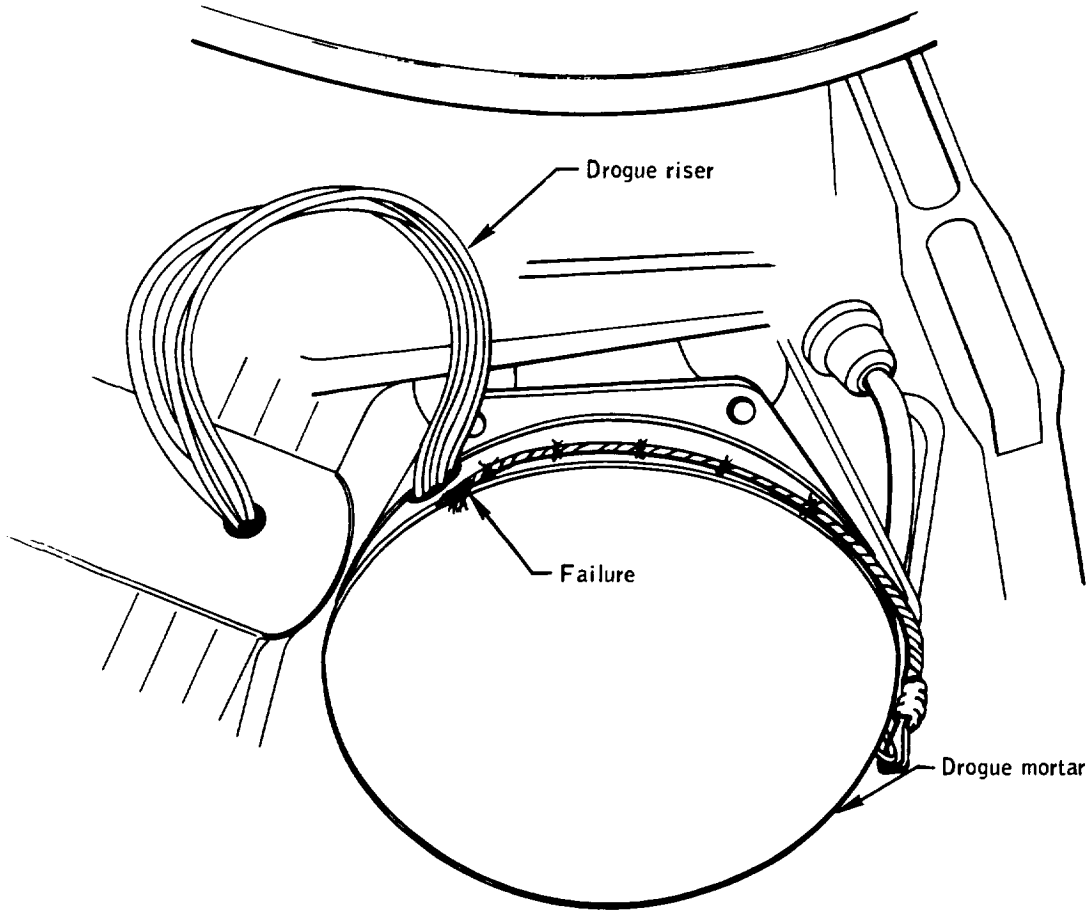
Figure 14-20.- Failed lanyard at right-hand drogue mortar.

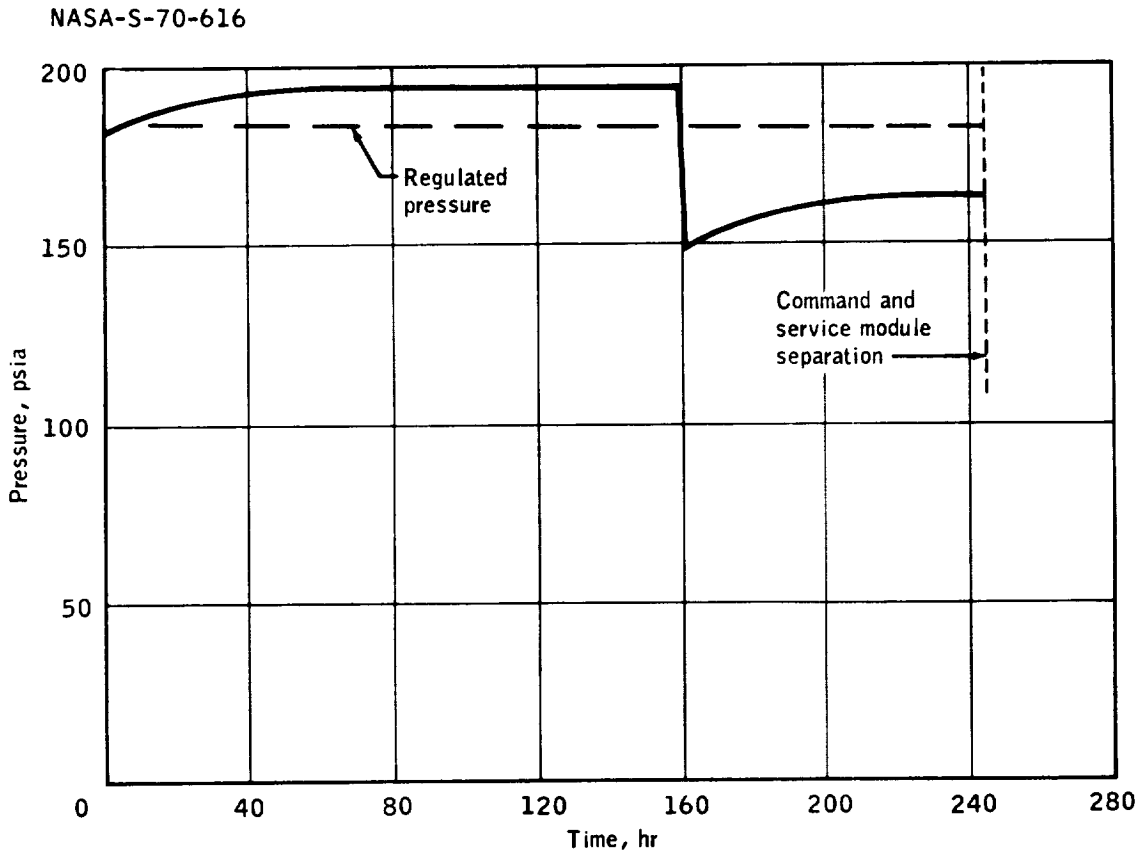
Shift in quad D helium manifold pressure.- The measurement for reaction control quad D helium pressure indicated erroneous values throughout the flight. During the first 70 hours, the pressure exhibited a slow drift of about 14 psia upward. At approximately 160 hours, the measurement then shifted from 192 to 150 psia, followed by a second slow drift upward (fig. 14-21). Both the slow drifts upward and the jump shown on the figure tend to support the conclusion that the strain-gage bonding had weakened. The measurement is primarily used during preflight testing to indicate the helium manifold pressure downstream of parallel redundant pressure regulators and is not necessary for flight.

Figure 14-21.- Quad D helium manifold pressure.

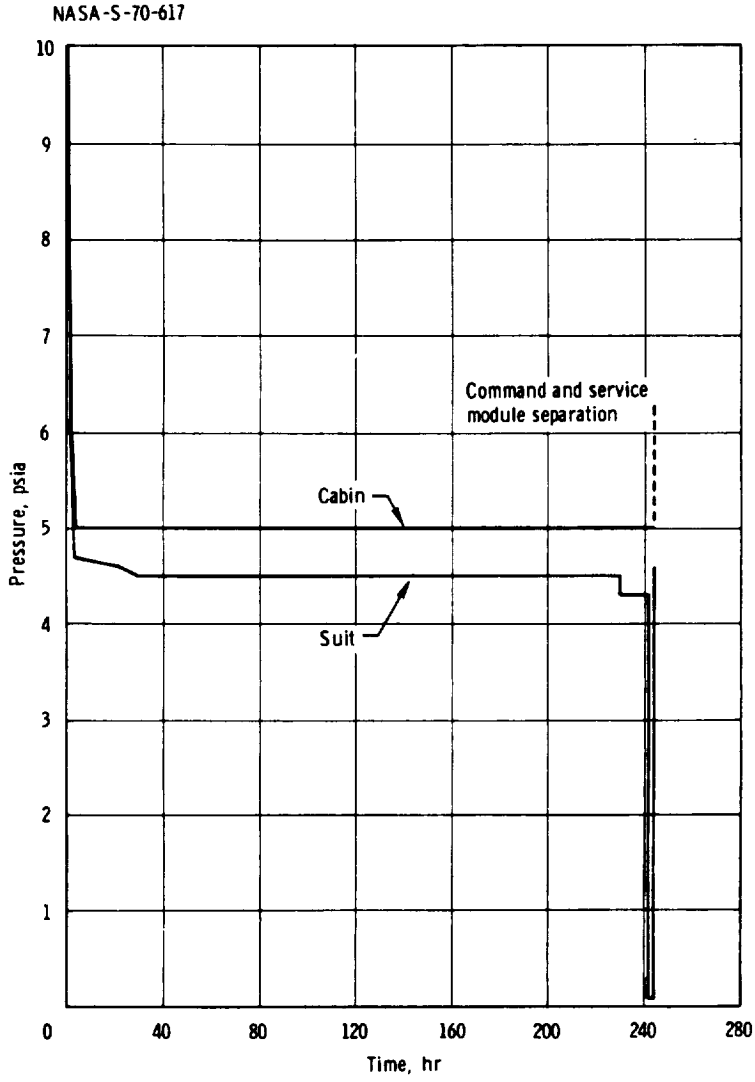
The suit pressure transducer operated properly throughout the prelaunch and launch activities. When the helmets and gloves were removed after launch, the transducer indicated 0.2-psid less than cabin pressure and at approximately 22 hours the differential was 0.4 psid. A 0.4- to 0.6-psid disparity existed between the indicated suit loop and cabin pressures until the final hours of the mission (fig. 14-22).

Figure 14-22.- Suit and cabin pressure history

At 241:41, the suit pressure transducer reading dropped to 0.1 psia, while cabin pressure was stable at 5.0 psia. About 3 hours later, at command module/service module separation, the transducer recovered to 4.6 psia. The transducer indicated a 0.4- to 0.5-psid discrepancy throughout entry. Postflight tests of the installed transducer repeated the flight anomaly. However, during subsequent tests of the removed transducer, the unit operated normally. The transducer was then returned to the manufacturer's facility, where flushing and disassembly revealed internal contamination from metallic nickel-plating particles. These particles could have caused an irregular transducer output by physically interfering with the Bourdon tube movement or by changing the inductance field of the unit. After the transducer was cleaned and reassembled, testing produced satisfactory operation. The noted contamination apparently resulted from either improper cleaning procedures or from self-generated particles within the unit.

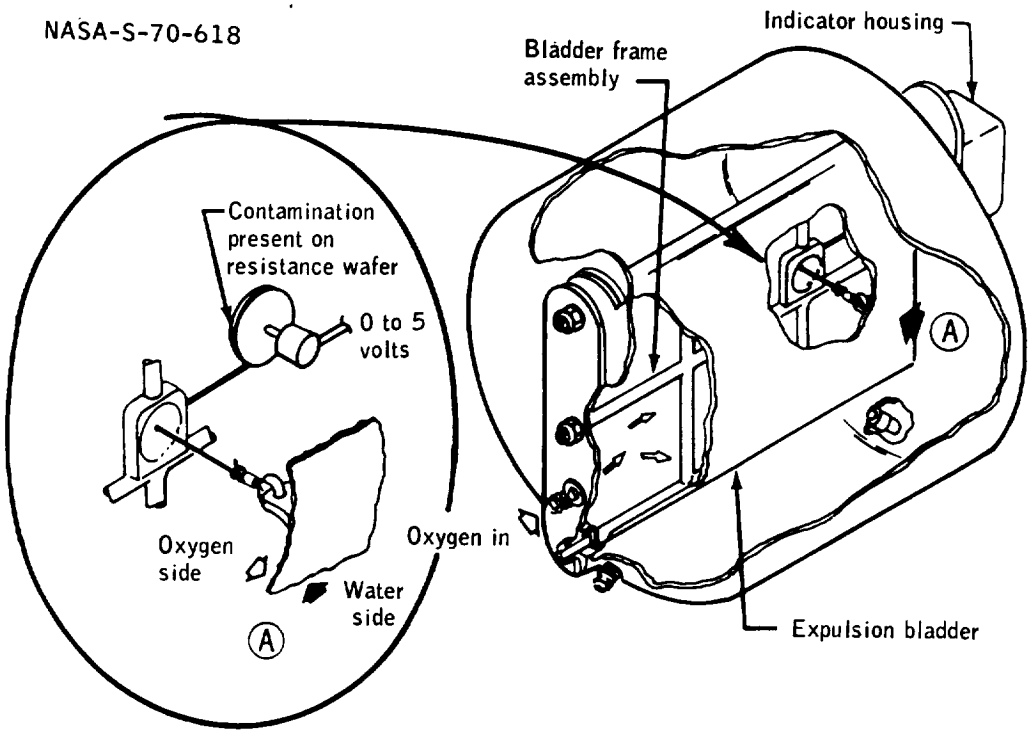
Tests of the potentiometer reproduced the output fluctuations for wiper positions equal to approximately zero quantity (zero volts) and full quantity (5 volts). The potentiometer was disassembled and appeared clean and free of contamination except for a slight stain on the end surfaces of the resistance wafer (fig. 14-24) corresponding to wiper positions for the 0 and 5 volts. The film was removed with a water-moistened swab, but the quantity of contaminate was too small to be identified.

Figure 14-23.- Area of failure in erratic potable water transducer.

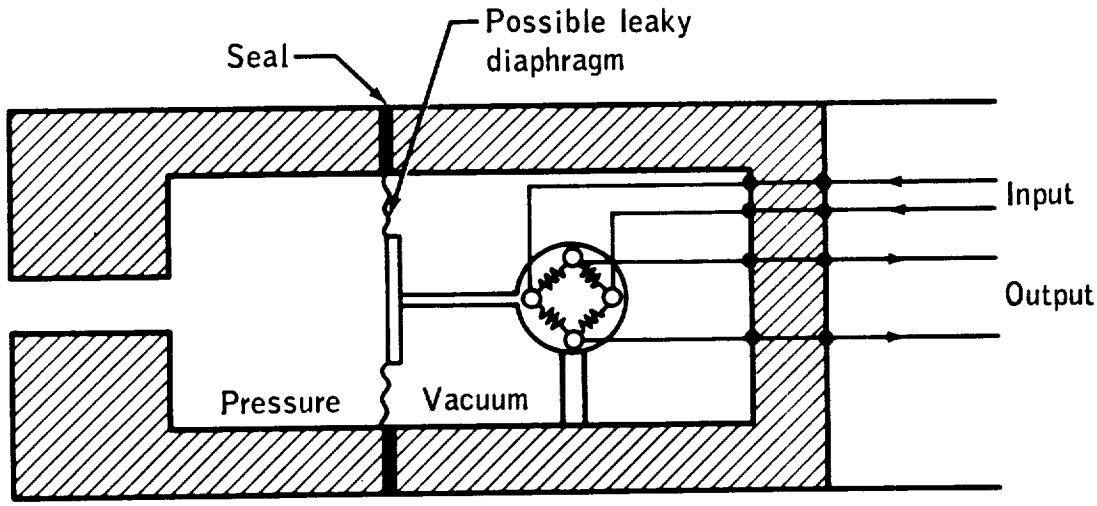
Figure 14-25.- Fuel cell 3 transducer schematic.

The apparent pressure drop has been attributed to a pressure transducer failure, with the most probable failure mode being a small leak through or around the stainless steel diaphragm in the transducer (fig. 14-25). Such a leak would allow hydrogen to enter the vacuum reference chamber of the transducer, thus destroying the normal pressure differential across the diaphragm. This reduction would result in the indicated pressure decay observed during the flight. A similar transducer failure occurred during a production fuel cell pre-test checkout.

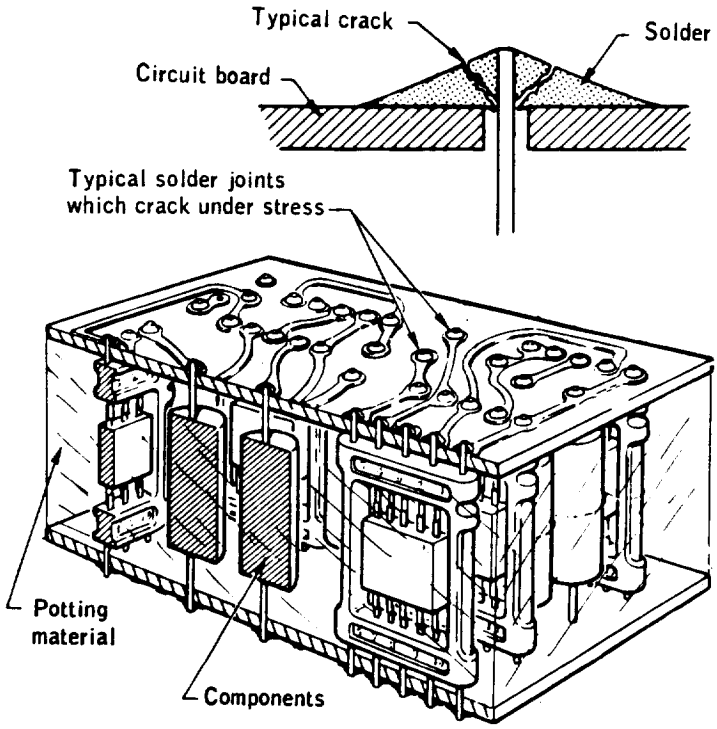
Figure 14-26.- Mission timer construction.

Based on previous mission clock failures, the most probable cause for this anomaly is a cracked solder joint in the cordwood construction. As seen in figure 14-26, electrical components (resistors, capacitors, diodes, etc.) are soldered between two circuit boards, and the void between the boards is filled with potting compound. The differential expansion between the potting compound and the component leads can cause solder joint cracks.

New mission timers, which will be mechanically and electrically interchangeable with present clocks, are being developed for Apollo 13 and subsequent spacecraft. The new clock design eliminates the cordwood construction and is less susceptible to electromagnetic interference.

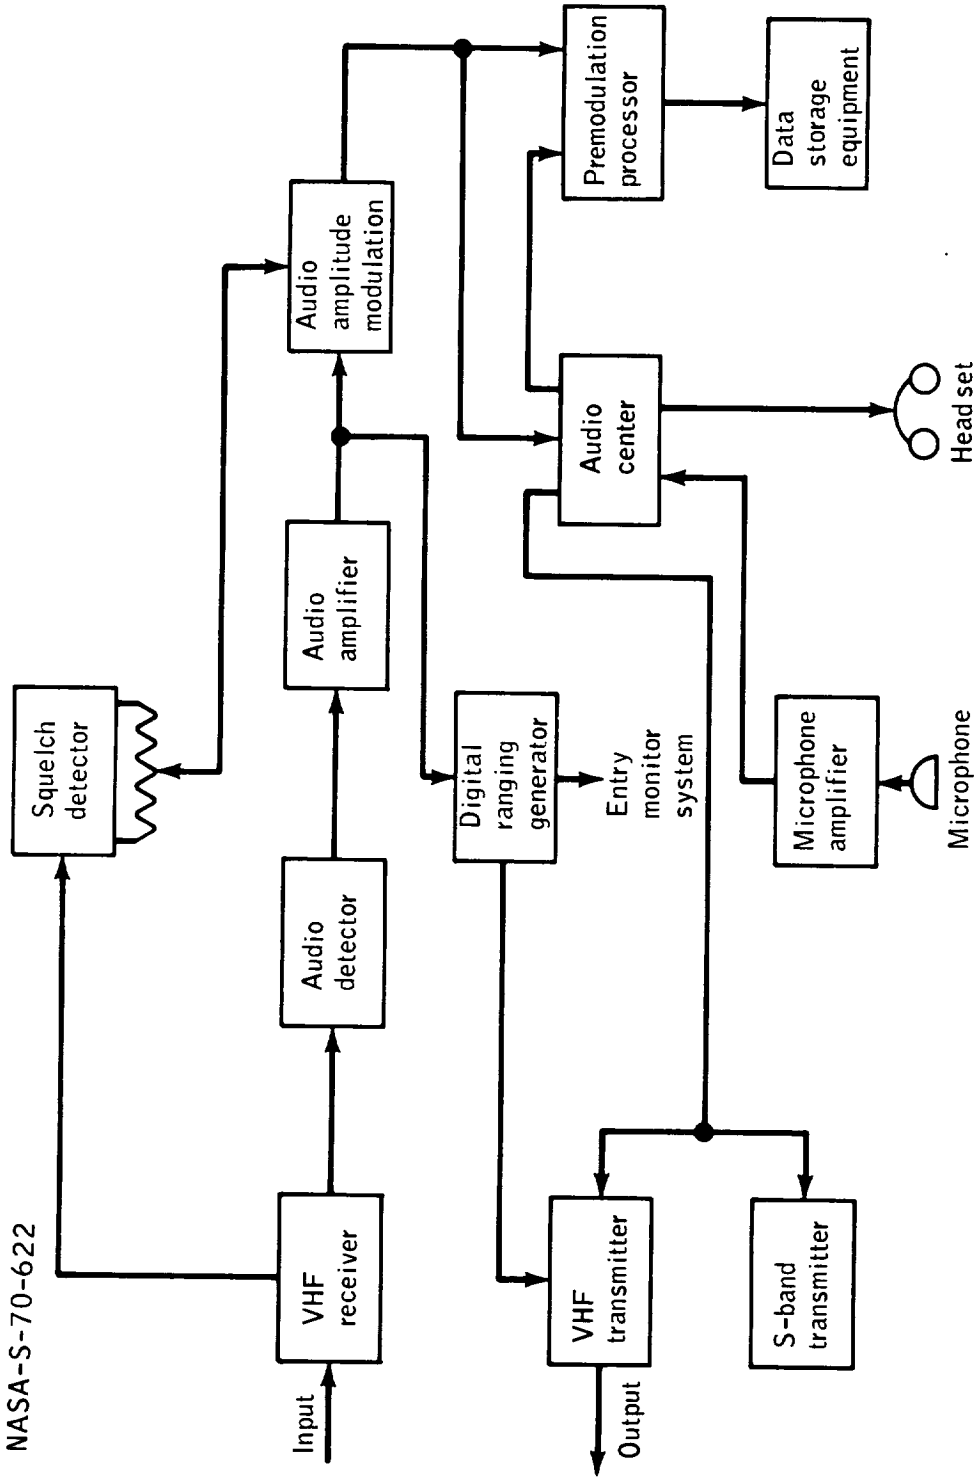
During the time period from 142:43:00 to approximately 142:53:00, the signal strength was strong enough to maintain the squelch circuit open, as verified by flight data. During the concentric sequence initiation maneuver, the squelch was noted as dropping in and out. According to predictions, the selection of either the left or the right command module antenna did not significantly affect voice communications. During this time, the received signal strength (fig. 14-28) was approximately minus 105 dBm while using the command module right antenna and lunar module forward antenna. This figure also shows the signal strength to be minus 102 dBm or less while using the command module left antenna and lunar module forward antenna according to the flight plan. From previous tests, the squelch thumbwheel, when set at approximately 6, requires from minus 100 to 105 dBm to unsquelch the audio signal.

Figure 14-27.- Command module VHF communications configuration.

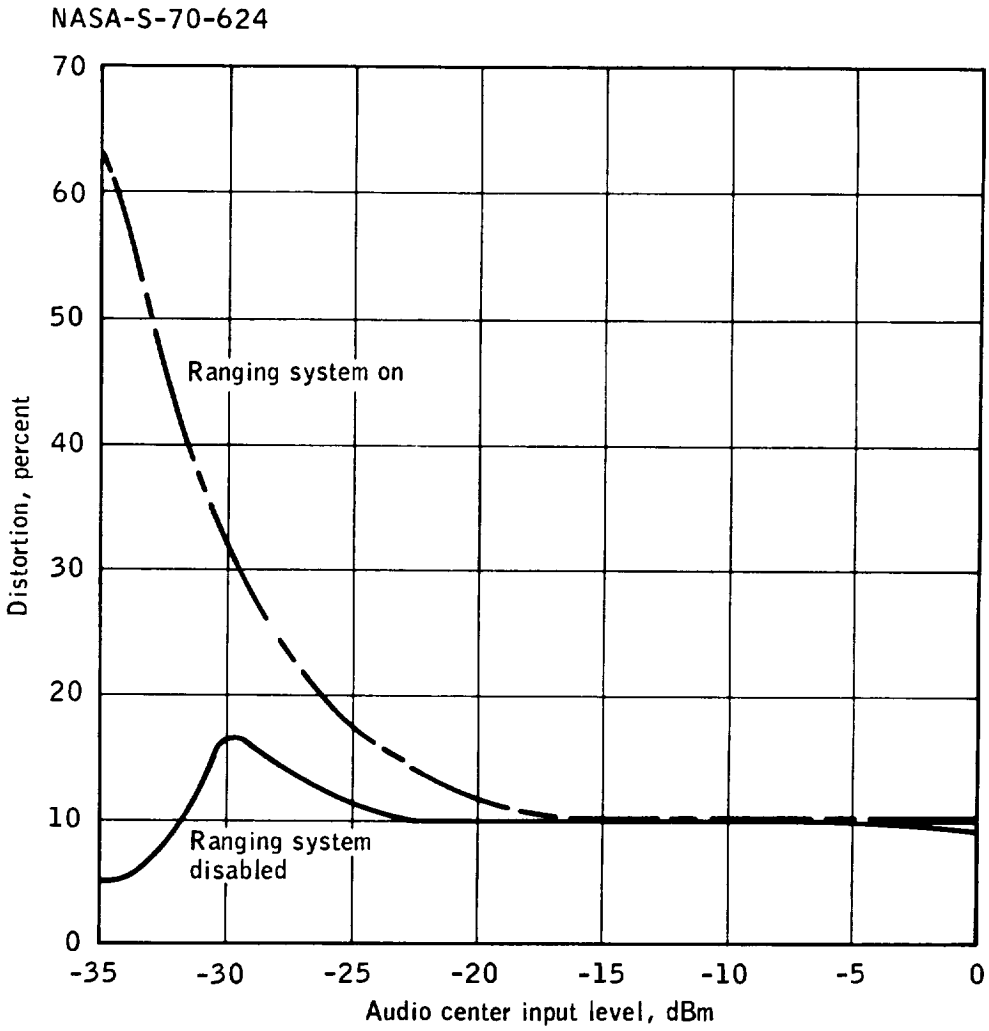
reduced level can then cause a voice-operated dropout of the voice operated transmitter. Such dropout did not occur at this time, because the Command Module Pilot was using the push-to-talk mode. Figure 14-29 shows the percent distortion of the lunar module received signal versus the command module audio center input, both with and without ranging. The curve shows that, in the ranging mode as the input level to the audio center decreases, distortion of the received signal increases significantly. This distortion cannot be directly related to intelligibility, but it does indicate that system performance is degraded by the low input levels.

Figure 14-29.- Lunar module received VHF audio distortion.

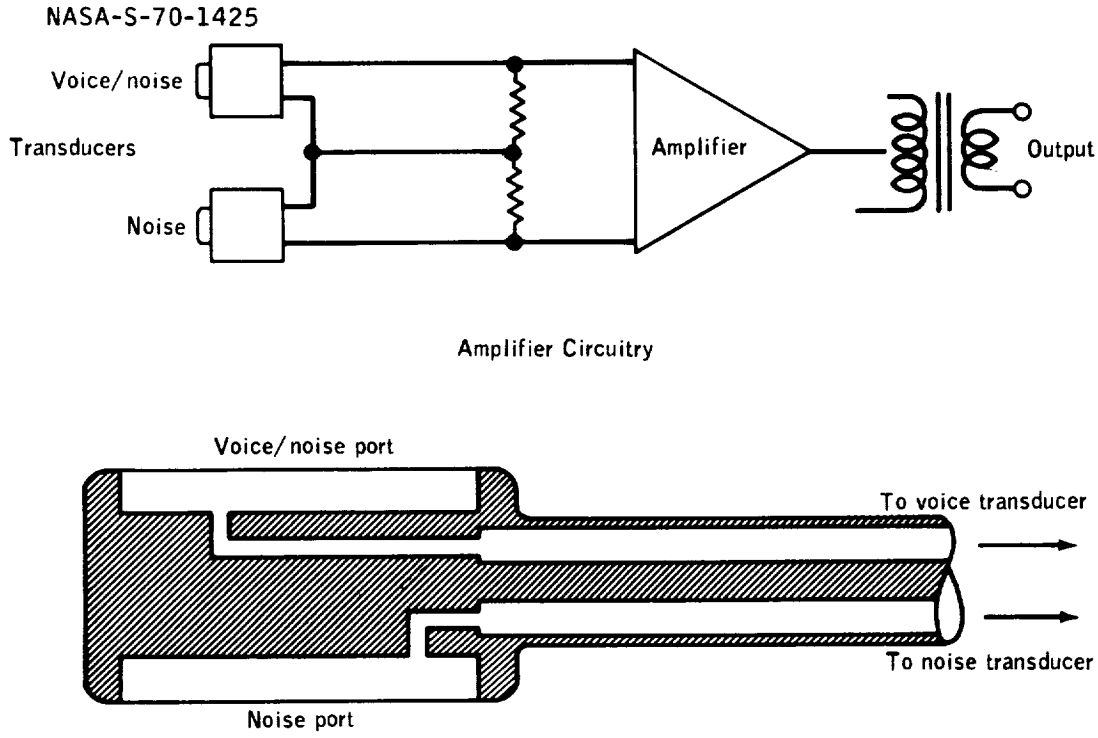
The headset microphone was designed to provide noise cancelling through mechanical spacing of the voice-capture and noise-cancelling ports (fig. 14-30). The output of the microphone amplifier is the amplified difference between the voice and noise transducer outputs. Therefore, with improper microphone placement, voice transmissions also enter the noise port, partially cancel transmissions entering the voice port, and thereby reduce the overall voice output level.

Figure 14-30.- Headset microphone voice/noise ports and amplifier circuitry.

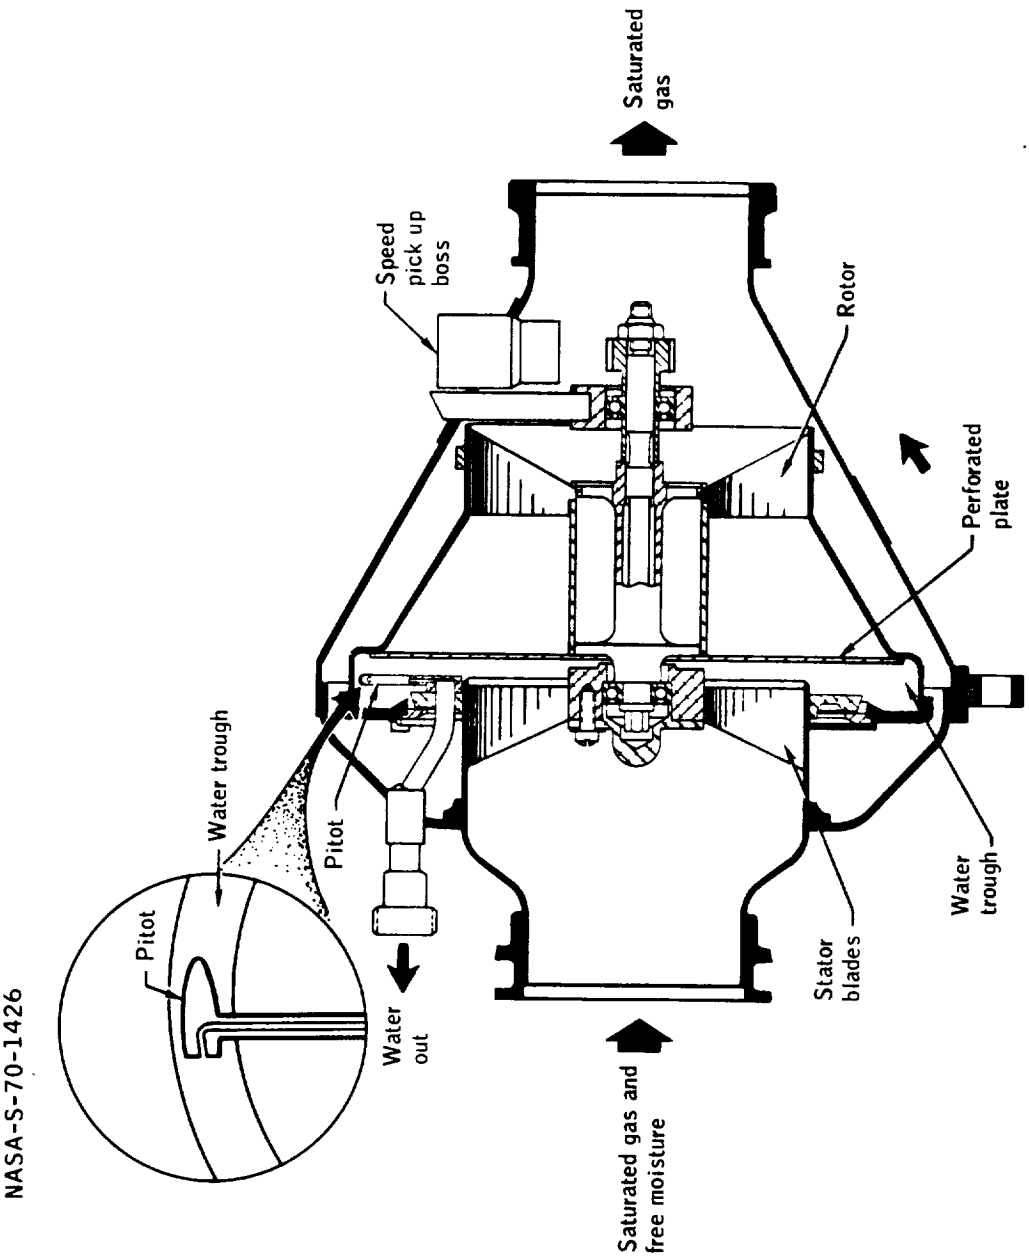
The water separator speed indication was above the upper limit (in excess of 3600 revolutions per minute) for about 50 percent of the mission. Since the water separator is a gas-driven centrifugal pump, this high speed indicates a higher than normal gas flow through the separator. Tests have shown that, at separator speeds in excess of 3700 revolutions per minute, water splashing occurs at the pitot tube (fig. 14-31) allowing water to bypass the separator.

Figure 14-31.- Water separator and pitot configuration.

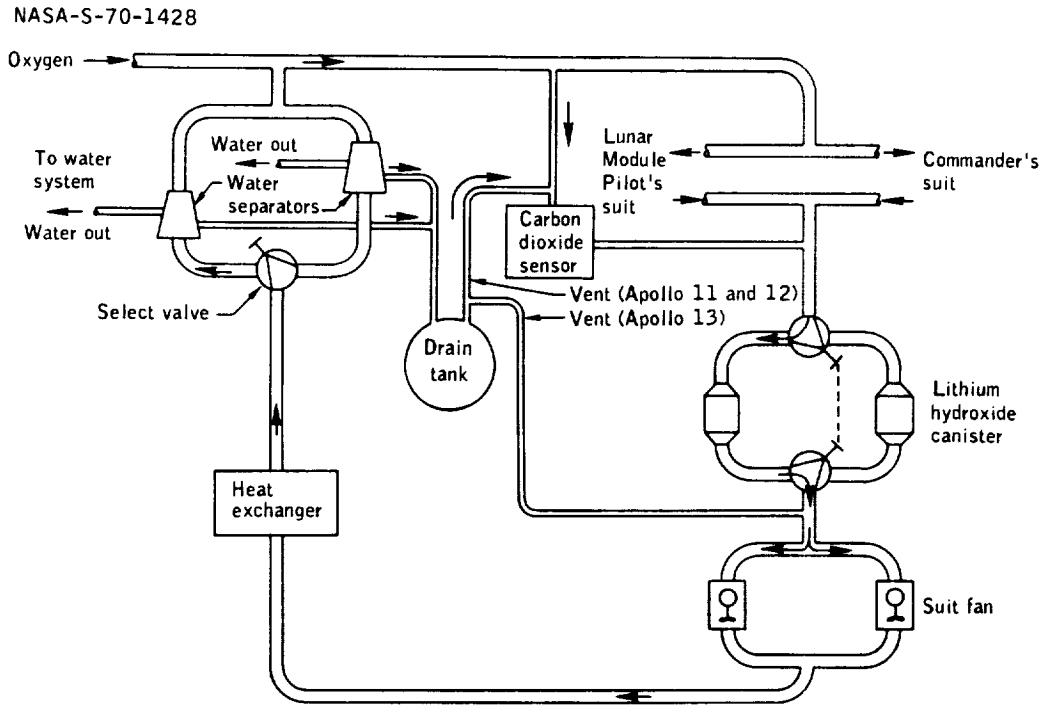
Figure 14-33.- Simplified suit loop schematic.

The carbon dioxide sensor is sensitive to free water, and the malfunction was probably caused either by water from the water separator sump tank entering the sensor or by water bypassing the water separator and entering the sensor. The water separator sump tank vent line joins the carbon dioxide sensor inlet sense line (fig. 14-33). This vent line has been rerouted for Apollo 13 and subsequent vehicles.

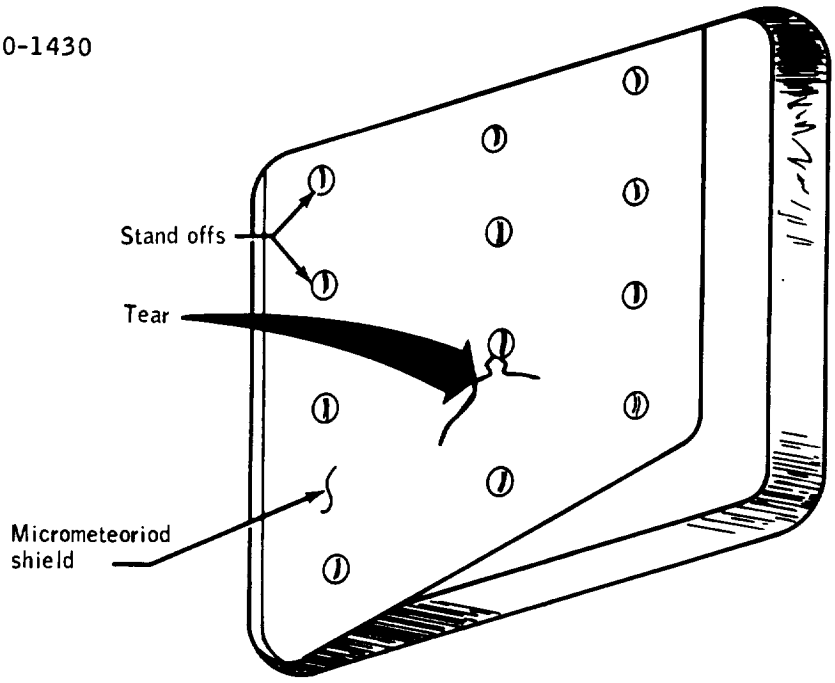
Figure 14-35.- Tear in forward hatch outer skin.

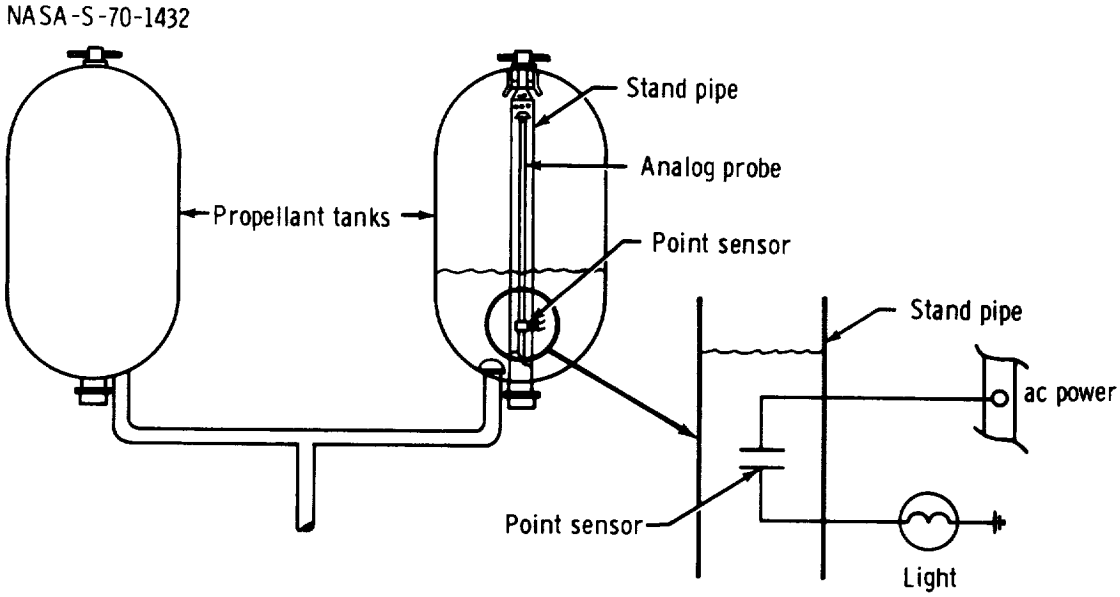
The low-level light for descent propulsion propellant quantities illuminated about 25 seconds early. The low-level light is activated and remains latched on when any one of the four low-level point sensors (one in each propellant tank) is uncovered (fig. 14-37).

Figure 14-37. - Descent propellant tank low-level sensor schematic.

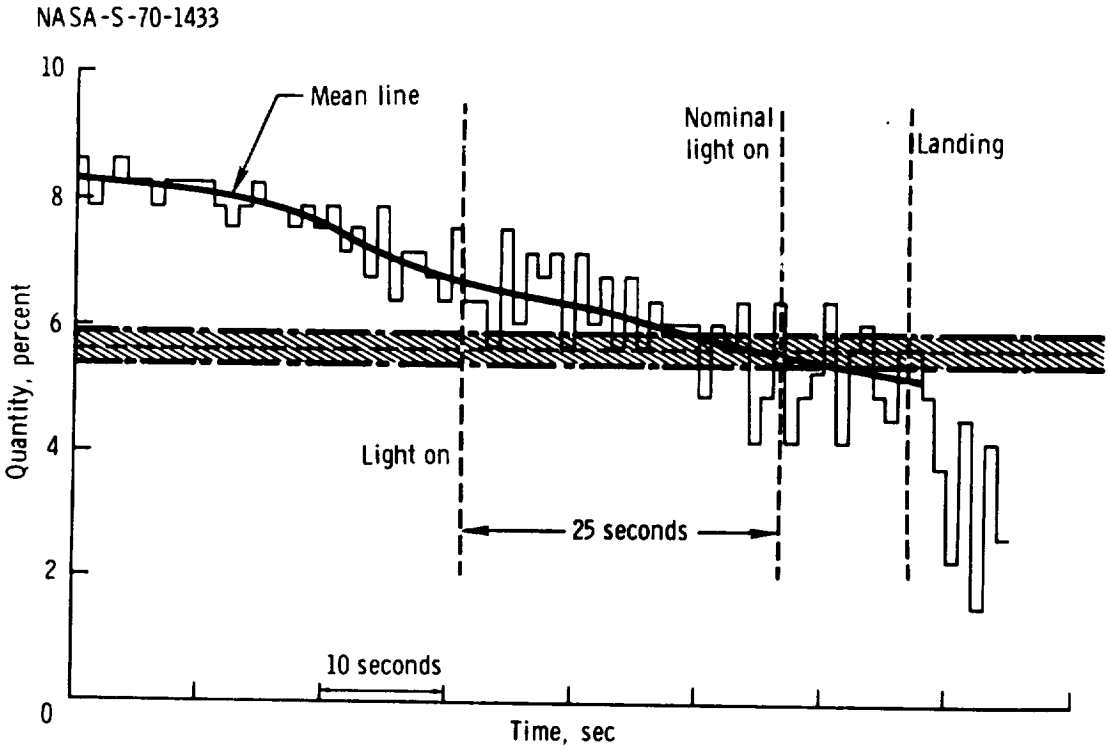
The quantity warning light should illuminate when the lowest indicated propellant level remaining in any tank reaches a value of 5.6 ±1/4 percent. Since the light came on when the averaged quantity measurement indicated 6.7 percent with an oscillation of ±1.1 percent, the

lowest excursion of the quantity reading was 5.6 percent and the display operated properly. The averaged propellant quantity reached 5.6 percent about 25 seconds later.

Figure 14-38.- Descent propellant quantity just prior to landing.

For Apollo 13, the quantity measurements for the four descent propellant tanks have been increased in sampling rate from 1 to 100 samples per seconds. These data will be averaged automatically and used to determine the low-level point from which the remaining firing time can be calculated. The 100 samples per second rate will provide data that will permit an understanding of the particular dynamics of the fluid in the tanks.

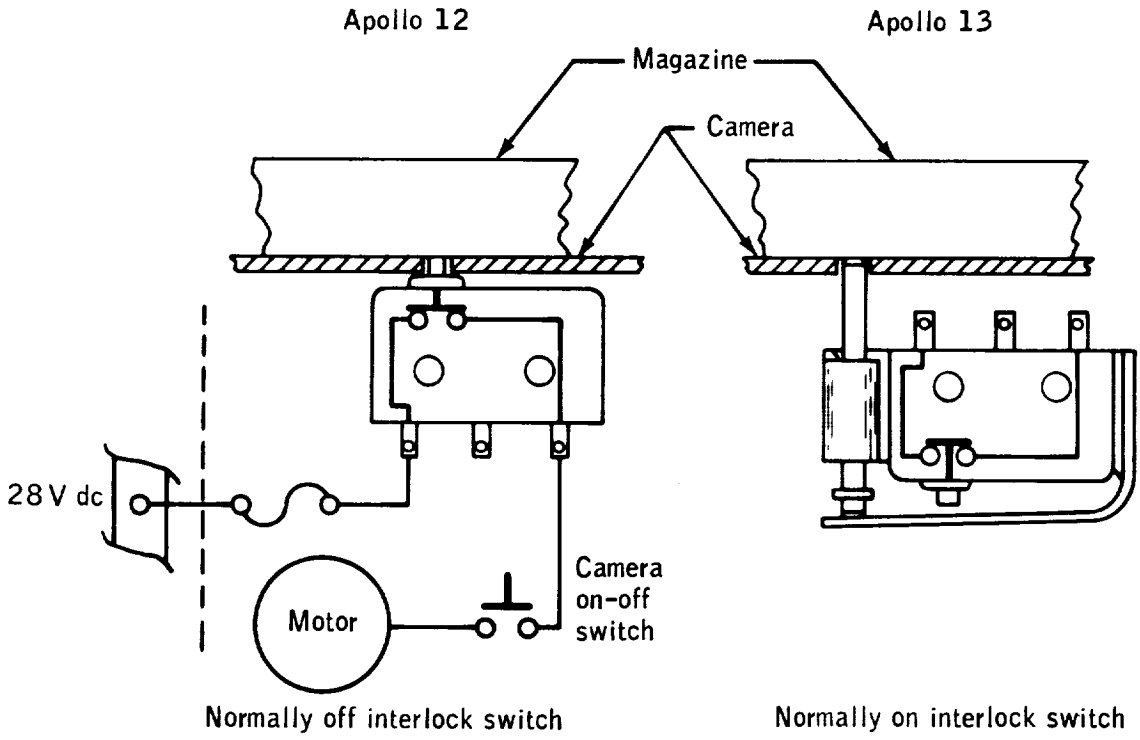
Although postflight tests showed the 16-mm camera and magazine to be in satisfactory operating condition, the characteristic sensitivity of the magazine interlock microswitch installation is such that the operating limits of the switch could cause intermittent actuation. The intermittent operation was duplicated on the flight and similar equipment by the application of pressure to the end of the magazine. The problem will be resolved by changing the interlock switch (fig. 14-40) to a configuration that is much less sensitive to variation in switch settings.

Figure 14-40.- Sequence camera interlock switch modification.

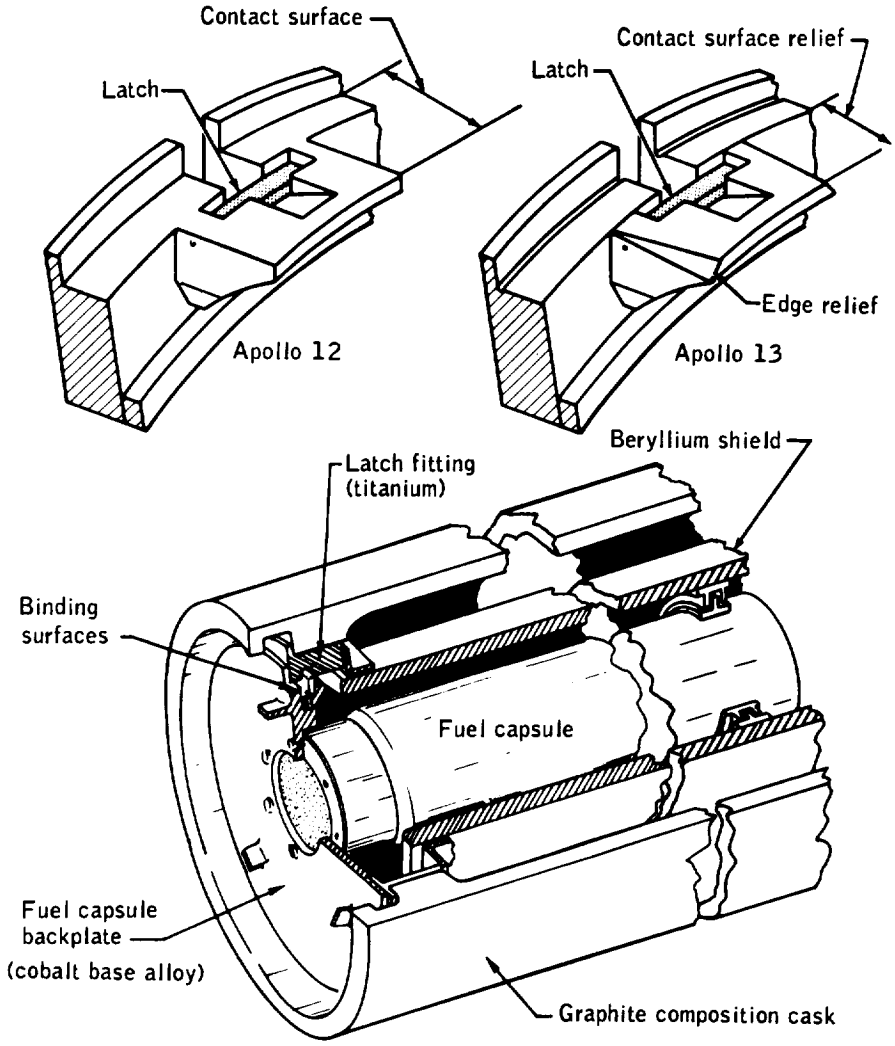
Figure 14-41.- Radioisotope fuel capsule configuration.

Thermal tests and analyses show that dimensional tolerances can diminish with temperature and result in binding between the latch fitting (C-ring) on the cask and the contact surface of the backplate on the fuel capsule (fig. 14-41). The longitudinal contact distance for these two surfaces is approximately 0.6 inch, and extraction was easily accomplished once this distance was negotiated.

As a result of the dimensional checks, the thermal tests, and analyses performed with both the qualification and Apollo 13 flight hardware, the contact surfaces of the fuel capsule backplates are being reworked as indicated in the figure. The outside diameter of the 0.10-inch long contact surface, while remaining within design limits, may be reduced as much as 0.005 inch for ease of capsule extraction. All existing capsule backplates will be reworked in this manner.

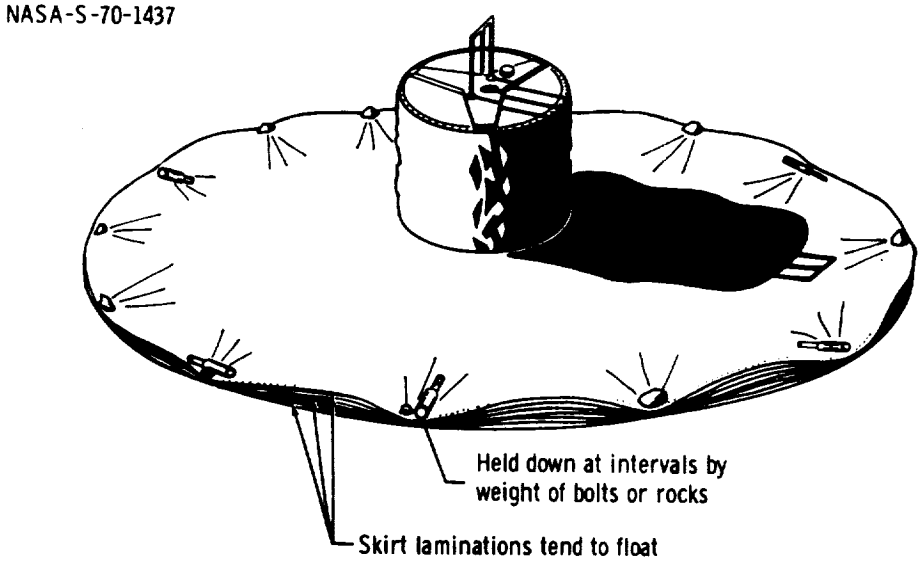
The thermal shroud tended to delaminate and rise up off the lunar surface. This condition had been anticipated, and lunar soil was placed on the periphery of the shroud to hold it down. When this operation proved difficult, tie-down bolts, which had been removed from the pallet during deployment of the experiments package, were placed on the shroud with satisfactory results (fig. 14-42).

Figure 14-42. - Passive seismic experiment deployed.

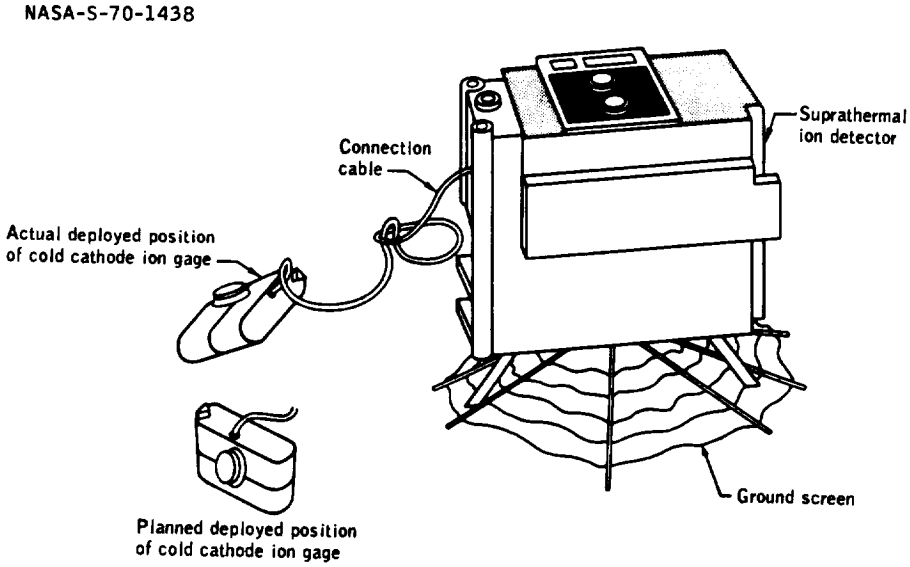
The cable connecting the cold cathode ion gage with the suprathermal ion detector was quite stiff. The combination of the spring effect in the cable, the reduced weight of the cold cathode ion gage under lunar gravity, and the softness of the lunar surface was apparently sufficient to cause the equipment instability during deployment. Final positioning of the equipment requires that the sensor aperture does not point directly at the surface nor directly at other experiment package components. The final positioning fulfilled this requirement.

Figure 14-43.- Cold cathode gage deployed.

The stiffness of the electrical cable joining the cold cathode gage to the suprathermal ion detector experiment caused some difficulty during deployment of the gage (see section 14.3.5). To avoid this problem the tape wrap will be eliminated from future experiment packages and will decrease the cable stiffness The instrument apparently suffered a catastrophic failure after about 14 hours of operation, because of a malfunction either in the 4.5-kV power supply or in the power-supply switching mechanism.

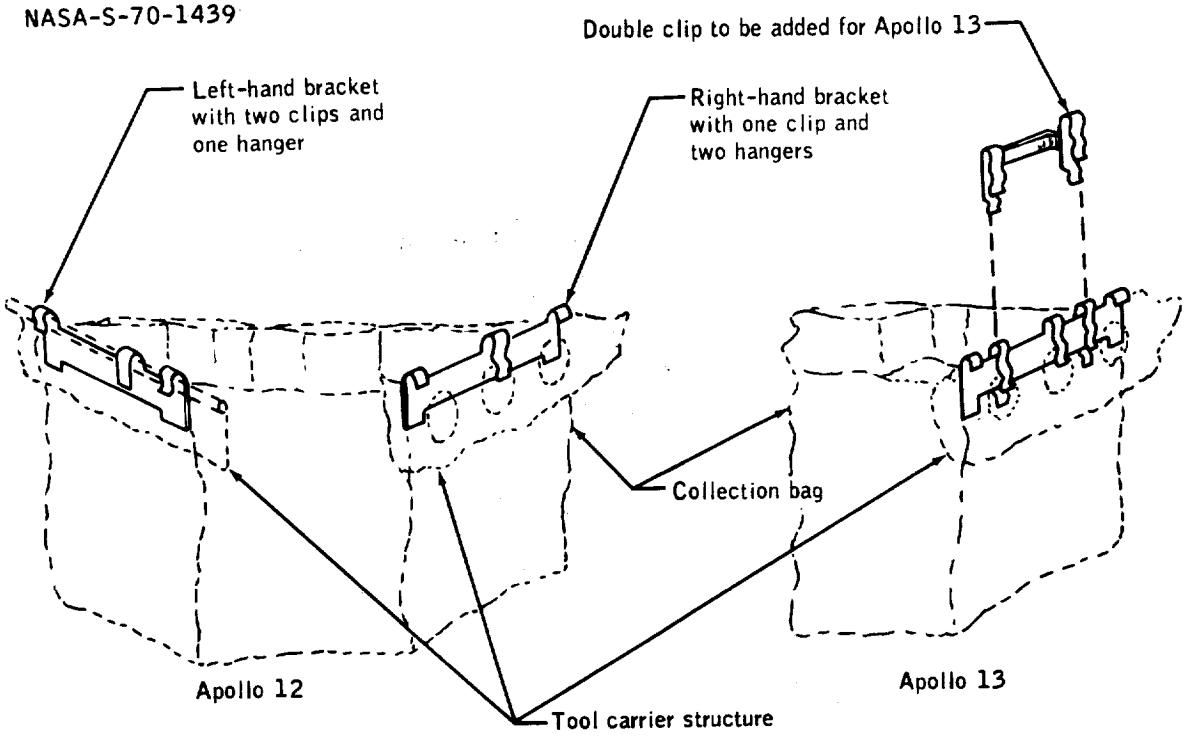
At the beginning of extravehicular activity, the empty tool carrier collection bag tended to rise out of the tool carrier until some lunar surface soil was put in to hold it down. The bag is attached to the carrier structure by three aluminum spring clips (fig. 14-44). The weight of the loaded bag is shared by these clips and three hangers. The retention force is limited so that the loaded bag may be easily lifted out of the carrier.

Figure 14-44.- Tool carrier collection bag retention.

The retention characteristics of the left side, with two spring clips over the 0.37-inch diameter rolled bead of the carrier structure, is satisfactory. However, the single spring clip over the 0.18-inch lip of the carrier on the right side did not provide sufficient positive retention. A separate double spring clip, which reaches over both the bag hanger and tool carrier structure, will be added for Apollo 13 to provide the necessary retention force as shown in the figure.
