MSC-01855

APOLLO 12 MISSION REPORT

MARCH 1970

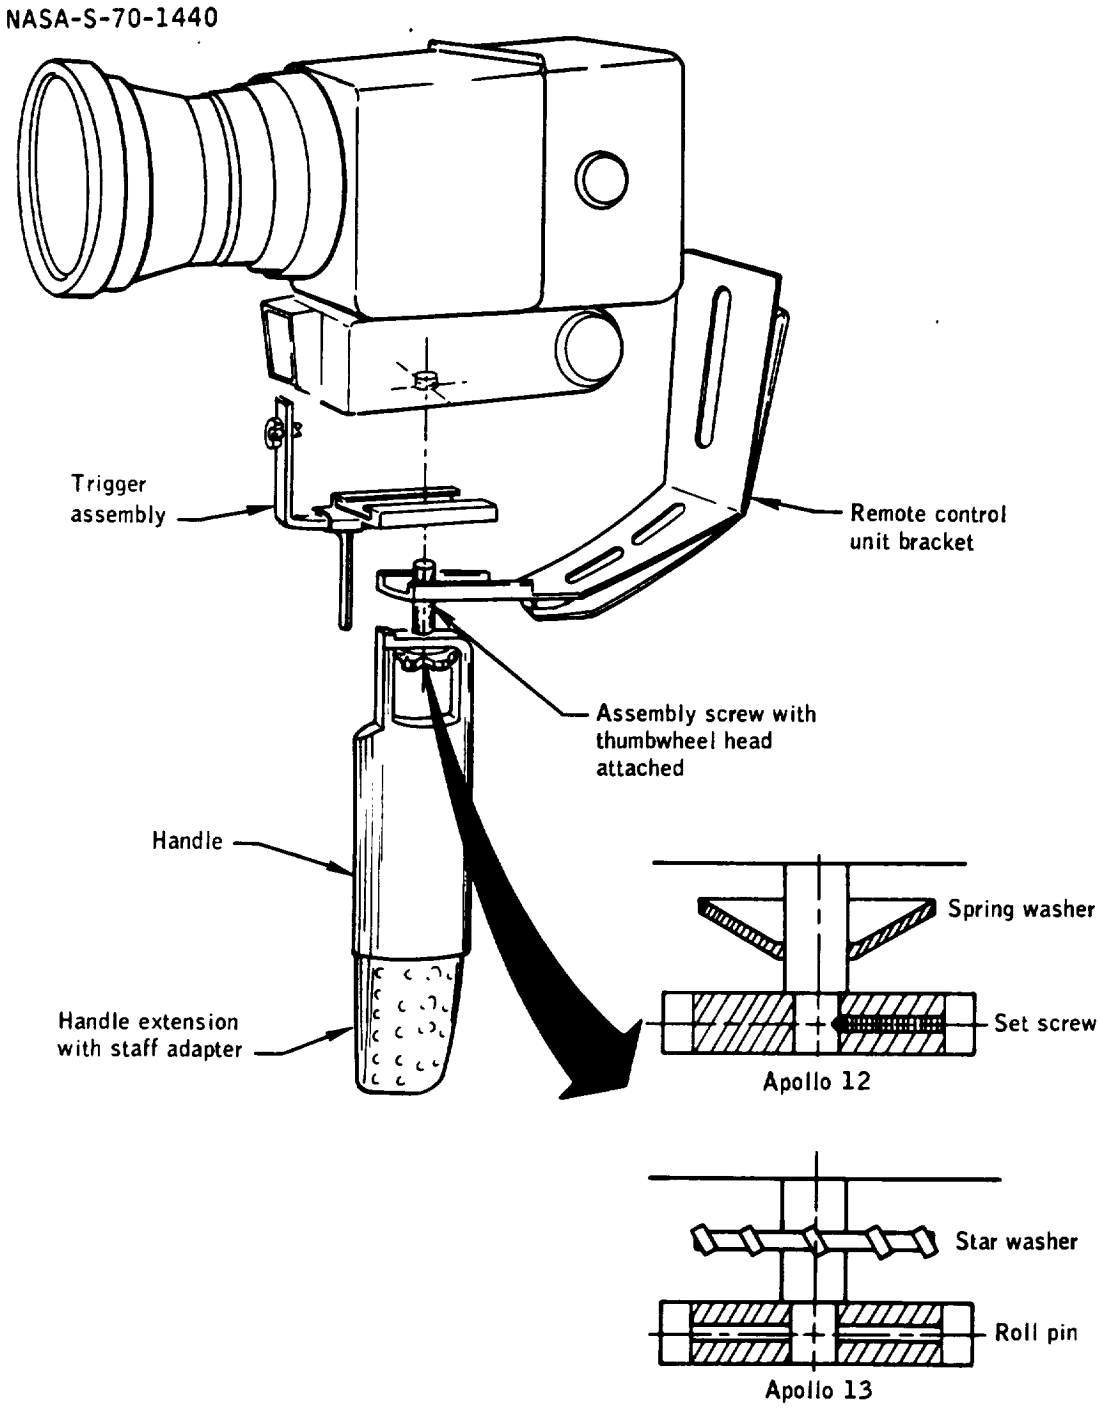
During the second extravehicular period, the Commander's camera did not advance and count every time the trigger was squeezed. Shortly afterwards, when both the camera assemblies were being removed from the remote control units in order to exchange them, both assemblies were loose, although they had been well tightened before egress. In the process of retightening on the lunar surface, the thumbwheel fell off the Lunar Module Pilot's camera assembly, making reassembly impossible (fig. 14-45). The empty camera and faulty assembly were then discarded. The Commander's camera assembly was retightened and performed satisfactorily during the remainder of the extravehicular activity.

Figure 14-45.- 70-mm camera handle assembly.

The intermittency experienced by the Commander in the shutter, counter, and film advance actions was the result of excessive trigger play caused by the loose assembly. The loss of the thumbwheel experienced by the Lunar Module Pilot was apparently the result of the improper installation of the thumbwheel setscrew.

For future missions, the cupped spring washer will be replaced by a star washer to resist rotation and loosening of the assembly screw, and the thumbwheel will be secured to the screw with a roll pin, instead of a setscrew.

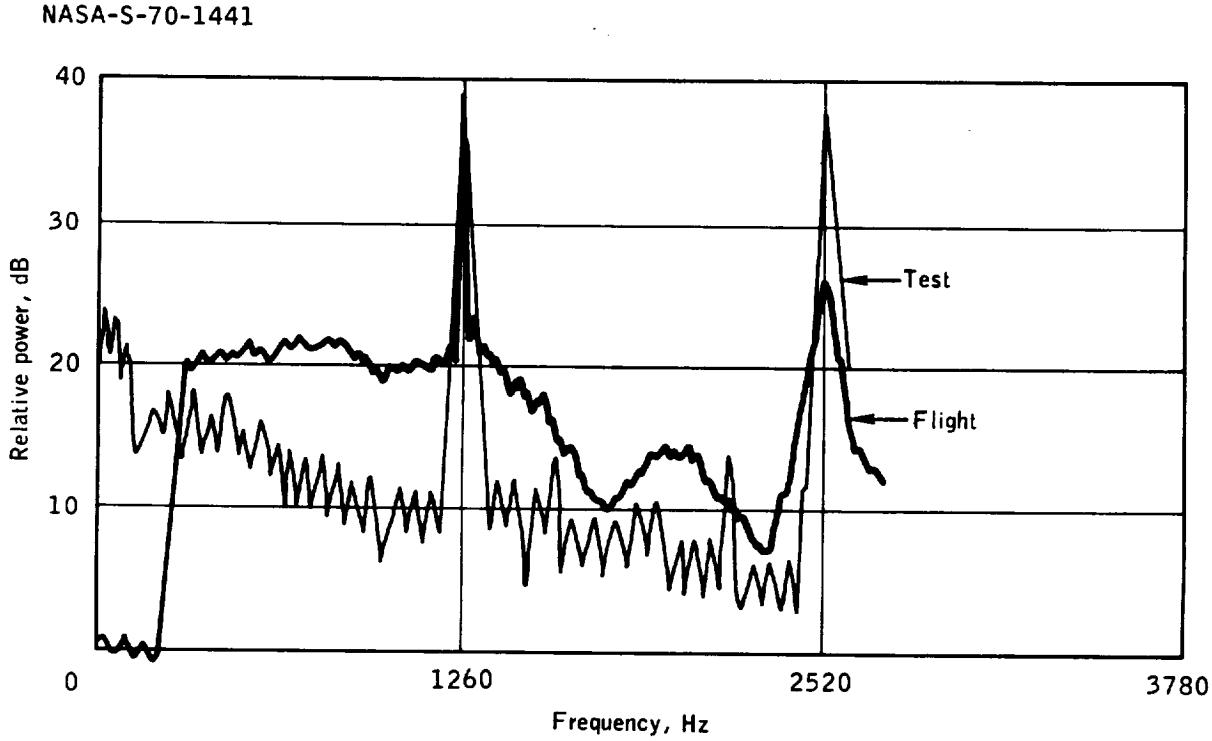
A subsequent analysis of the telemetry data transmitted from the extravehicular mobility unit did not show any degradation of data quality as a result of the noise. Power spectral density plots, however, revealed a fundamental frequency of approximately 1260 hertz and a harmonic frequency of 2520 hertz. Postflight interference tests of an equivalent extravehicular mobility unit revealed the same 1260-hertz tone on the battery-bus leads and shield which originated from the fan-motor ripple current. This condition is normal and has been noted during qualification testing of the extravehicular mobility unit. Figure 14-46 illustrates the tone interference generated by the fan motor. However, during these initial tests, the noise interference could not be made to enter the audio system such that the audio tone heard in flight was simulated.

Figure 14-46.- Tone power spectral density.

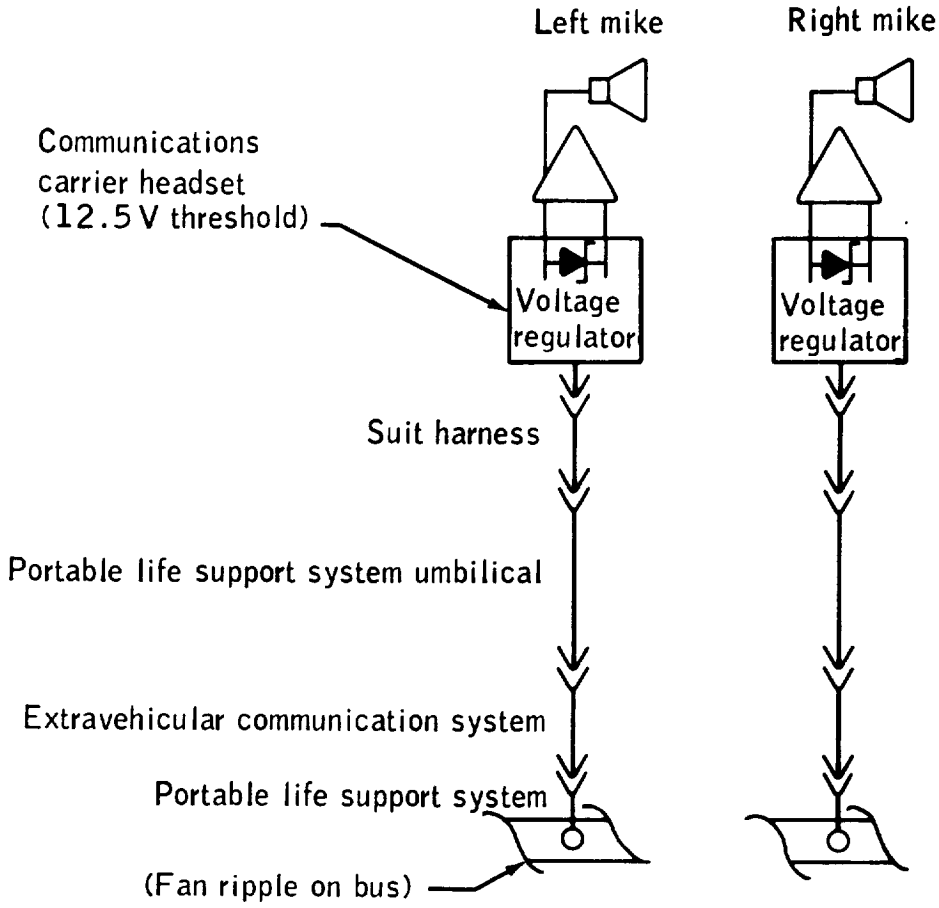
NASA-S-70-1442

Later laboratory testing of the communications carrier headset demonstrated that lowering a microphone amplifier supply voltage below the regulator threshold of 12.5 volts caused tone interference to enter the audio system. Subsequent analysis showed that a high resistance or the failure of a regulating diode or a transistor in the microphone amplifier regulator could result in a loss of regulator filtering action. The normal operating voltage for the microphone amplifier is from 15.7 to 20.5 volts. When the microphone amplifier supply voltage is above the regulator threshold of 12.5 volts, the tone interference does not enter the audio system.

Figure 14-47.- Communications carrier headset power path.
