C25(88)**Level 2.5****Repair Documentation**

The C25 is the first dualband handset (GSM-900 and GSM-1800) in the C-class. The C2588 is a special version for the asian market featuring a graphic display instead of the alphanumeric C25 display.

This manual is intended to help you carry out repairs on level 2.5, meaning limited component repairs. Failure highlights are documented and should be repaired in the local workshops.

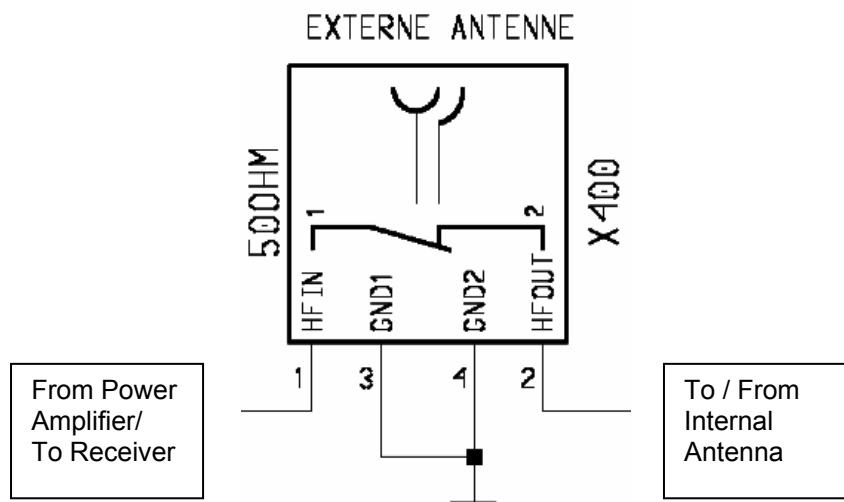
The Antenna Connector is a mechanical switch operated by the RF plug of a carkit or, for testing purposes, of an RF clip.

Normally the RF signal goes to and comes from the internal antenna. Whenever an RF plug is plugged into the antenna connector the connection to the internal antenna is opened and the connection to the external antenna socket is made. See drawing below.

Use hot air blower to remove defective connector
Avoid excessive heat!
Watch surrounding components!
