MSC-PA-R-68-15

APOLLO 7 MISSION REPORT

MANNED SPACECRAFT CENTER

DECEMBER 1968

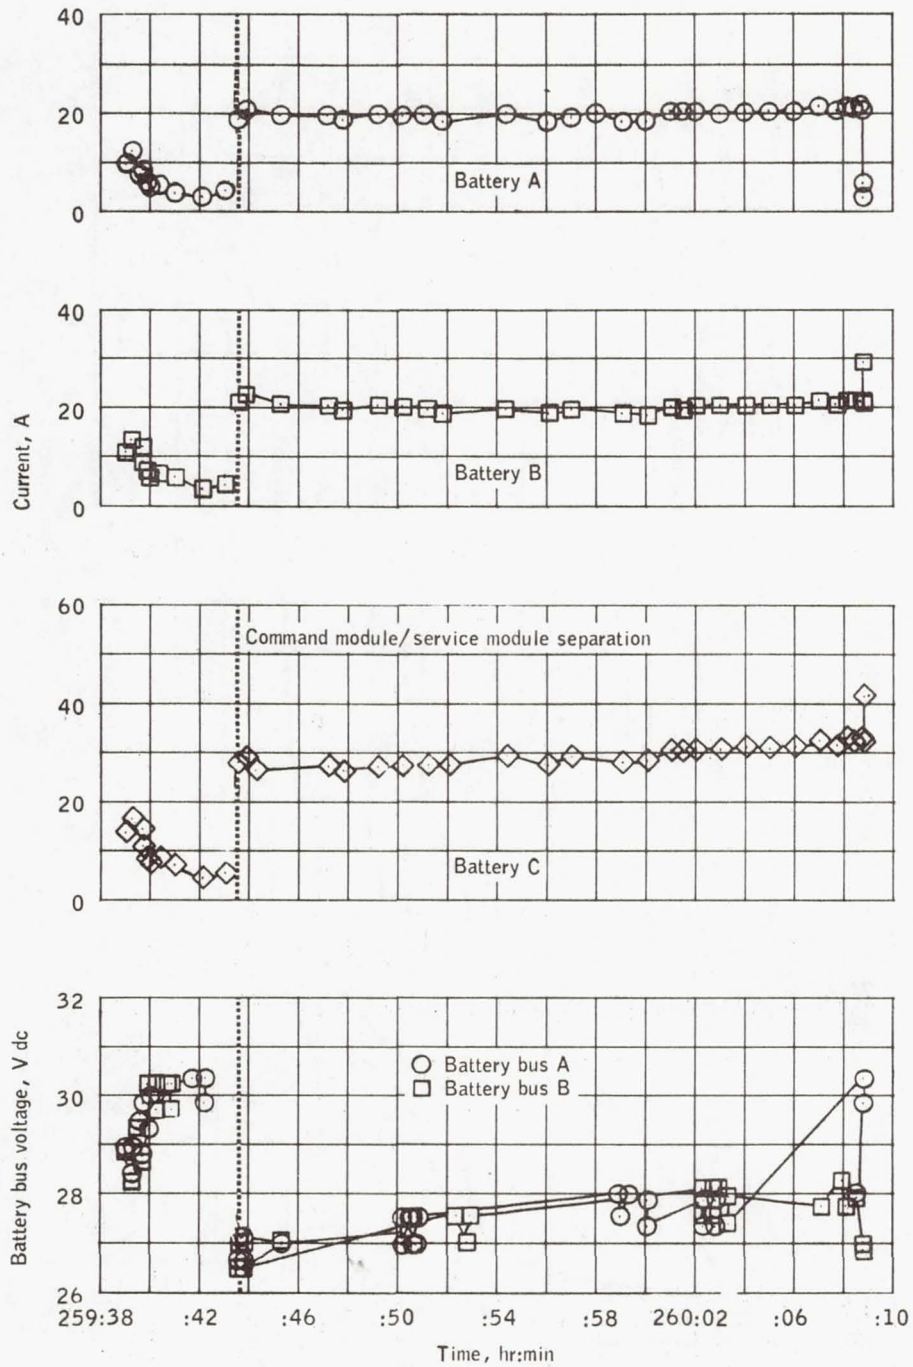
Figure 5.8-7.- Entry battery performance following deorbit maneuvers.

During service propulsion maneuvers, battery A and B voltages and current-sharing with the fuel cells were within nominal limits; however, on the later maneuvers, the batteries exhibited lower ratios of power-sharing as the states of charge decreased (see fig. 5.8-7). Voltages on batteries A and B declined in accordance with a normal slope for a load of 0.021 ampere per battery, caused by the small loads which are continuously tied to battery relay buses. When the total spacecraft electrical load was imposed on the batteries at command module/service module separation, the voltage on battery buses A and B decreased to 26.4 volts,

resulting in main bus voltages of about 25 volts. Consequently, the low-voltage indication (26.2 volts) came on. The voltage slowly increased above the alarm level about 12 minutes later. All equipment, however, operated satisfactorily during this period. The performance of the entry batteries is presented in figure 5.8-8. These conditions were caused by both the cool temperatures and the states of charge of the batteries. A more detailed discussion is given in section 11.

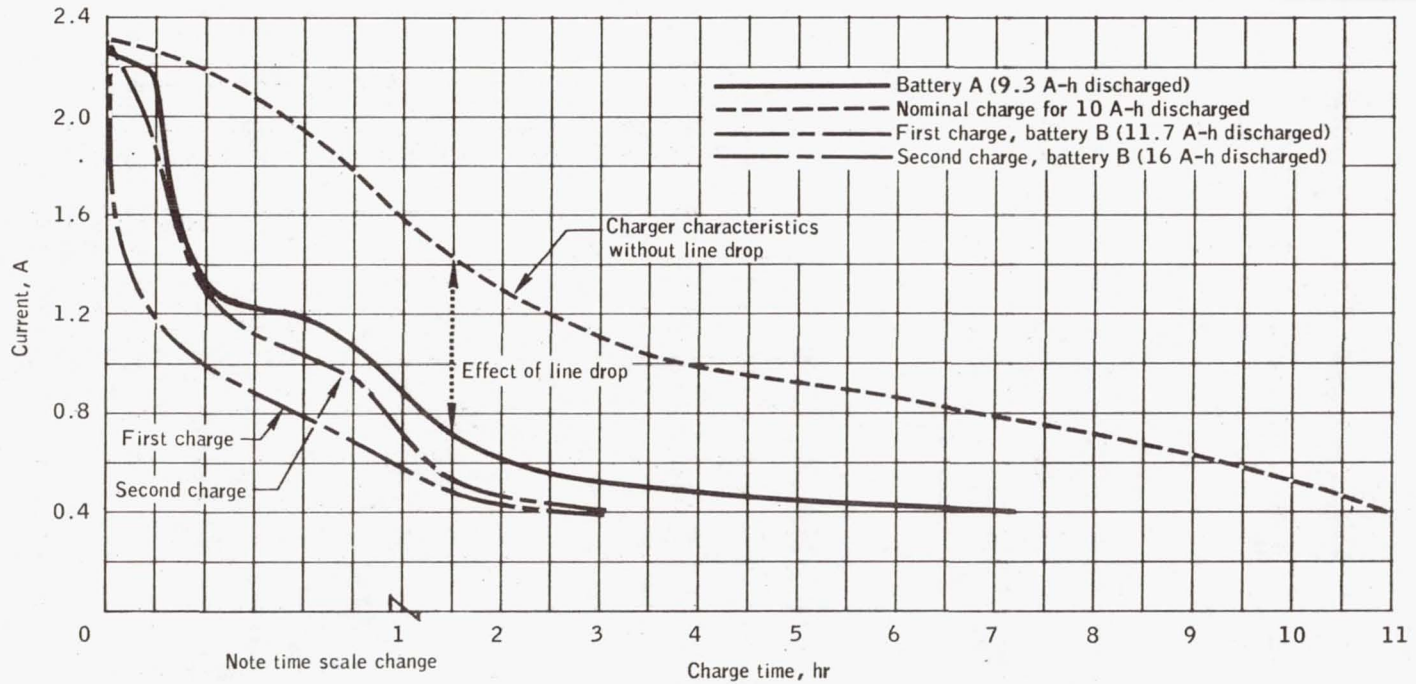
Figure 5.8-8.- Entry battery charging characteristics.

Another flight discrepancy was the inability to fully recharge entry batteries A and B because the lower charge rate limit of 0.4 ampere was reached sooner than expected. Figure 5.8-9 indicates charging current decrease with time, and figure 5.8-10 shows the charger current/voltage characteristics. The condition resulted from the particular characteristics of the charger, coupled with the normal line resistance between the charger and the batteries. Further details are presented in section 11.

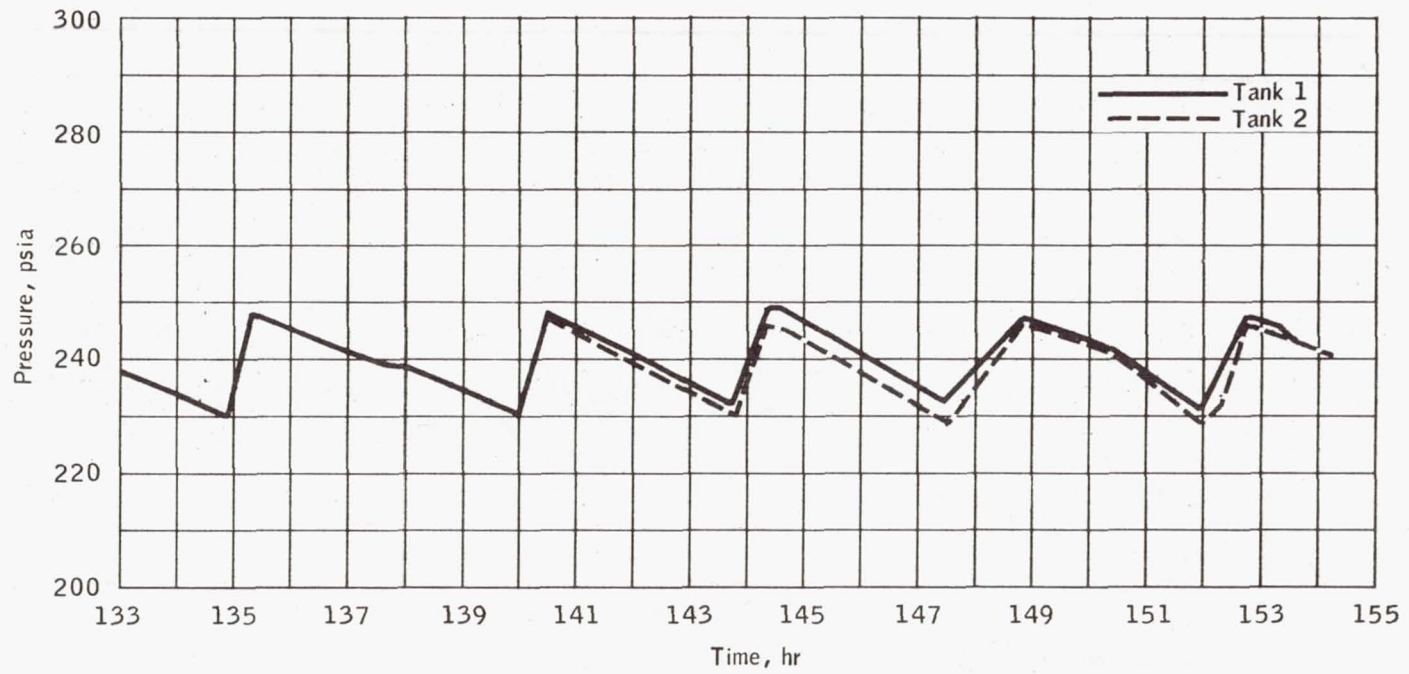
Figure 5.9-2.- Typical hydrogen tank pressure history with automatic fan and heater cycles.

The automatic pressure control system maintained tank pressures at an acceptable level. Typical pressure cycling is shown in figures 5.9-2 and 5.9-3 for hydrogen and oxygen, respectively.

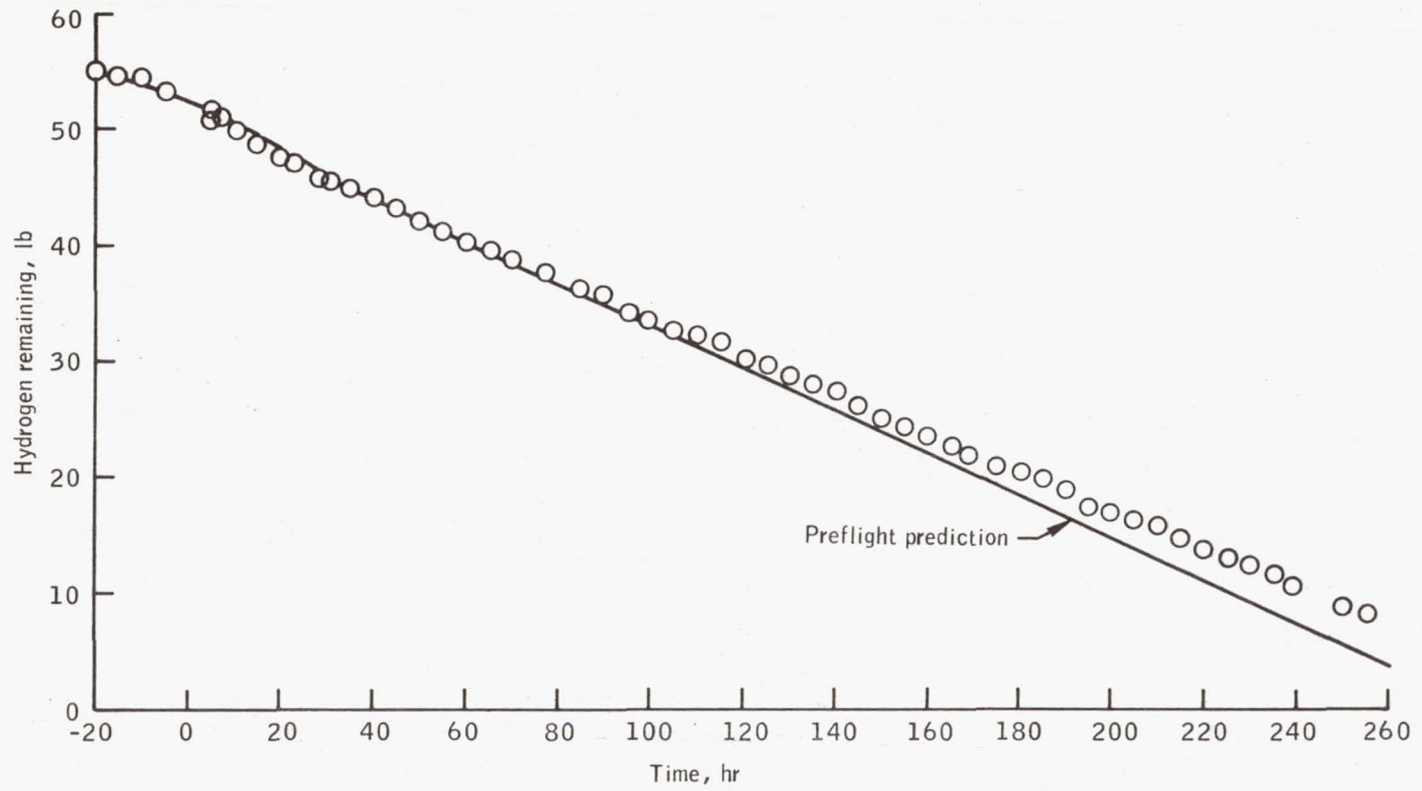
Figure 5.9-6.- Hydrogen quantity profile.

The following table indicates that the quantities of hydrogen and oxygen used during the mission and the calculated usage by the environmental control system and fuel cells agree to within 0.7 pound of hydrogen and 3.5 pounds of oxygen, both within instrumentation accuracy. The hydrogen and oxygen quantity profiles are shown in figures 5.9-6 and 5.9-7.

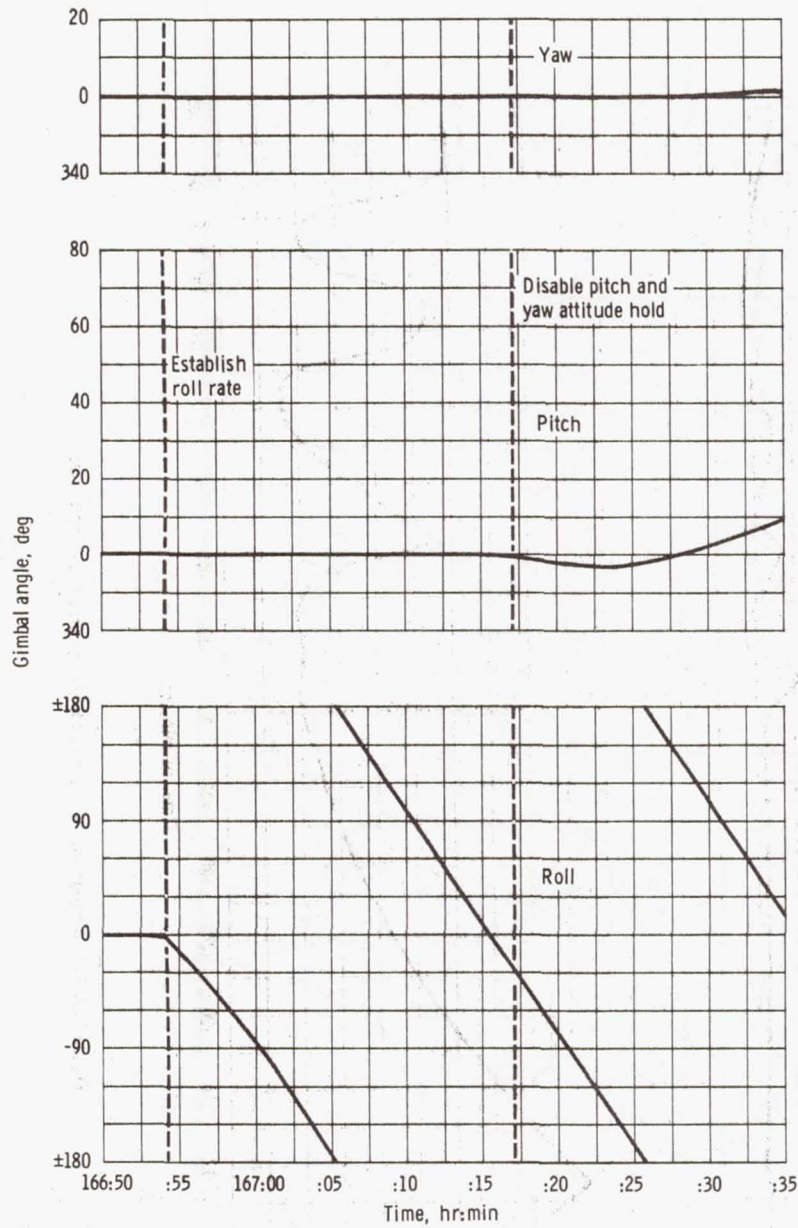
Figure 5.16-24. - Gimbal angles during roll passive thermal control test.

Passive thermal control.- The primary objective of the passive thermal control tests was to validate procedures for passive thermal control through examination of initial rate and attitude data. Figures 5.16-24 and 5.16-25 contain time histories of spacecraft attitude during the roll and pitch passive thermal control modes, respectively. Stability characteristics of each mode may be observed from the attitude time histories after attitude hold is relinquished in the two non-stabilized axes. The roll mode test stability characteristics were considered good with the pitch axis divergence attributable to aerodynamic disturbances. The roll axis divergence during the pitch mode test cannot be attributed to aerodynamics. These results indicate that the roll mode will be more stable in an environment in which aerodynamic moments are negligible.

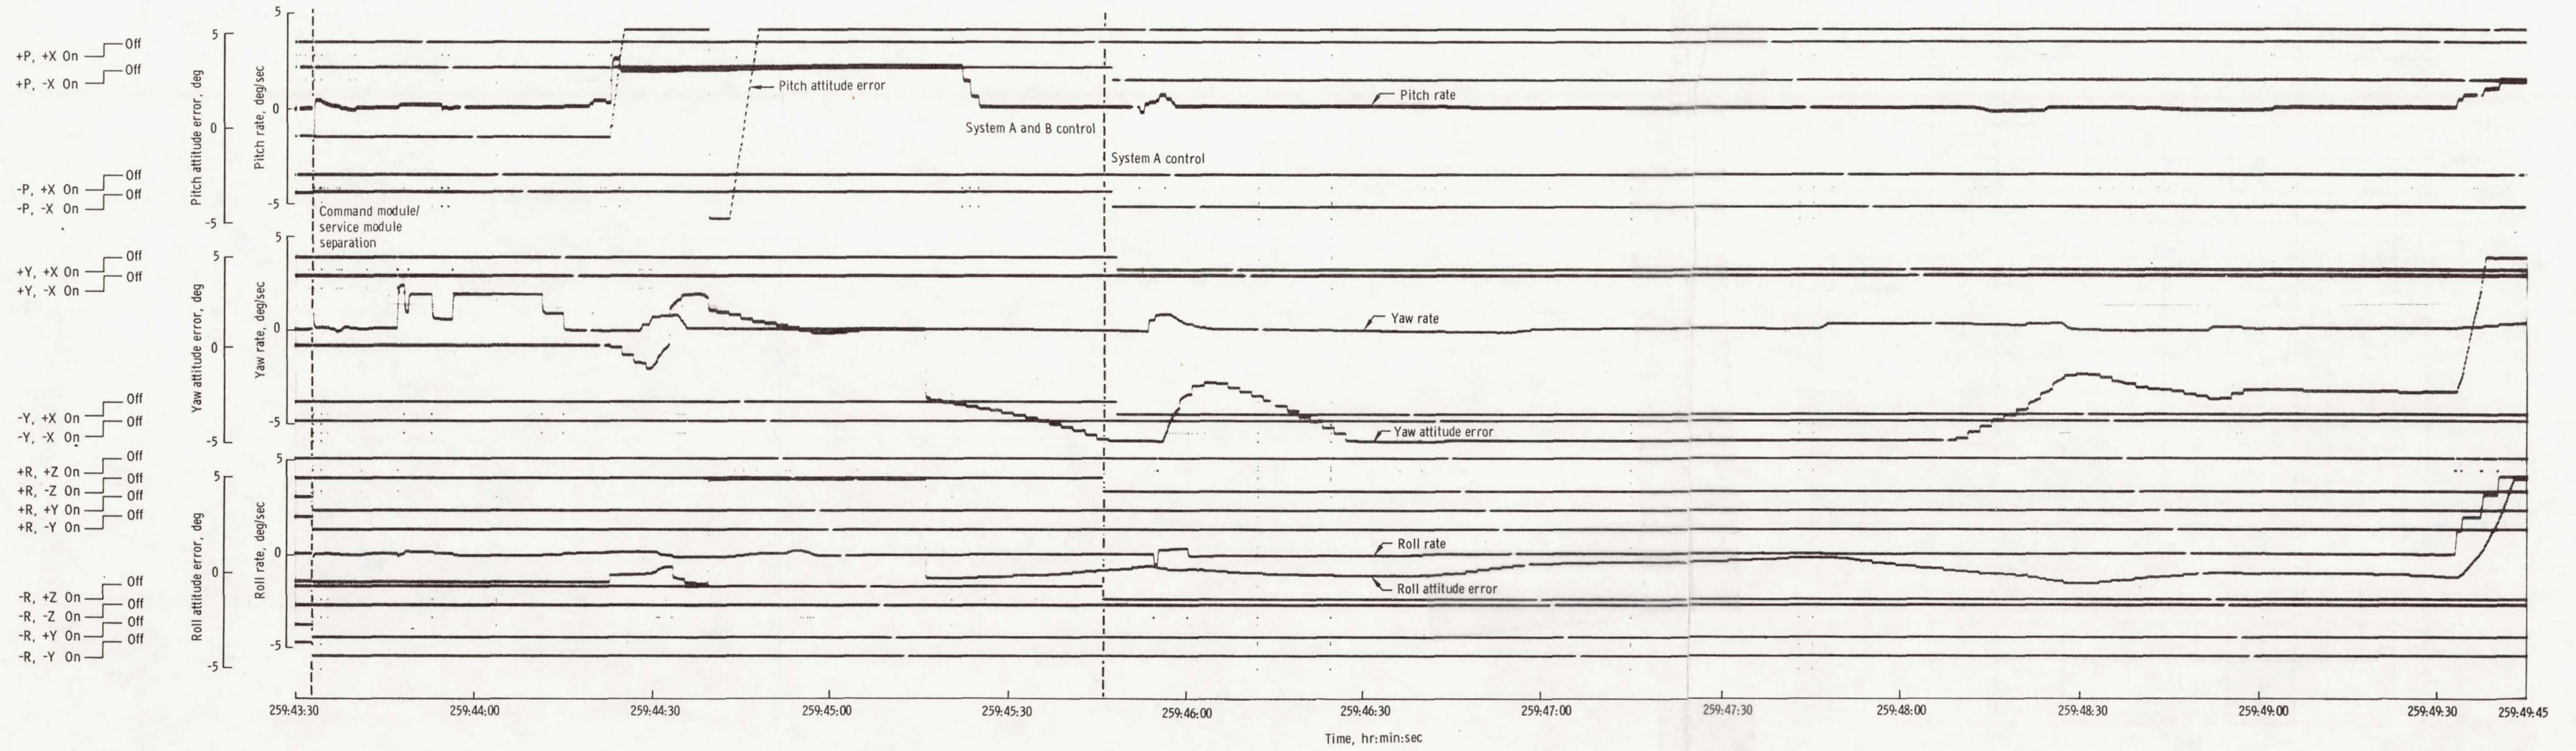
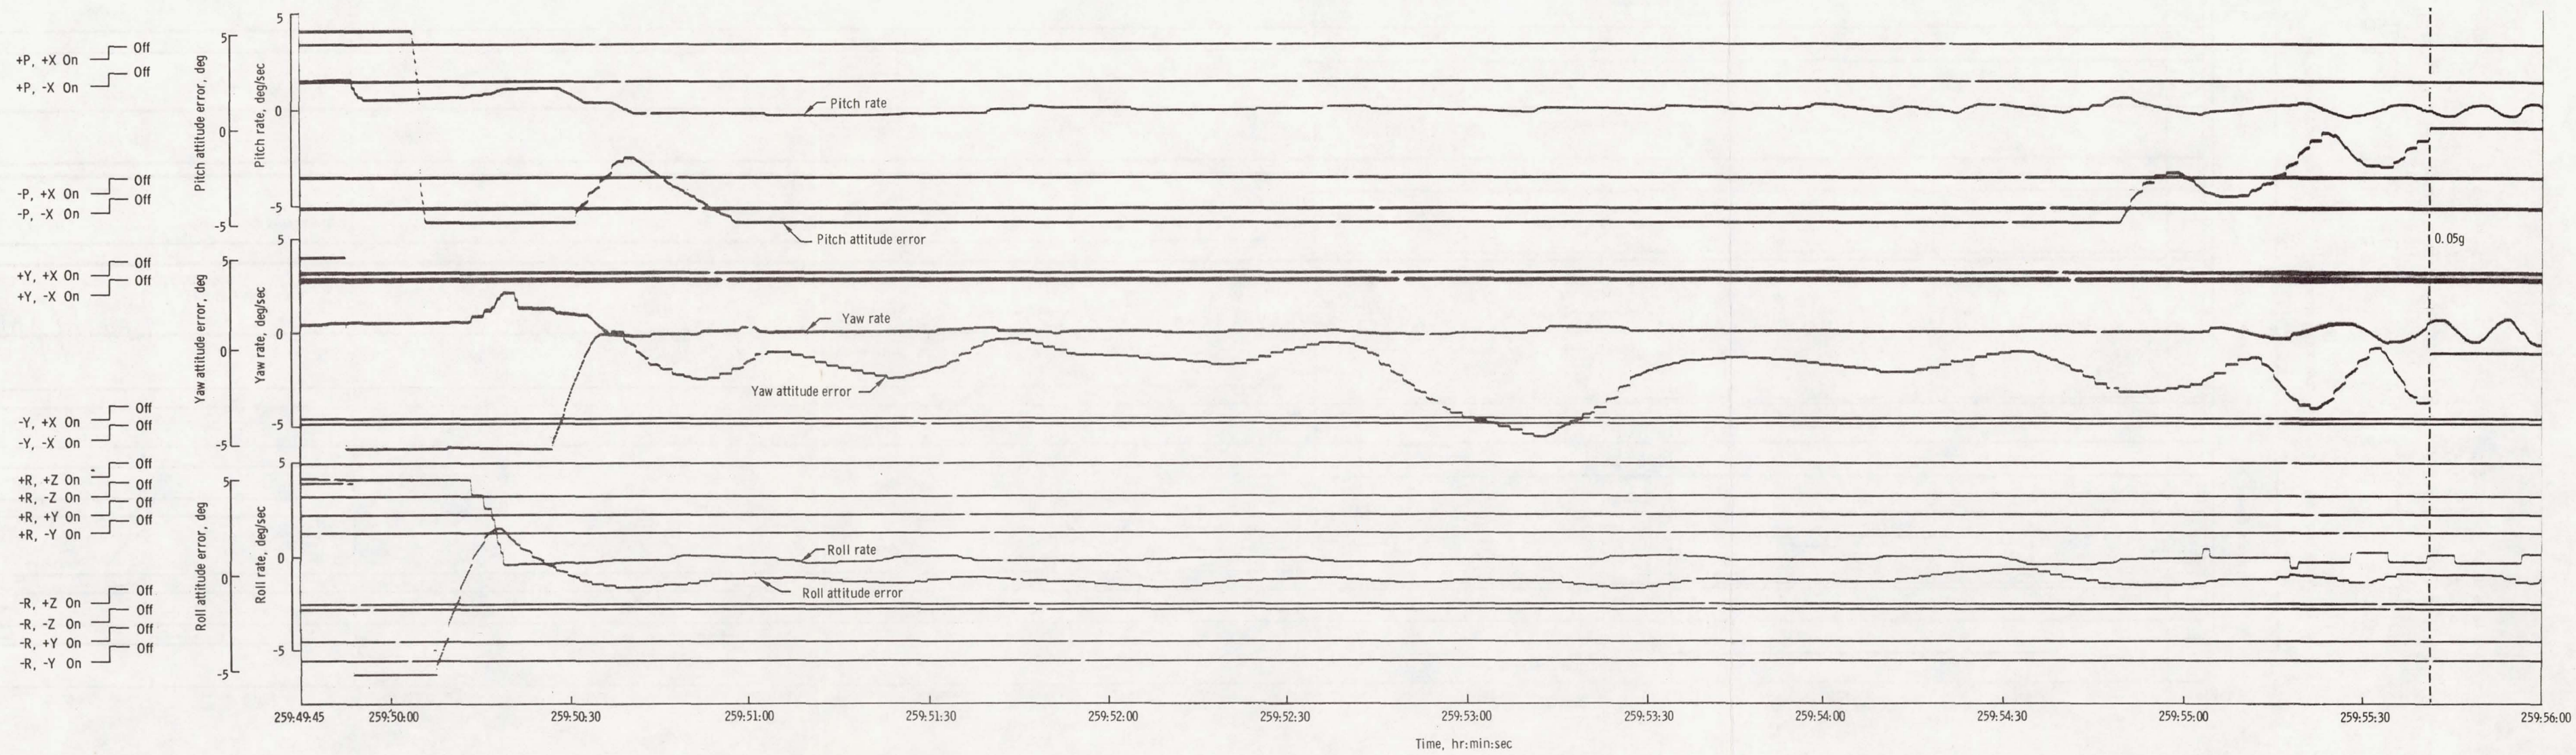
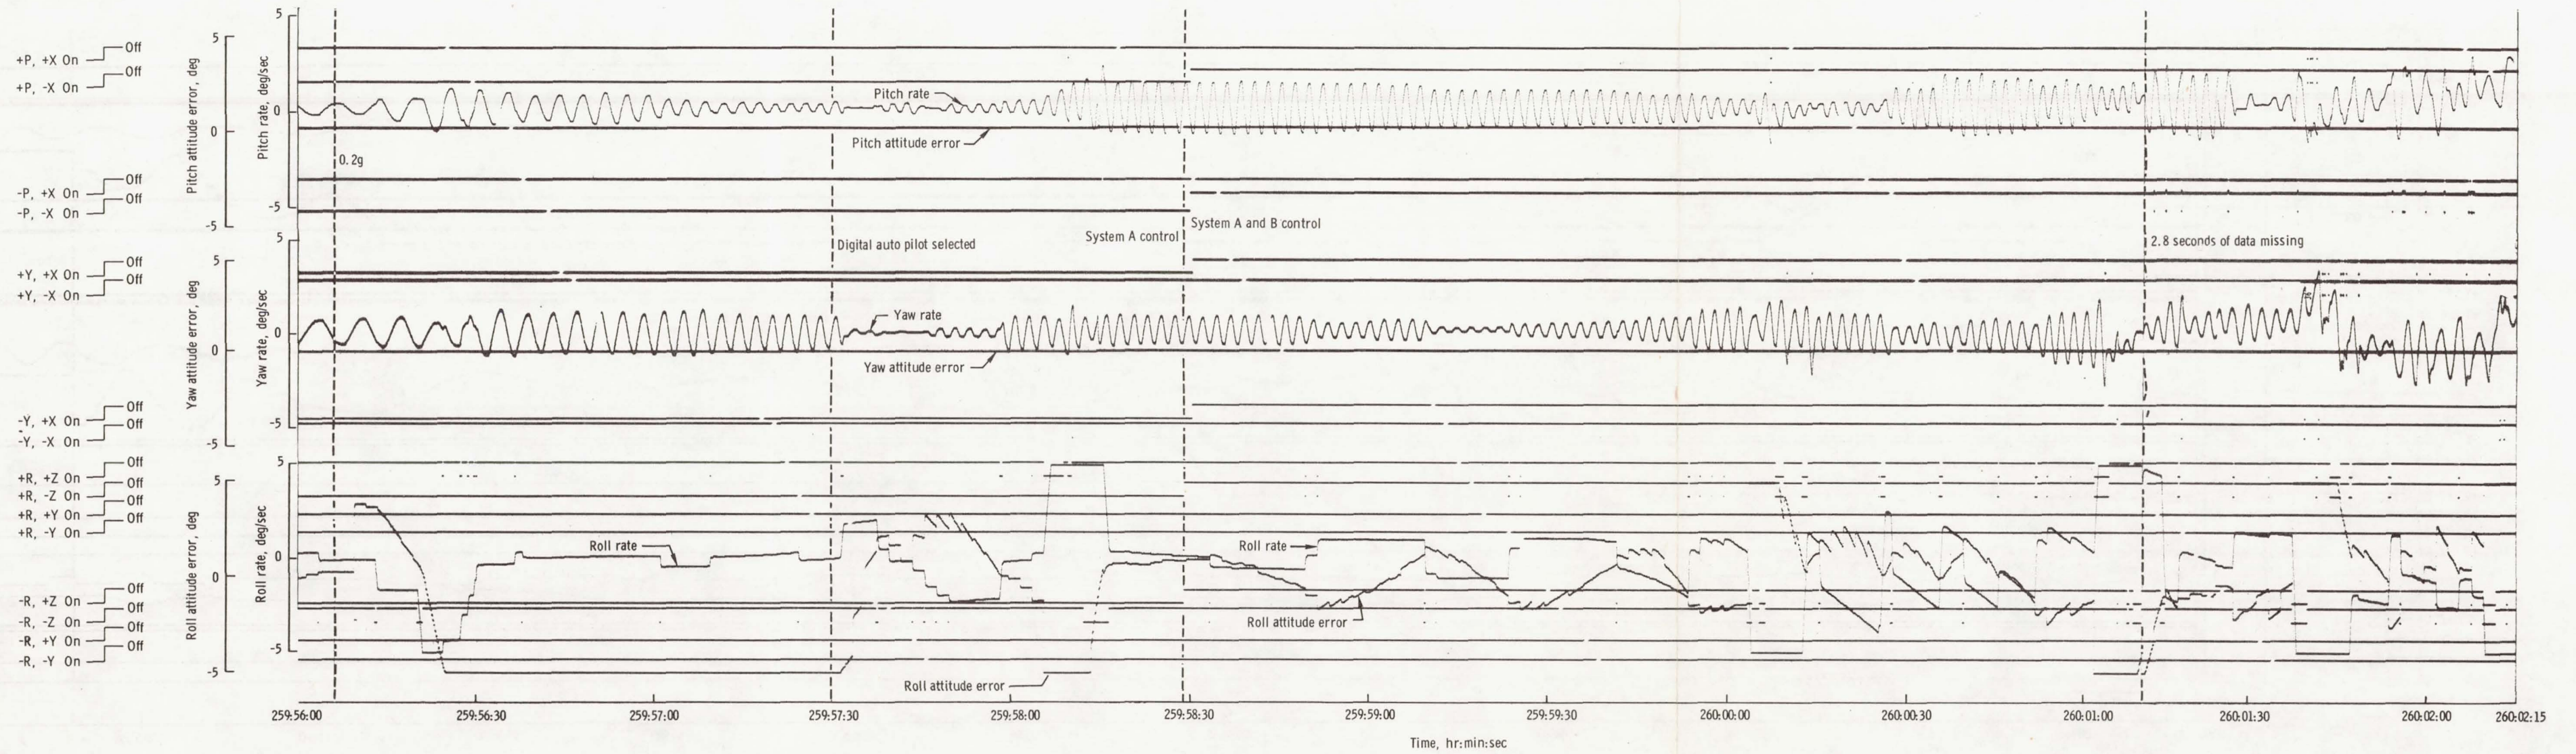
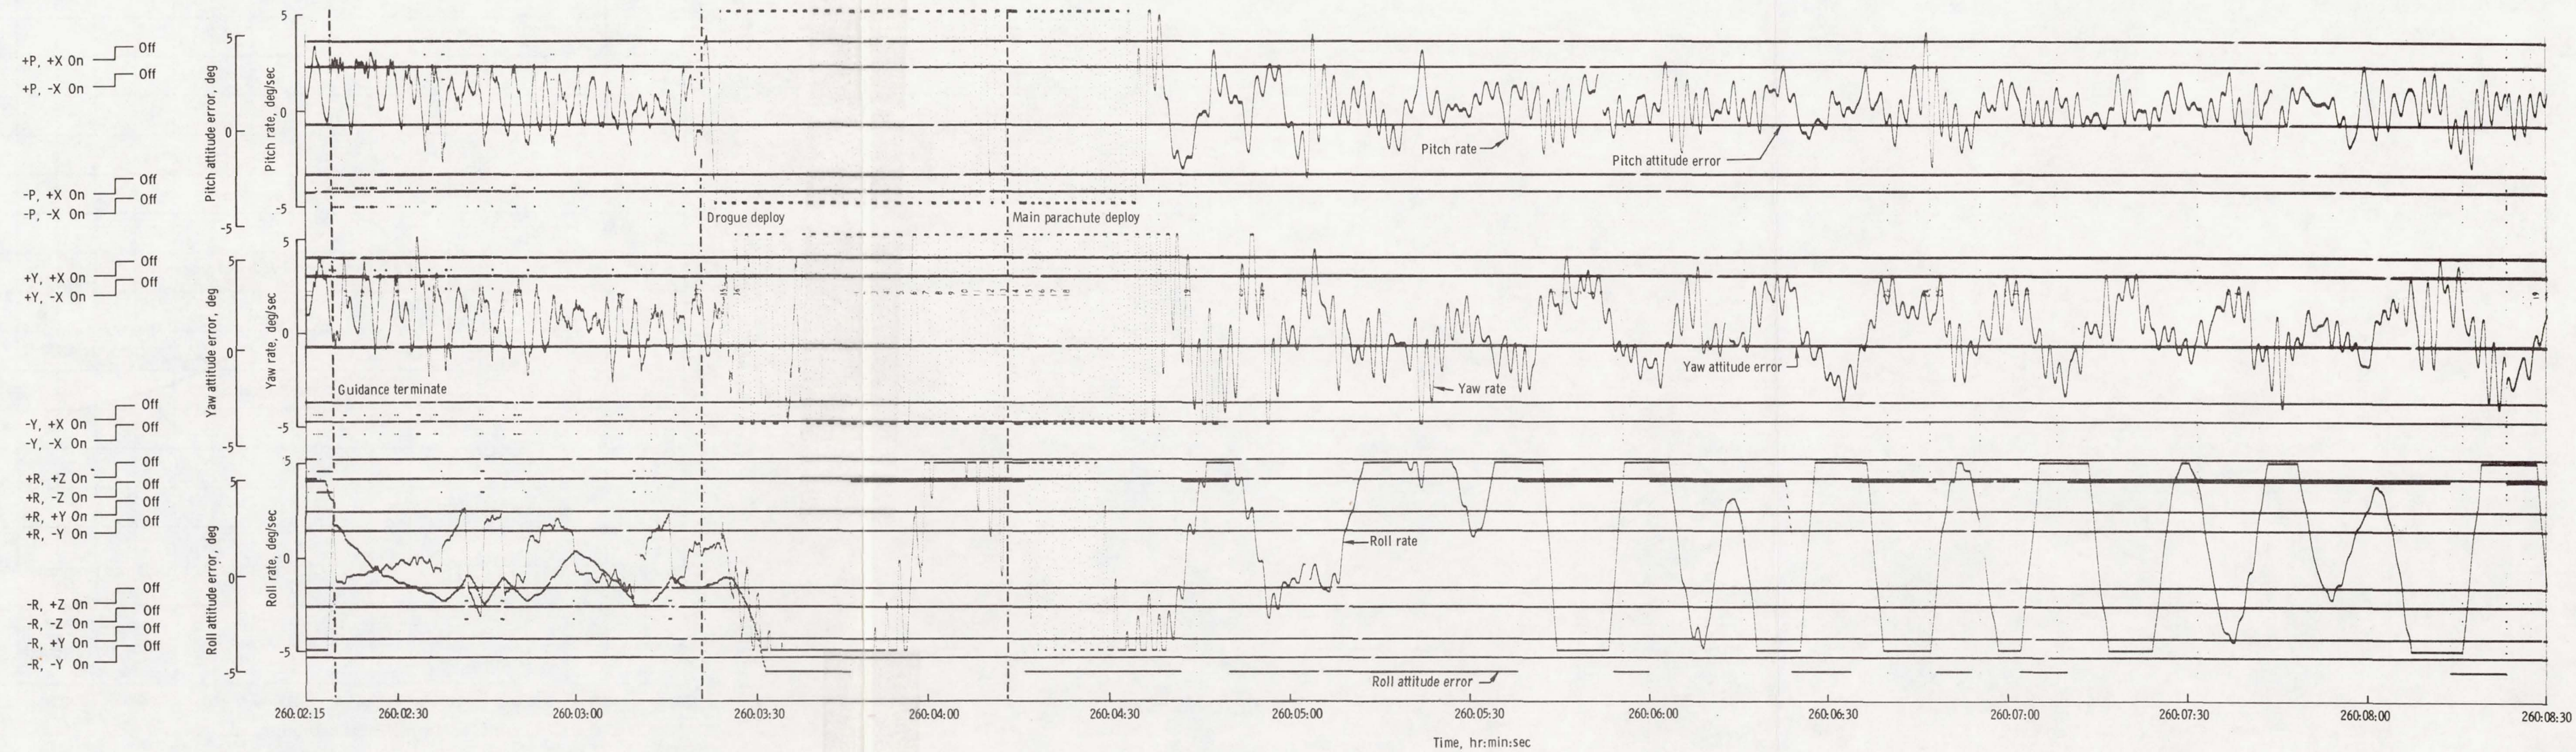
Figure 5.16-26. - Spacecraft dynamics during entry.

Entry.- A time history of dynamic parameters during entry is shown in figure 5.16-26. As noted, the spacecraft was controlled manually until 259:57:26 and automatically by the digital autopilot thereafter. The crew switched to dual reaction control system operation at 259:58:29 after reporting a large pitch disturbance and other visual observations (see section 11). The only abnormality visible in the data during this period occurred approximately 15 seconds before the crew switched to dual-system operation. At this time, sharp, but relatively small, amplitude changes were discernible in the pitch and yaw rate data. (See section 3.) Coupling of roll activity into both pitch and yaw axes occurred throughout the entry.

The proportion of the total fuel used to damp pitch and yaw rates was higher than predicted. All the excess was used in the 2-minute period before drogue deployment after the spacecraft entered the aerodynamically unstable transonic region. Simulations to reproduce flight results using transonic aerodynamic coefficients and gusting winds show fuel usage of this order is to be expected under these conditions with dual system operation.

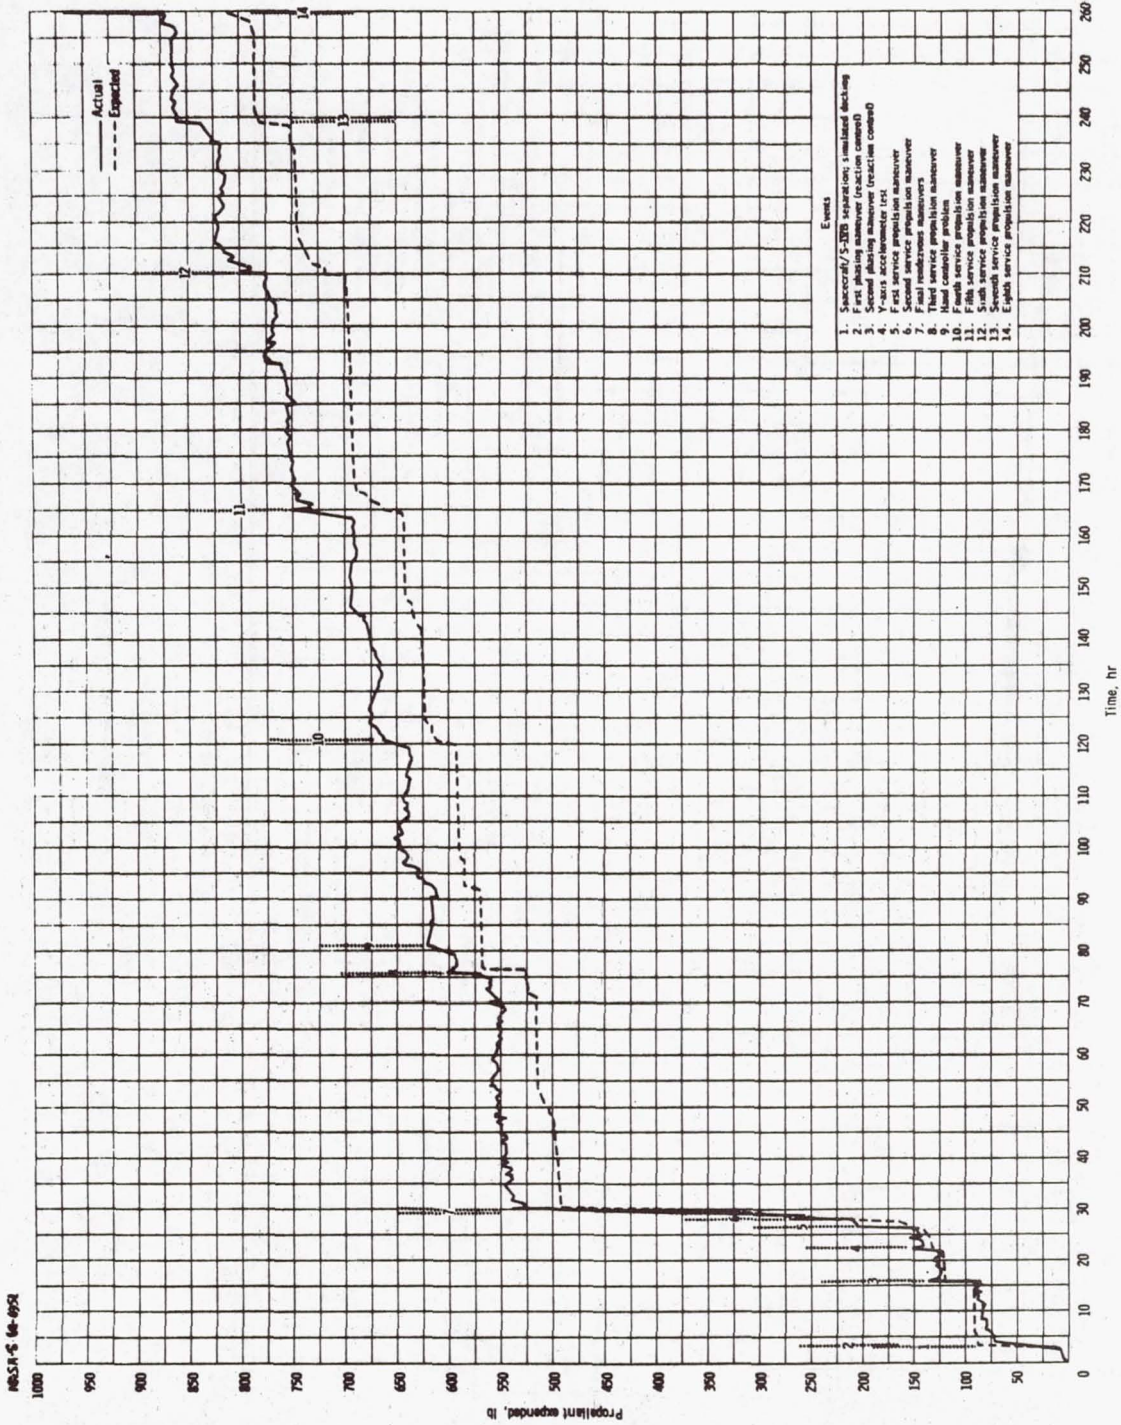
Figure 5.17-1. - Total propellant expended from service module reaction control system.

The total propellant consumption during the flight is shown in figure 5.17-1. With the major exception of rendezvous, propellant consumption approximated the predicted usage as adjusted for flight plan changes. The rendezvous required approximately 37 pounds or 11 percent more than predicted.

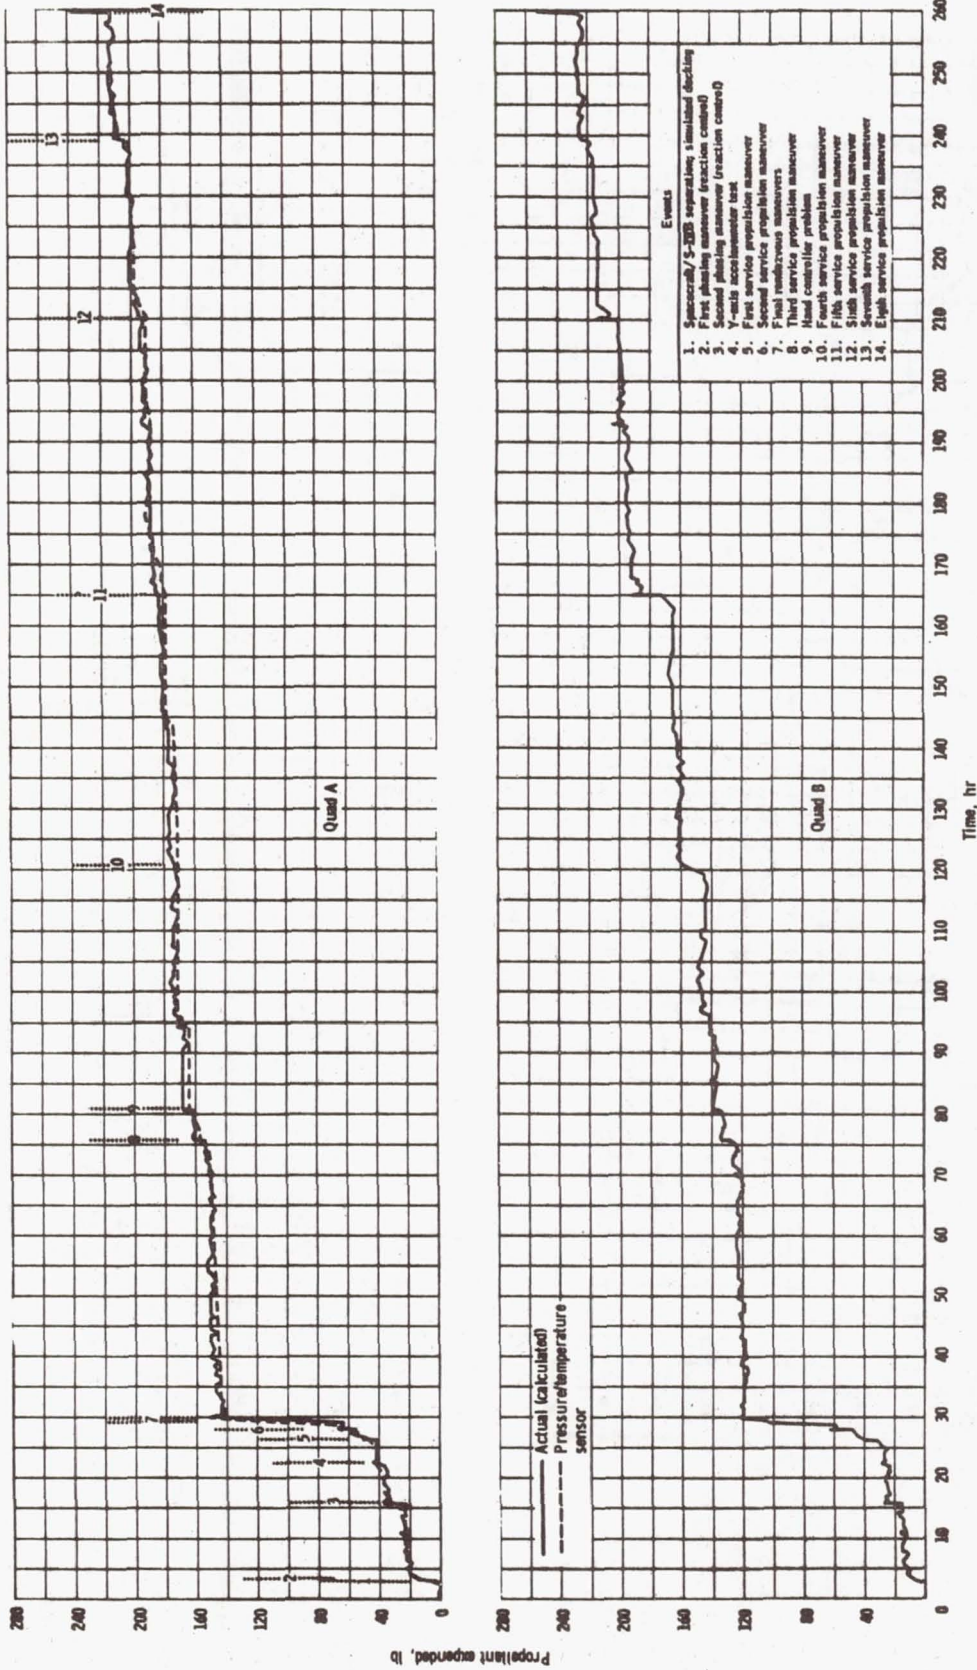
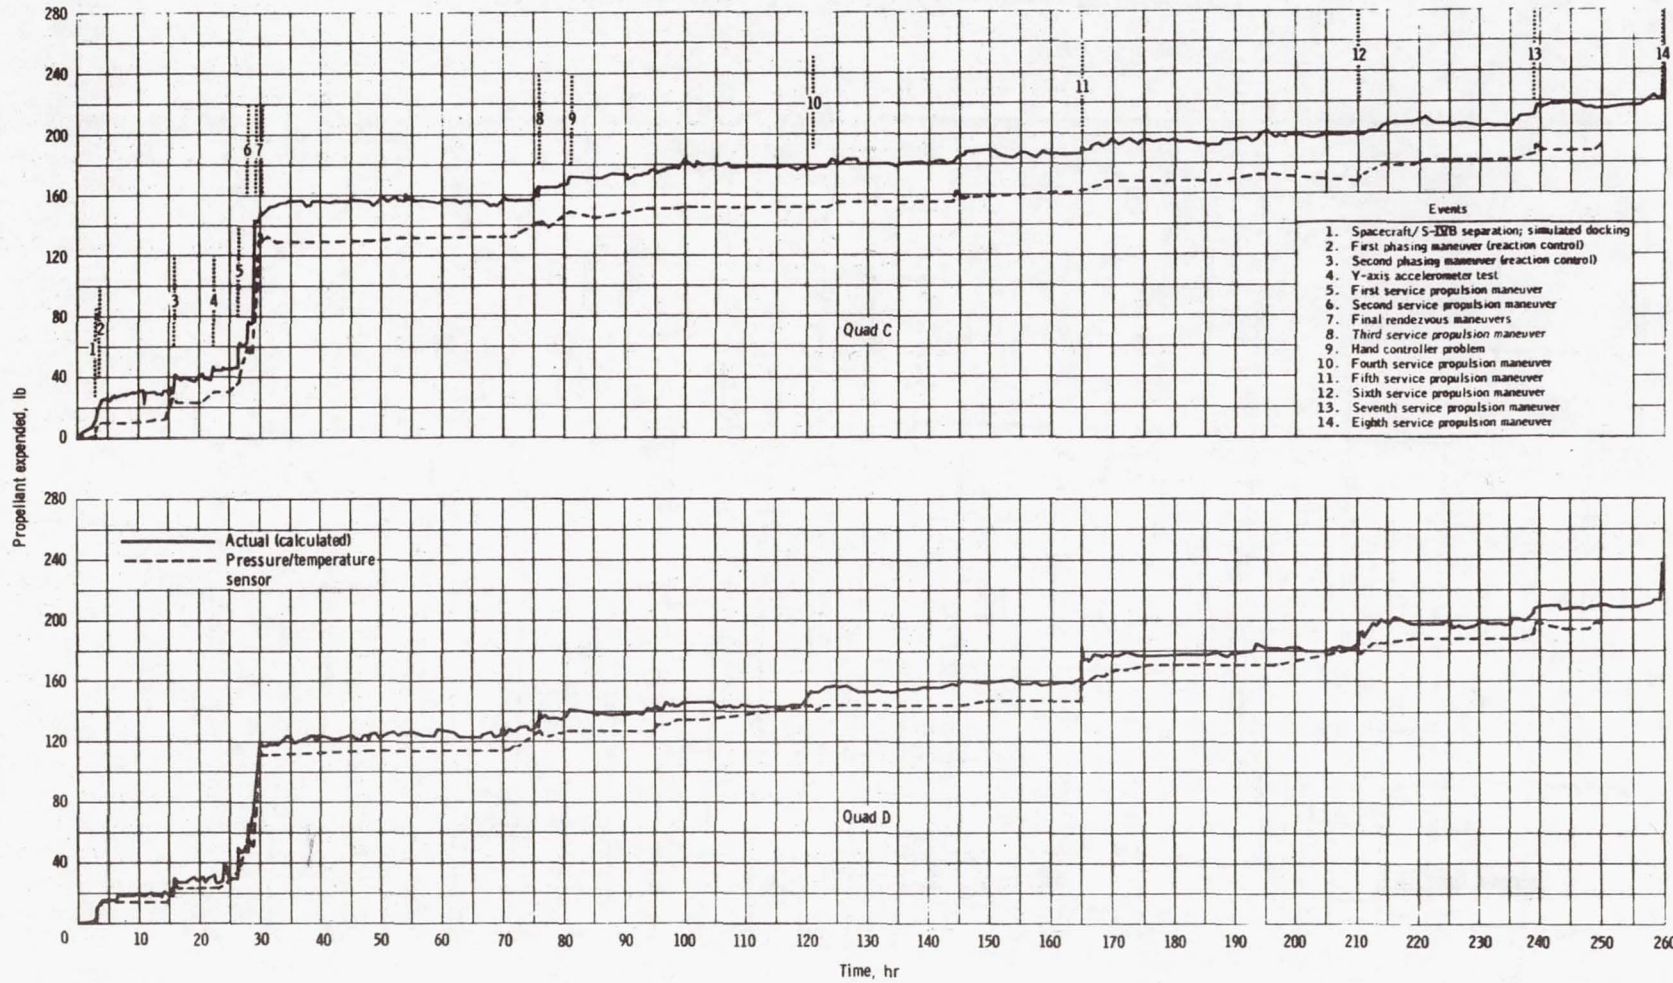
Figure 5.17-2. - Propellant consumed from quads.

The propellant usage for each quad is shown in figure 5.17-2. The maximum mismatch in propellant quantity remaining among the four quads was maintained within 36 pounds by selectively varying combinations of one-, two-, and four-jet roll maneuvers and two- and four-jet plus X translations. A comparison of ground calculations with the onboard gage readings is shown in figure 5.17-2 for quads A, C, and D. The sensor for quad B failed before launch (see section 5.15). The telemetered gage readings have been converted from percent to weight of propellant remaining.

The fuel and oxidizer are each stored in two tanks, primary and secondary, with 38 percent of the total in the secondary tanks. Because of the uncertainty in the ground calculations (primary gaging system), the crew was requested to switch from the primary to the secondary tanks for each quad when the ground calculated quantity reached 43 percent remaining. This procedure precluded the possibility of supplying only oxidizer or only fuel to the engines, a condition which would be detrimental to the engines. To accomplish the switchover at 43 percent, the crew was instructed to switch at onboard gage readings of 46 to 54 percent, depending on the quad (as shown in table 5.17-1).

This variance from 43 percent was the correlation noted between ground calculations and the indication on the cabin gage. The major

contributing factor to this disparity was the selected helium pressure at propellant depletion used for the gage design. This and other factors are incorporated into a calibration nomograph, which was used to obtain corrected gage readings. The time of switchover, the telemetered and corrected gage readings, and the ground calculated quantity are also shown for comparison in table 5.17-I. As noted, the variance between ground calculations and corrected gage readings is 0.4 to 1.7 percent of full scale, whereas the differences for the uncorrected values are 2.4 to 8.7 percent. The cabin gage readings are then sufficiently accurate to be used as the primary gaging system by the crew, when corrected.

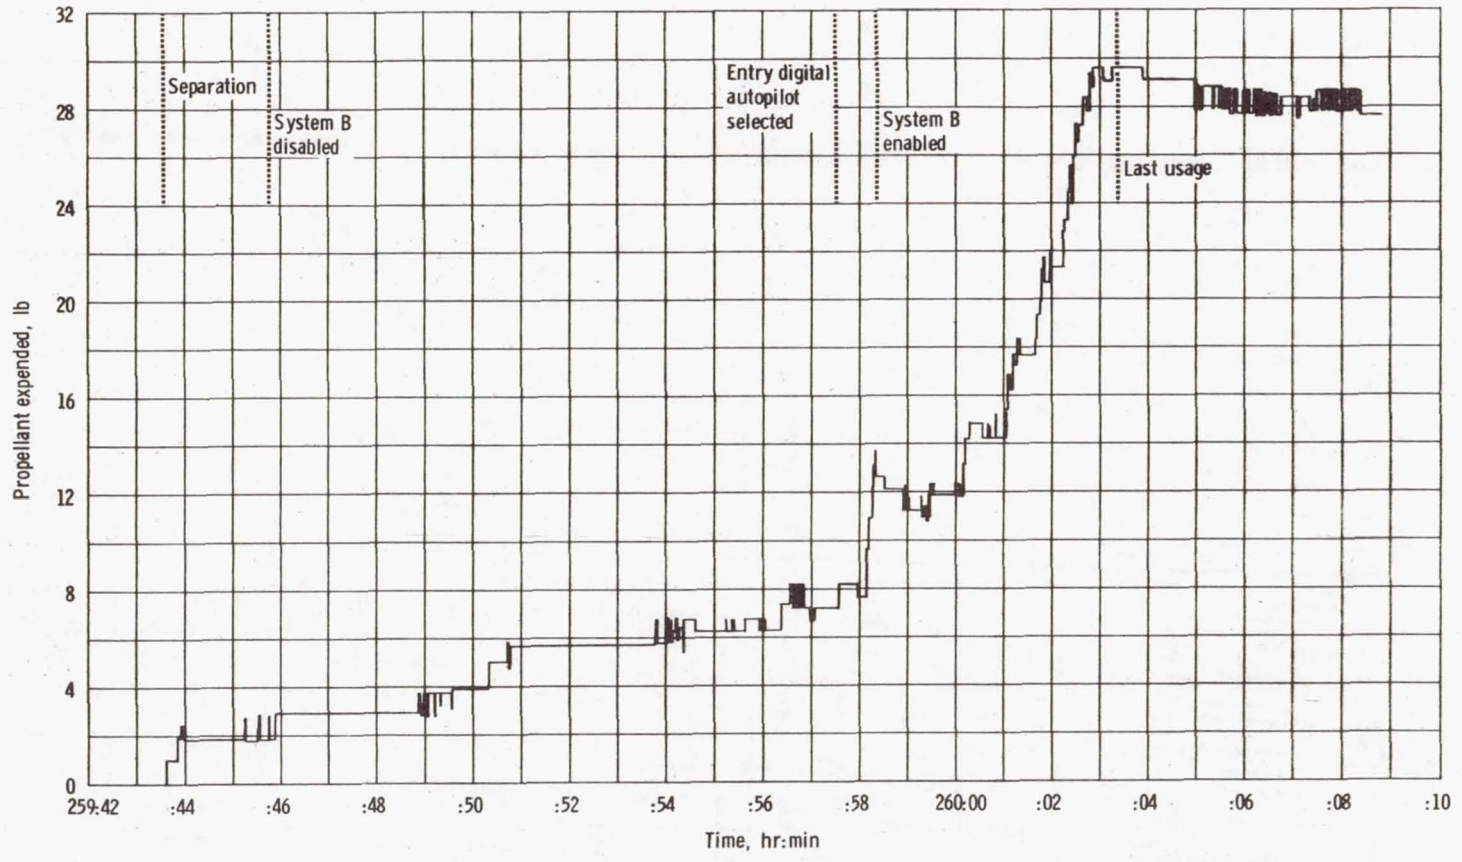
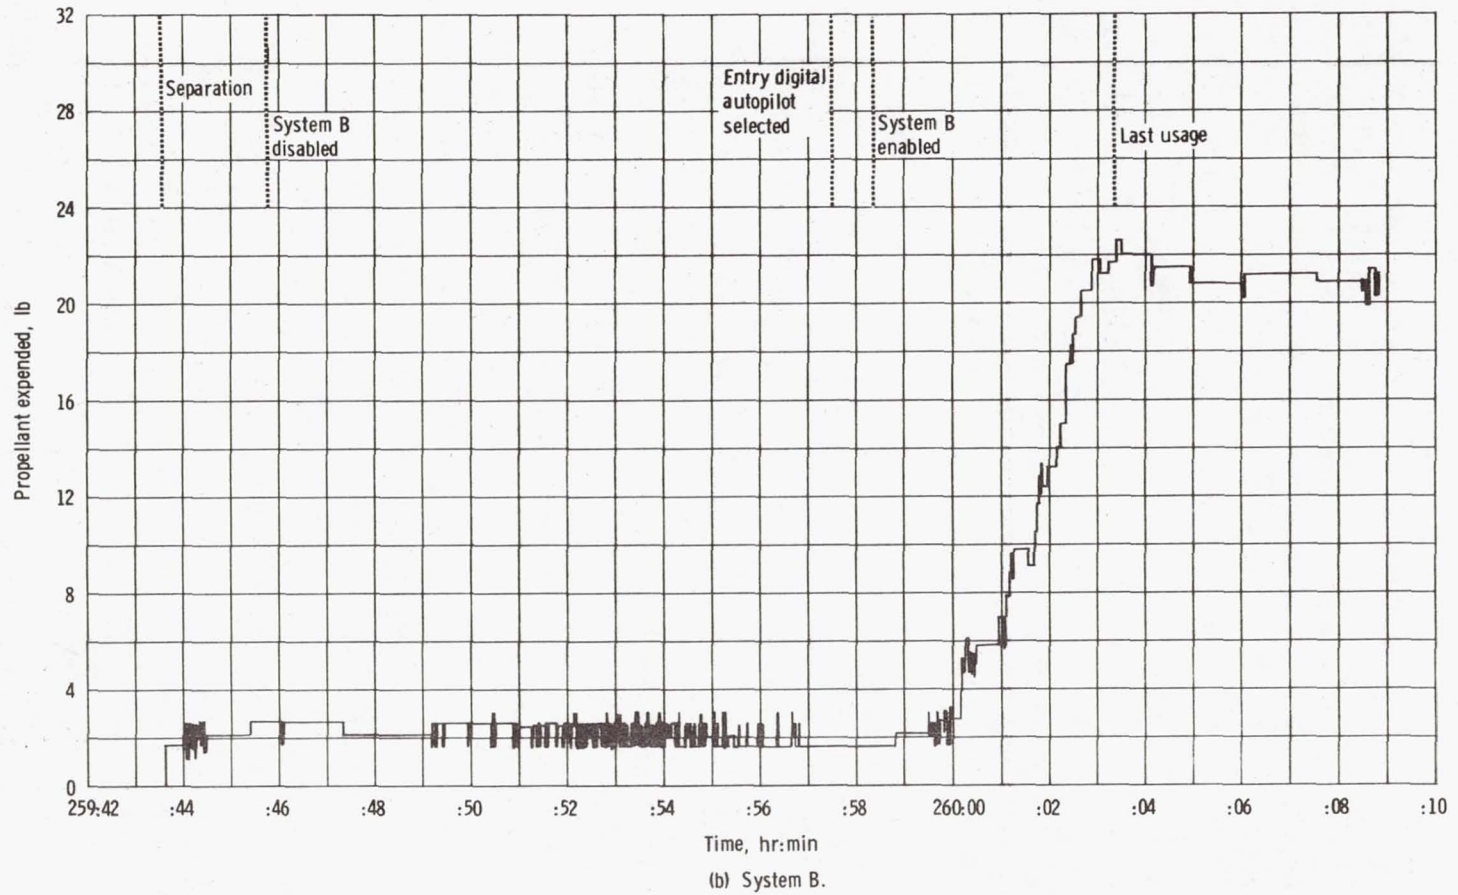
Figure 5.17-3. - Propellant expended from command module reaction control system.

A total of 50 pounds of propellant was used (29 and 21 pounds from systems A and B, respectively). The amount of propellant used during a particular event can be determined from figure 5.17-3. The momentary decreases in propellant expended after any usage are associated with system and instrumentation thermal stabilization. Consequently, the stabilized values indicate the amount of propellant consumed.
