MSC-PA-R-68-15

APOLLO 7 MISSION REPORT

MANNED SPACECRAFT CENTER

DECEMBER 1968

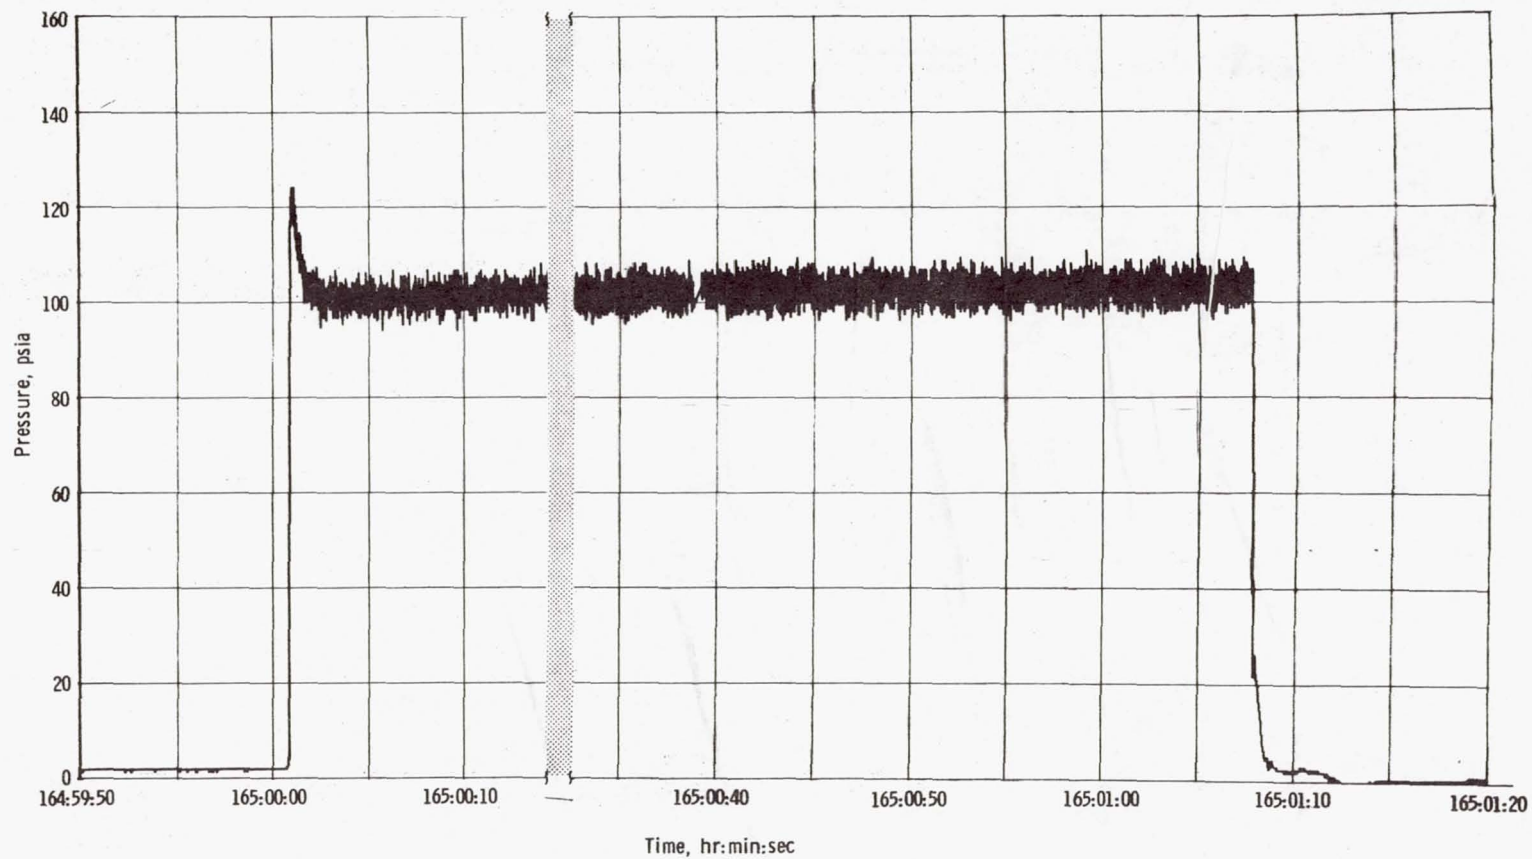
Figure 5.18-1. - Chamber pressure during fifth service propulsion maneuver.

A comparison of calculated and predicted steady-state values is shown in table 5.18-I. The calculated values were obtained from the simulation that best matched the command module computer acceleration data and provided the best estimate of the specific impulse (314.0 seconds). Measured chamber pressure during the fifth maneuver is shown in figure 5.18-1.

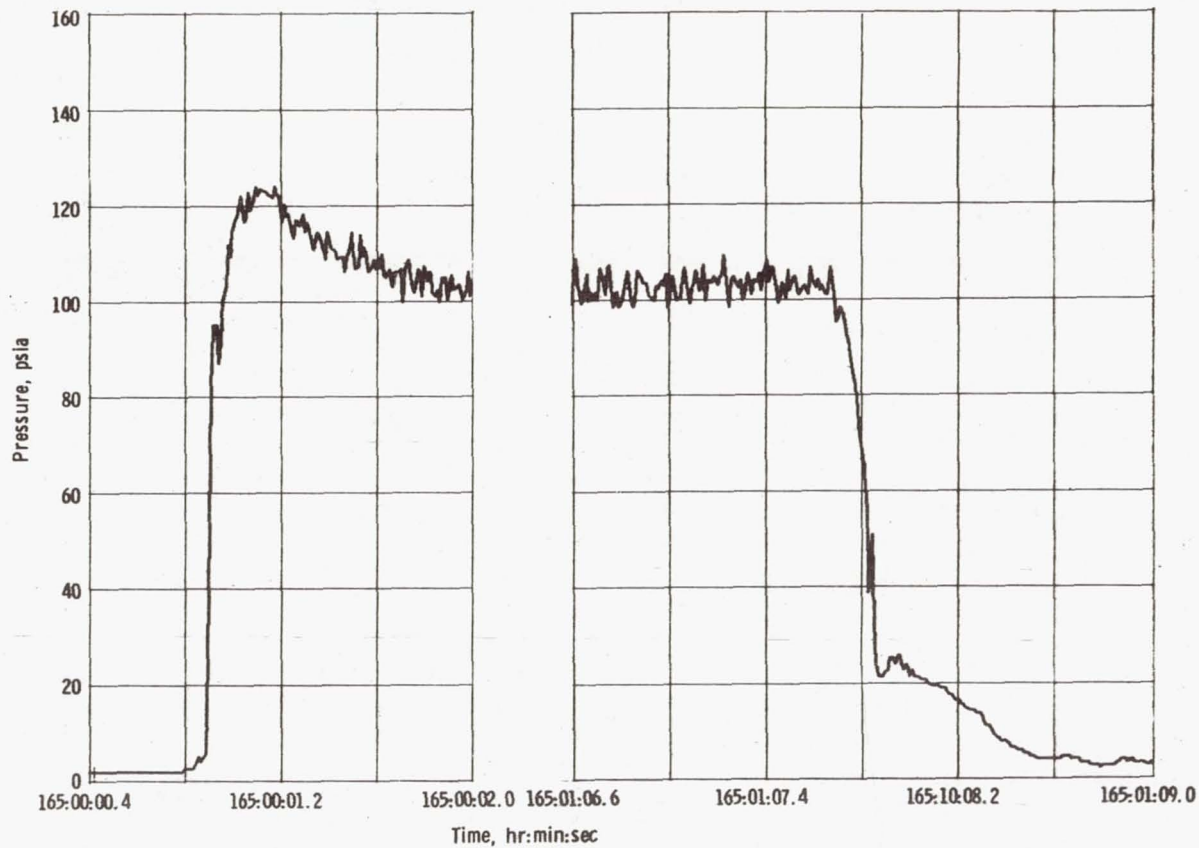
Figure 5.18-2. - Start and shutdown transients for fifth service propulsion maneuver.

No start transient analysis is given, as recent ground tests have shown that the response of the flight-type chamber pressure transducer is thermally affected, thus giving erroneous indications during this period. The total impulse of shutdown transients (calculated from cutoff signal to zero-percent thrust) was nominal for the six full engine operations. The time from cutoff signal to 10-percent of steady-state thrust was within specification limits. The start and shutdown transients during the fifth operation are shown in figure 5.18-2.

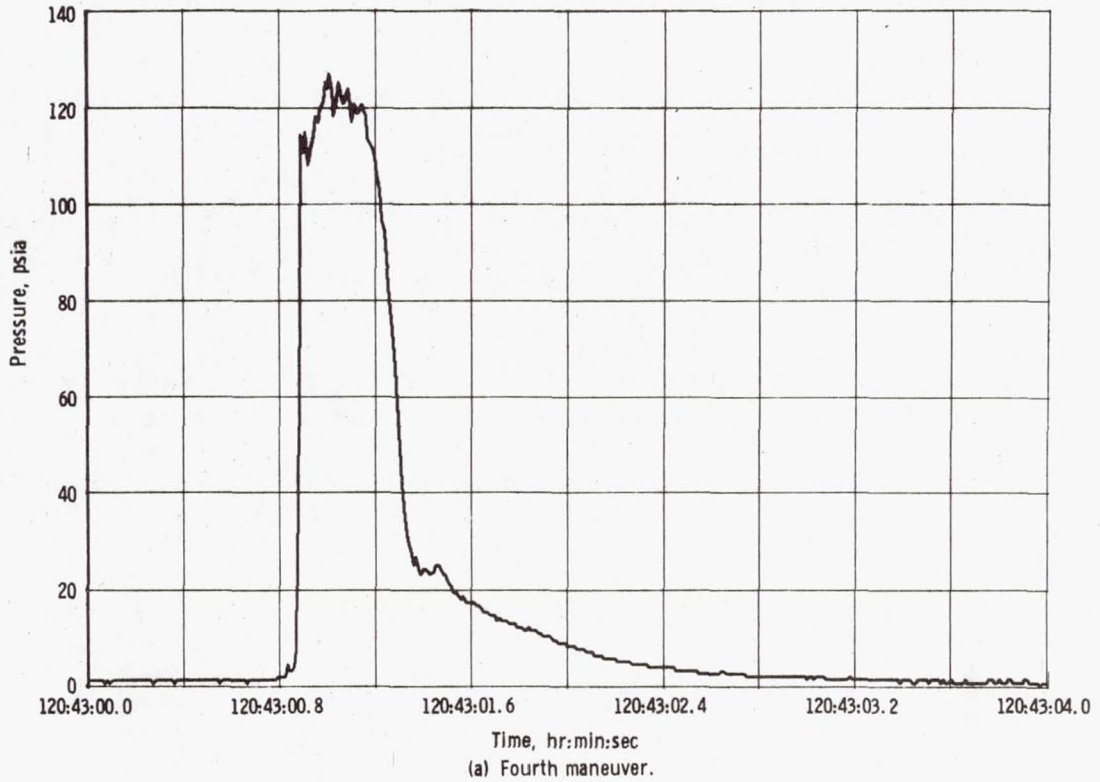
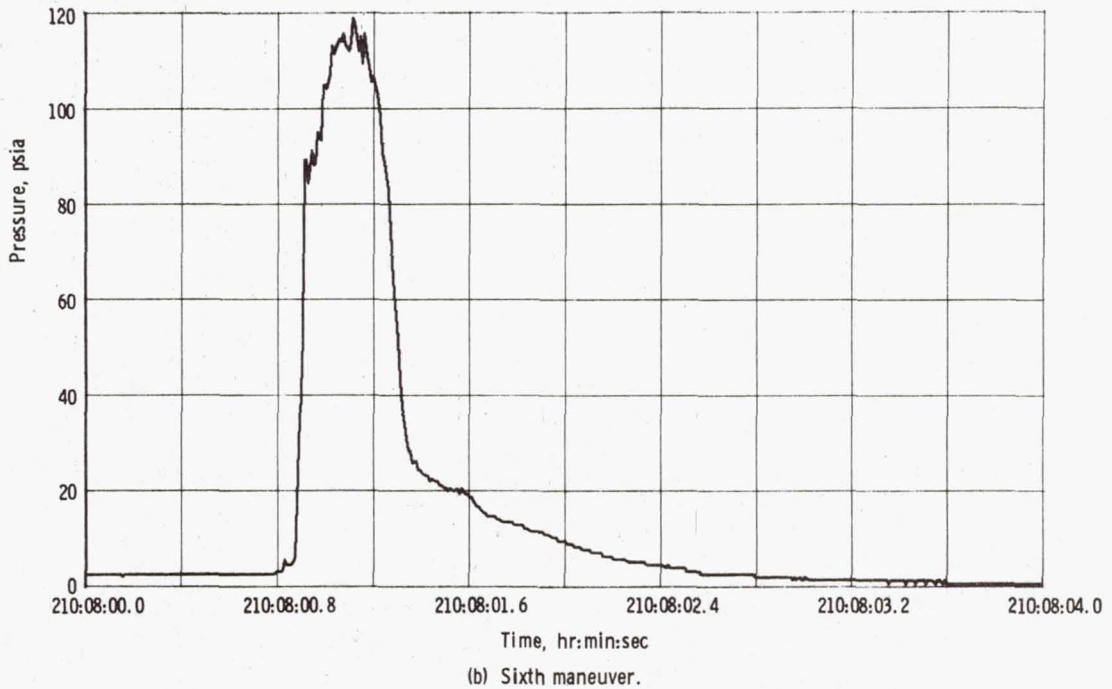
Figure 5.18-3. - Chamber pressure during minimum impulse firings.

chamber pressure or incremental velocity data. Chamber pressure during the two minimum impulse firings is shown in figure 5.18-3.

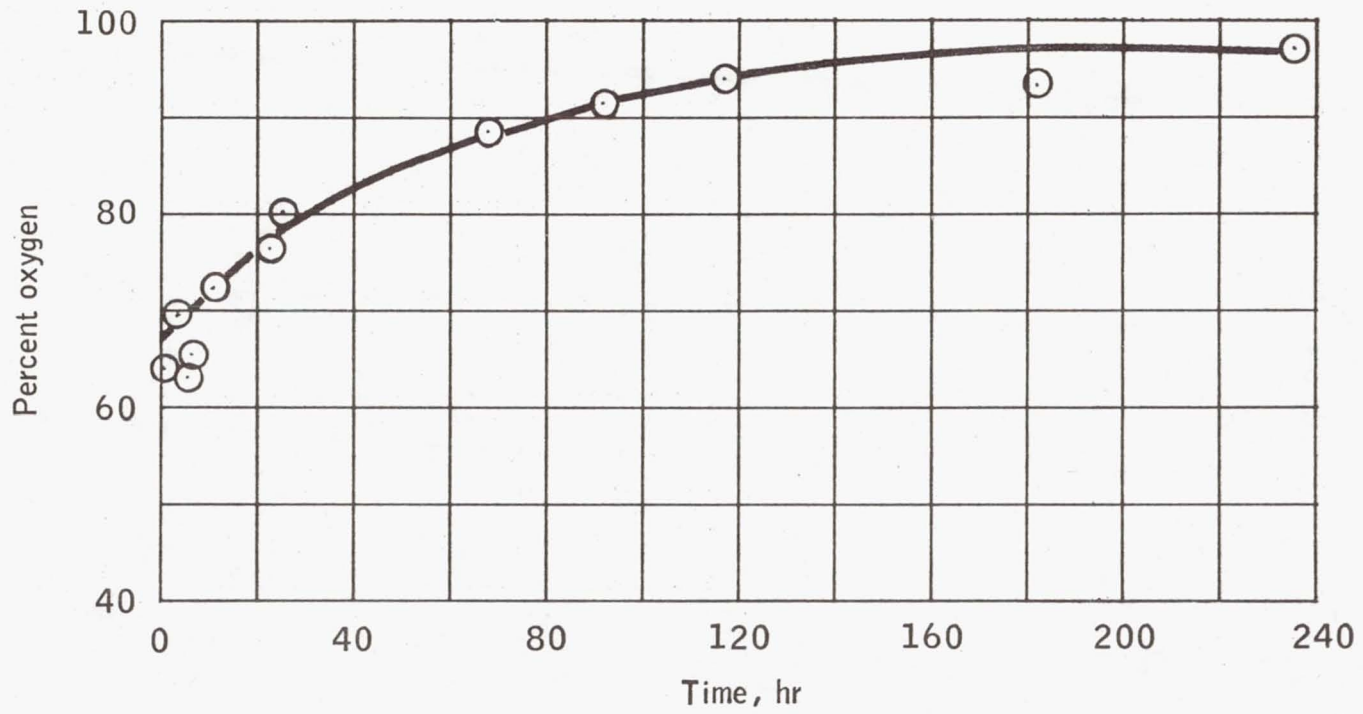
Figure 5.19-2.- Oxygen content of total cabin pressure.

The cabin pressure began relieving at 6.0 psid 48 seconds after launch. The relief valve sealed at 5.9 psig at about 5 minutes after launch, and the cabin pressure decreased fairly rapidly to cabin regulator operating pressure at about 02:40:00. The launch parameters for suit and cabin circuits are given in figure 5.19-1. The figure demonstrates the effect of launch vehicle acceleration the suit-to-cabin differential pressure; as acceleration is terminated, the suits tend to expand in volume, decreasing the differential pressure until the gas flow can compensate. A high cabin pressure decay rate was observed during the early phase of the mission because the waste management overboard dump valve was open to accelerate oxygen enrichment of the cabin gas. The oxygen enrichment cabin purge was ended at about 11:00:00, and the resulting oxygen partial pressure profile in the cabin gas is given in figure 5.19-2.

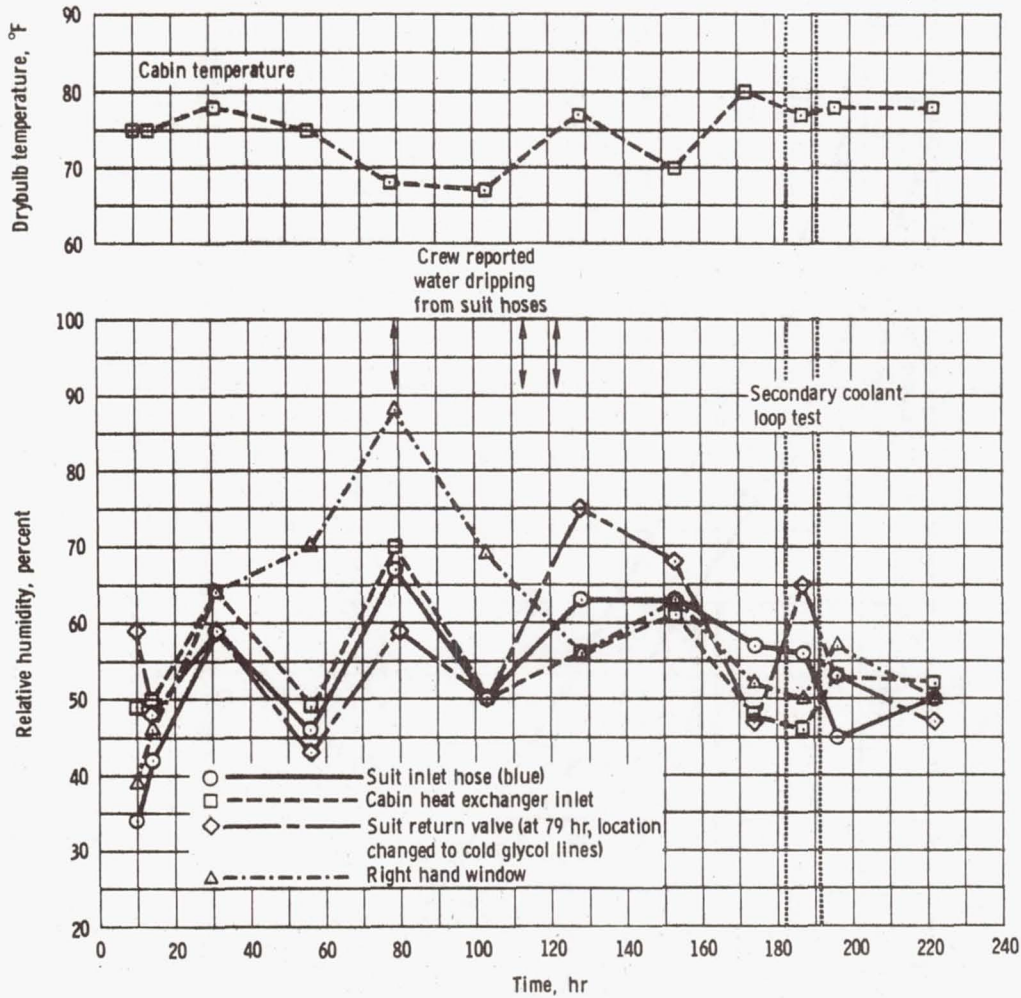
Figure 5.19-6. - Relative humidity survey.

Cabin fans.- The crew reported that the cabin fans were so noisy that first one fan and then both fans were turned off. The crew said they were comfortable without the fans operating. During postflight testing, the fans met all acceptance test requirements, but a washer and a nut were found between the cabin heat exchanger and fans, two washers were found between the exit screens and the downstream end of the fans, and the leading inlet edges of the fan blades were nicked. The noise is attributed to these foreign articles hitting the fan blades and moving back and forth between the fan and heat exchanger. It should be noted that the cabin temperature sensor is located at the inlet to the cabin heat exchanger, which is a relatively stagnant area without fan operation and thus not indicative of true cabin air temperature. The use of the cabin dry bulb temperature obtained during humidity surveys is, therefore, used as representative cabin temperature (fig. 5.19-6).

The dew point hygrometer was successfully used to perform eleven humidity surveys.
