GEMINI PROGRAM MISSION REPORT

GEMINI V

MANNED SPACECRAFT CENTER
HOUSTON, TEXAS

AUGUST 1965

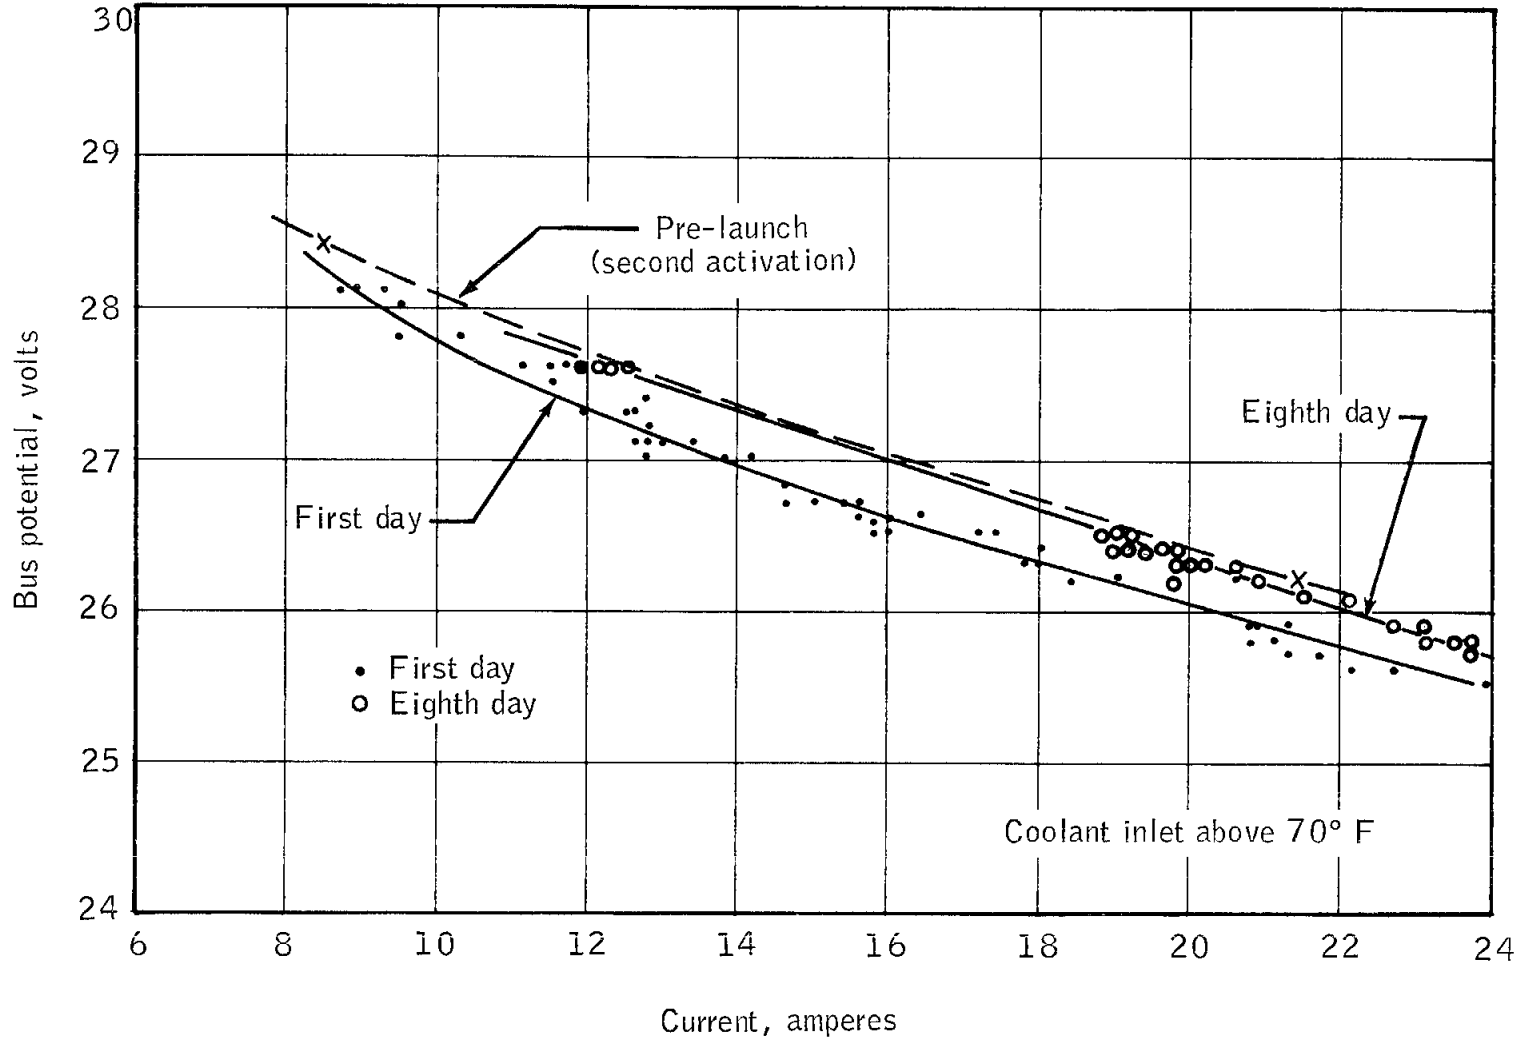
Figure 5.1.7-1. - Fuel cell section 1 performance.

The performance of section 1 was plotted discarding all data taken when the inlet coolant temperature to the section was below 70° F (fig. 5.1.7-1). At a load of 15 amperes, approximately a 0.4-volt decline was observed between the section's second activation on August 18, 1965, and the performance on August 21, 1965, the first day of flight. Continuing operation showed a gradual increase in performance until the eighth day of flight, when the performance was approximately equal to that experienced at the second activation.

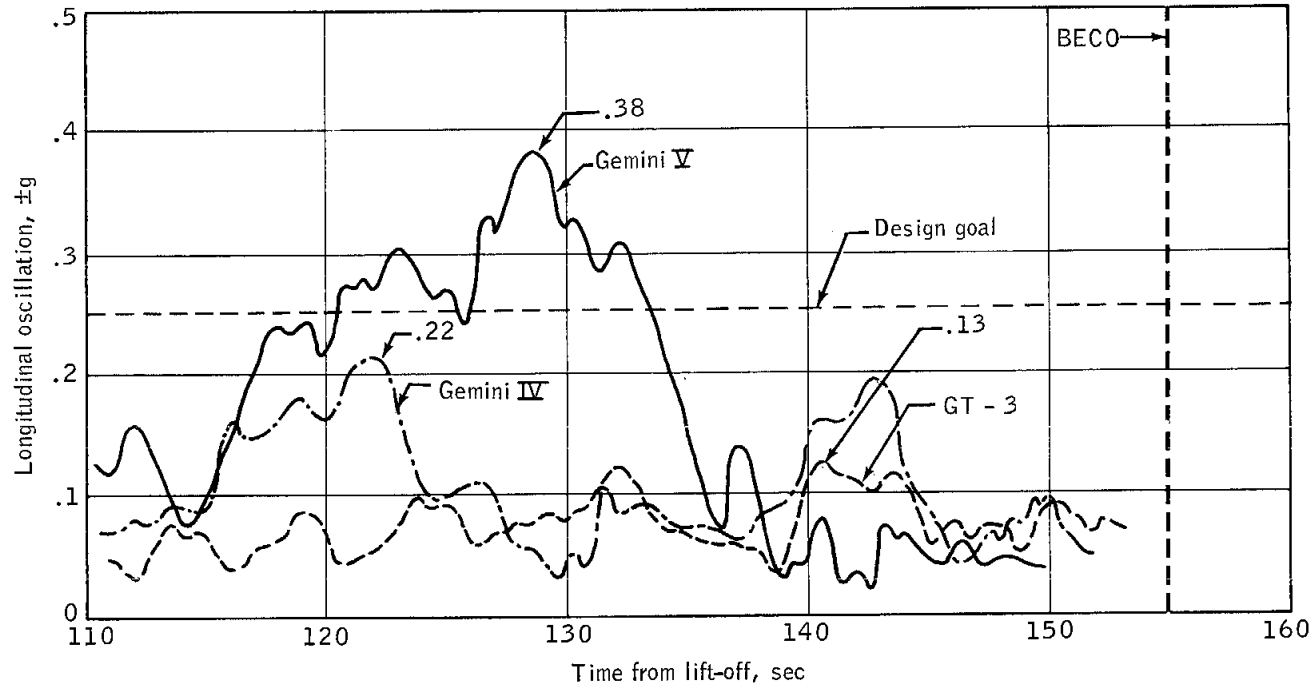
Figure 5.2-1.- GLV longitudinal oscillation.

5.2.1.1 Longitudinal oscillation (POGO).- The flight crew reported objectionable longitudinal oscillations (POGO) during the boost phase of flight, stating that panel gages could not be read to a desired degree of accuracy and that speech was difficult. Analysis of the flight data verifies that the onset of POGO occurred at LO+92 seconds, had a duration of 46 seconds, and reached a maximum amplitude of $\pm 0.38g$ at the spacecraft-launch vehicle interface. The POGO amplitude was higher than the Gemini launch vehicle design goal of $\pm 0.25g$ for approximately 13 seconds. POGO oscillations during this flight period were sustained oscillations as compared with the intermittent characteristic of the suppressed responses exhibited on previous vehicles (see fig. 5.2-1). A discussion as to the cause of this high value is given in section 5.2.2.2 of this report.

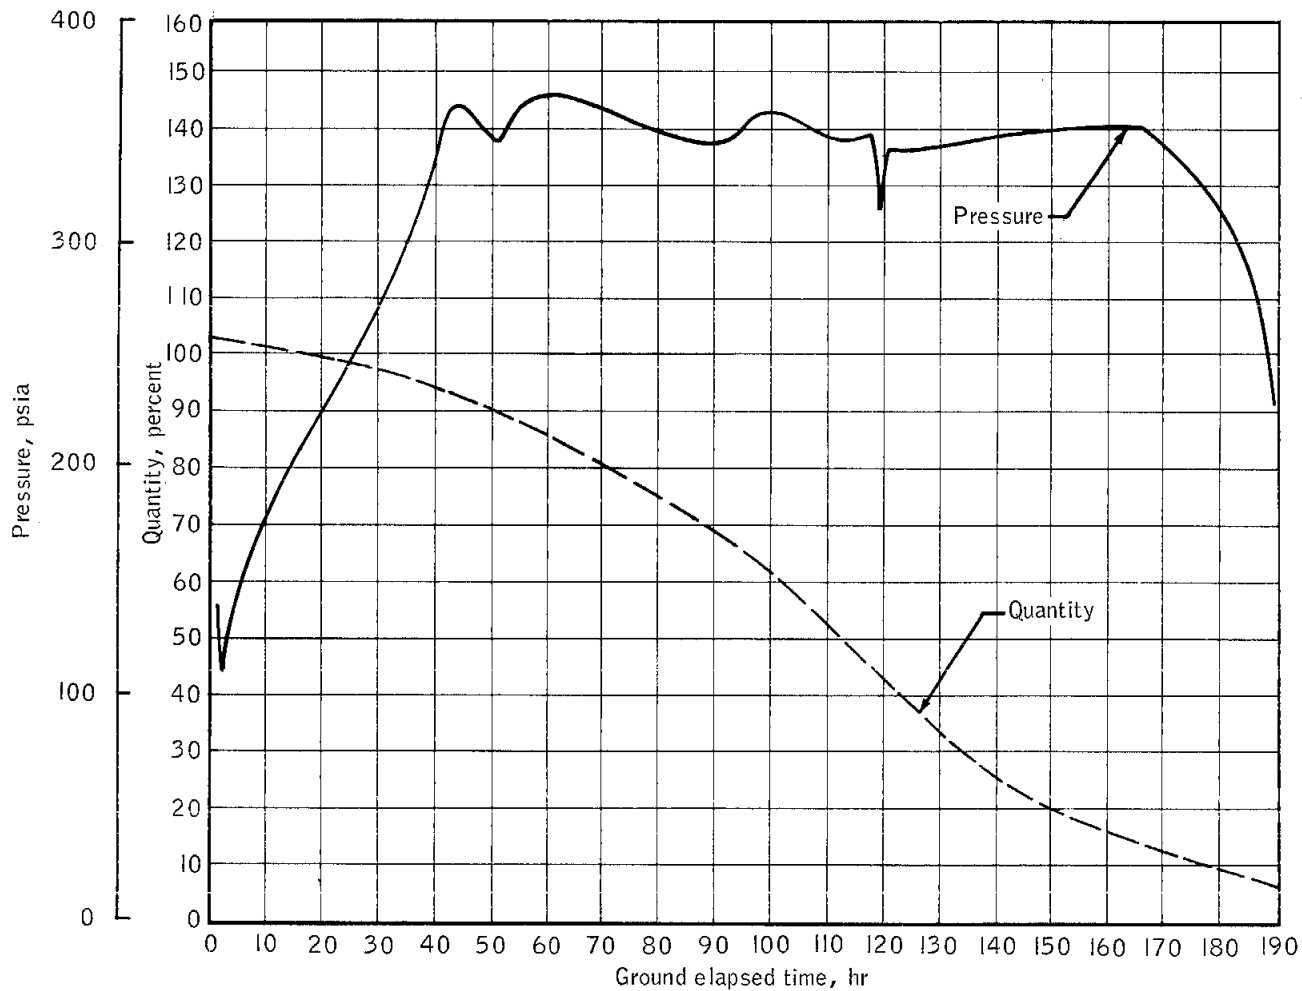
Figure 6.1-2. - Real - time data concerning the fuel-cell hydrogen supply.

In contrast to the fuel-cell oxygen tanks, both the fuel-cell hydrogen and environmental control system (ECS) oxygen tanks vented at high pressure due to heat leak as anticipated. As shown in figure 6.1-2, the hydrogen pressure varied with demand, reaching a peak vent rate at approximately 120:00:00 g.e.t. The sharp pressure drop at that time was

believed to be caused by normal poppet action of the pressure relief valve. ECS oxygen curves in figure 6.1-3 show the rise in the primary oxygen supply pressure at 26:00:00 g.e.t., when the automatic heater was turned on. Subsequently, the pressure rose to the vent pressure of 1020 psia; however, the mass quantity usage curve indicates a negligible amount of oxygen loss.

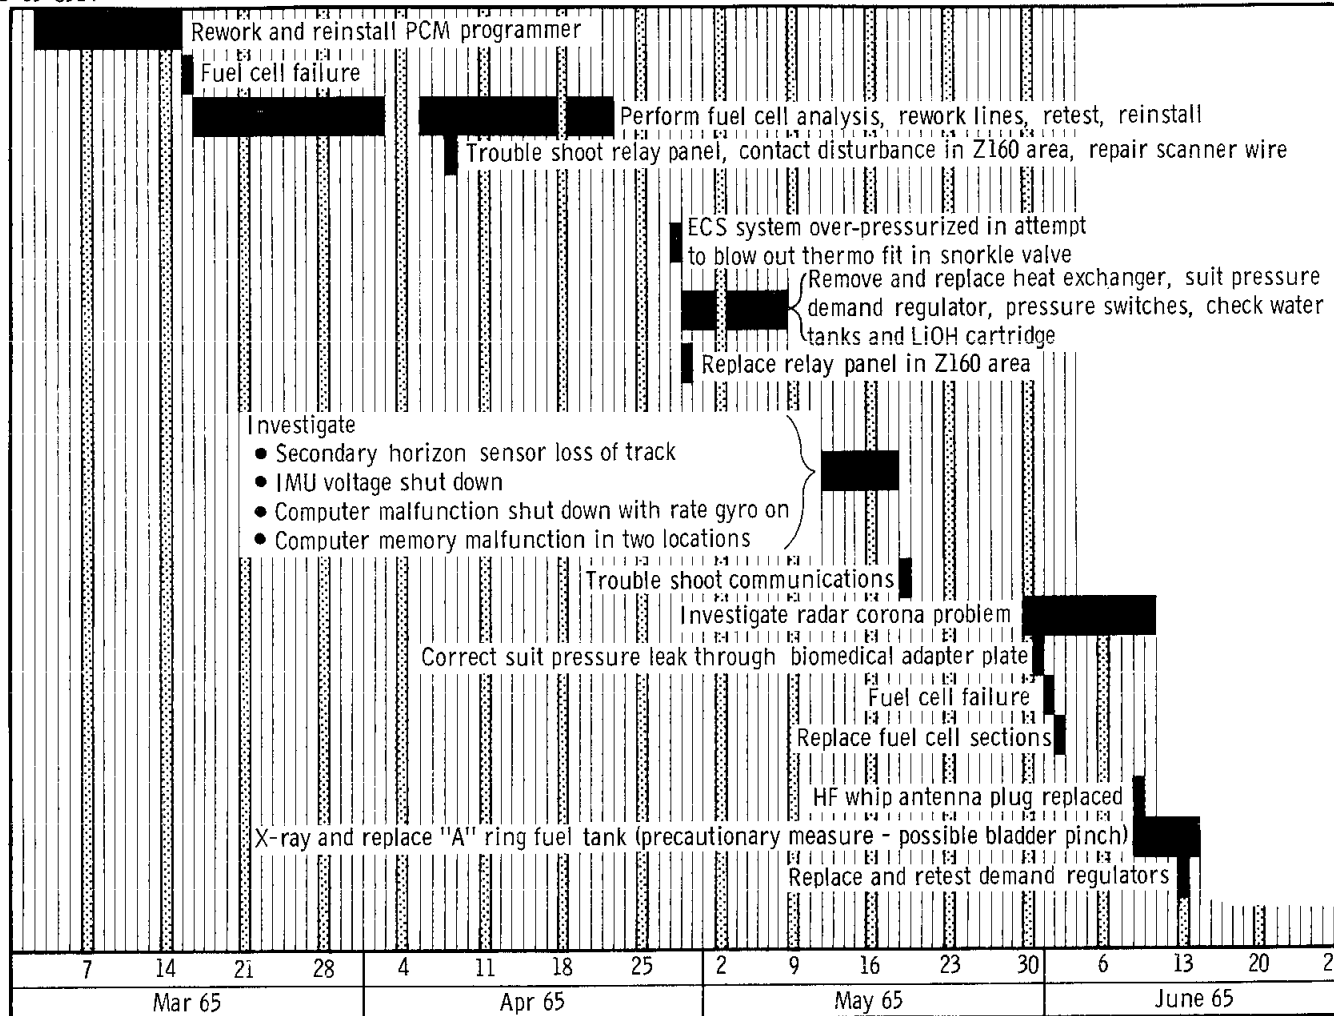
Figure 12.1-2. - Spacecraft 5-significant problem areas at contractor facility.

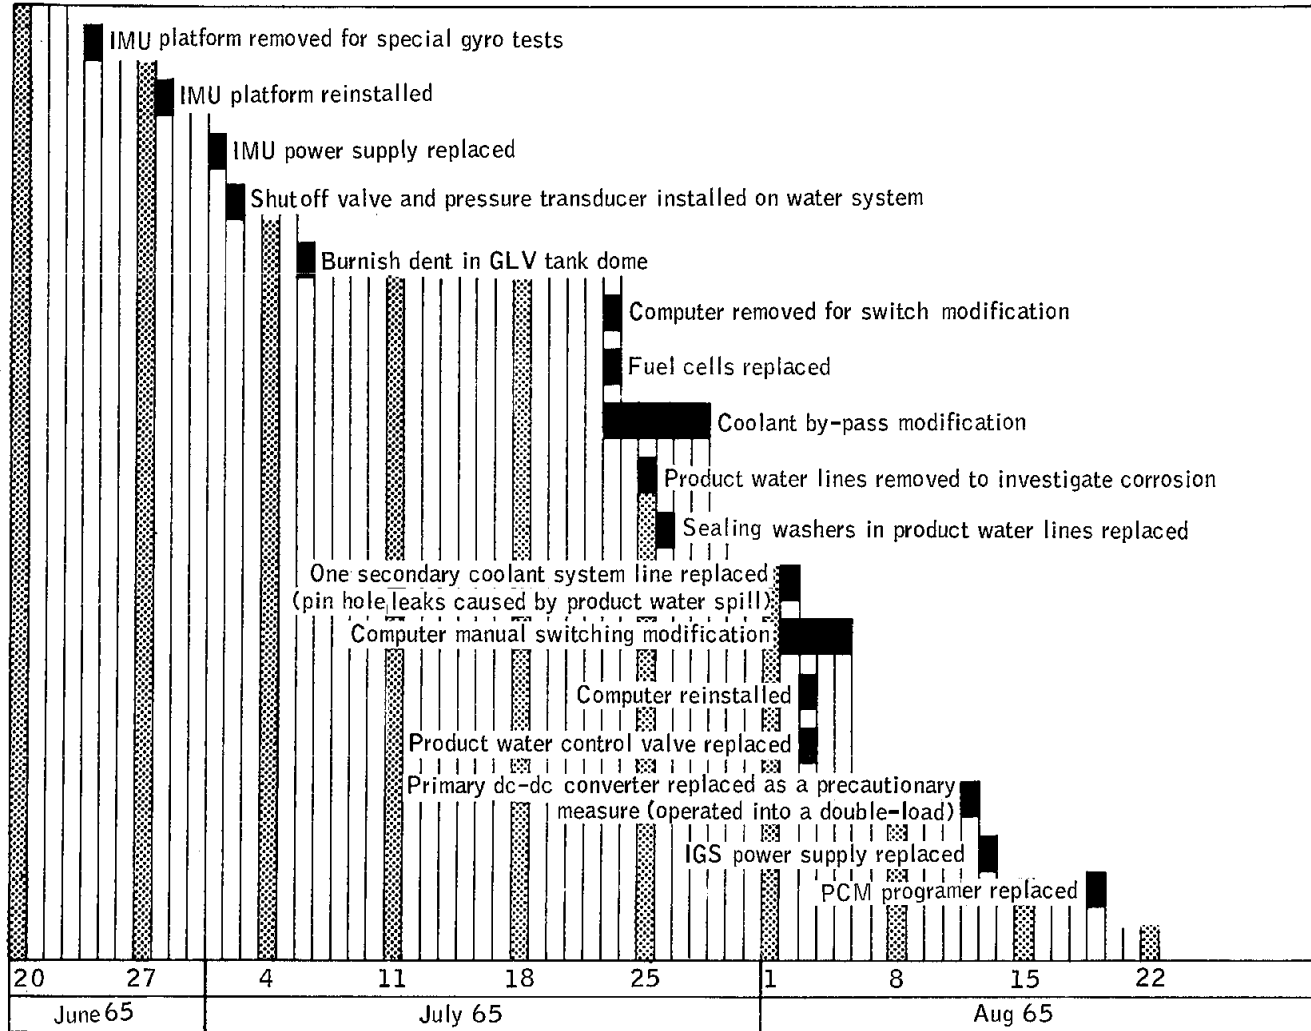
Figure 12.1-4. - Spacecraft 5 significant problems at Cape Kennedy.
