IPC-PE-740

Revision A
December 1997

Troubleshooting for Printed Board Manufacture and Assembly

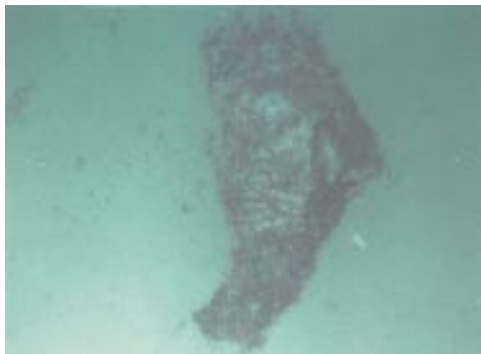
Figure 4-1.
Copper or zinc inclusion in laminate.

A	PROBLEM	CAUSE	ACTION
	Copper or Zinc embedded in the laminate resin. (See Figure 4-1.)	Usually caused by a large nodule (tooth) that has broken off the copper foil and become embedded in the resin.	Evaluate for intended application. Review the profile of the copper foil for consistency and dimension. (Use low or very low profile foil, if required for application.)

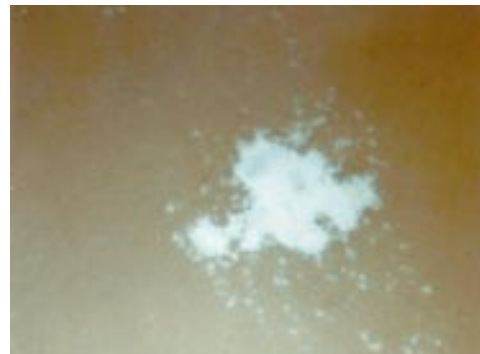
Figure 4-2.
Etch pits in laminate.

B	PROBLEM	CAUSE	ACTION
	Etch pits in the laminate. (See Figure 4-2.)	A large copper nodule is etched away leaving a pit or white spot in the laminate.	Evaluate for application. Review copper profile. Specify low or very low profile foil.

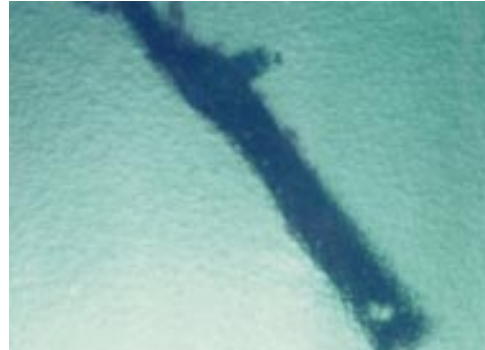
Figure 4-3.
Dark spots within laminate.

D	PROBLEM	CAUSE	ACTION
	Dark spots within the laminate or prepreg.	Contamination of dirt from raw materials or laminator's plant.	Evaluate for intended application. Perform audit of operation for cleanliness. Instruct supplier to review quality of incoming raw materials.
		Darkened resins from reaction vessels or treater ovens.	Evaluate for intended application. Review preventative maintenance frequency for cleaning of treater ovens.
		Lint, fiber or hair in the laminate or prepreg. (See Figures 4-3 & 4-4.)	Evaluate for intended application. Review clean room practices. Review static electricity levels in the prepreg sheeting and lay up operations.

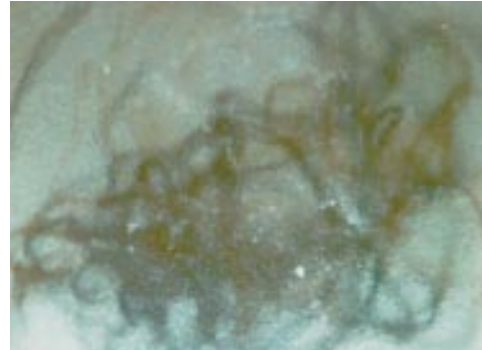
Figure 4-4.
Lint within laminate.

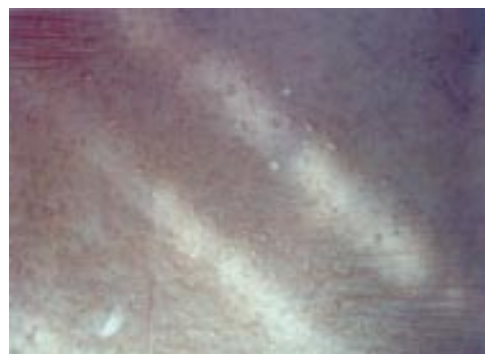
Figure 4-5
Scratches on copper treatment.

B	PROBLEM	CAUSE	ACTION
	Scratches in the metal surface or treatment. (See Figure 4-5.)	Handling during the manufacturing process or storage.	Review equipment, conveyors, shelves and tables for sharp edges that could scratch laminate. Review proper handling procedures with operators.

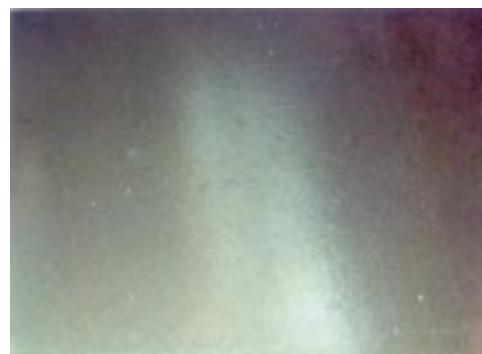
Figure 4-6
Shiny spots on copper foil.

E	PROBLEM	CAUSE	ACTION
	Shiny spots on the copper clad laminate. (See Figure 4-6.)	This is caused by a high resin spot on the prepreg due to broken filaments or chafed ends etc. in the glass cloth. This condition is not known to cause defects in the inner layer process, unless a wrinkle in the copper foil is present. Severe conditions can abrade the treatment on the back side of the foil.	Determine acceptability within the process. Inspect prepreg for resin lumps caused by broken filaments. Select glass styles and resin contents to minimize condition. Work with glass manufacturer for long term elimination of broken filaments.

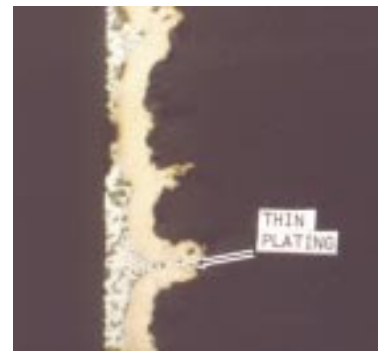
Figure 5-4 Rough Hole

E	PROBLEM	CAUSE	ACTION
	Rough hole walls. (See Figure 5-4.)	Excessive in-feed variation.	Maintain constant in-feed.
		Feed rate too high.	Optimize feed/speed relationship.
		Improper entry or material.	Change entry or material.
		Insufficient drill bit retention vacuum.	Check drilling machine's vacuum system. Check spindle speed variation.
		Retract rate.	Optimize retract/speed relationship.
		Chipped/bad drill bit.	Inspect drill bits prior to use. Improve drill bit handling practices.
		Excessive spindle run-out.	Check and clean spindle, collet and collet seat.

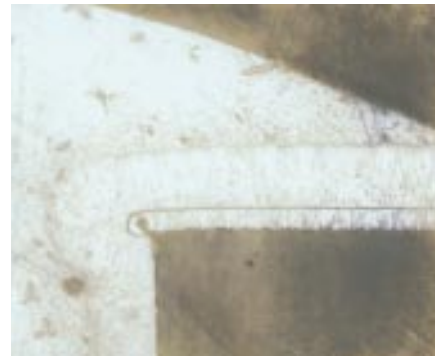
Figure 5-6
Connected curl chip

J	PROBLEM	CAUSE	ACTION
Connected curl chip on top of board. (See Figure 5-6.)		No entry material used.	Use overlay material.
		Improper drilling parameters.	Decrease in-feed rate (ipm)/increase rotary speed (rpm).

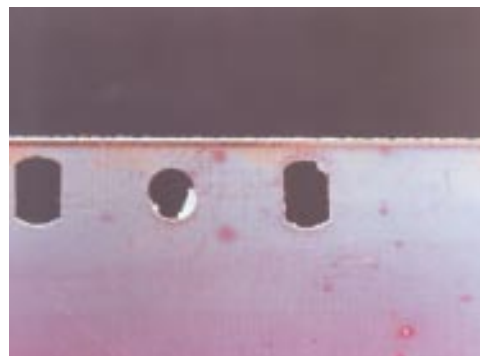
Figure 5-7
Rough edges
of punched hole

B	PROBLEM	CAUSE	ACTION
	Fibers and/or roughness along edges. (See Figure 5-7.)	Worn tooling.	Sharpen punches. Adjust tool sharpening schedule for the specific material type, material thickness and tolerance.
		Excessive clearance between die and punch.	Verify if the clearance between the perforators and the die features is correct. Modify the tool to reduce clearance if necessary.
		Stripping pressure of the blanking die too low.	Add more springs under the lower stripper plate.
		Improper tool timing.	Verify the die settings and compare with the settings suggested by the die manufacturer. Correct if necessary.
		Dirty tooling.	Improve material handling procedures.

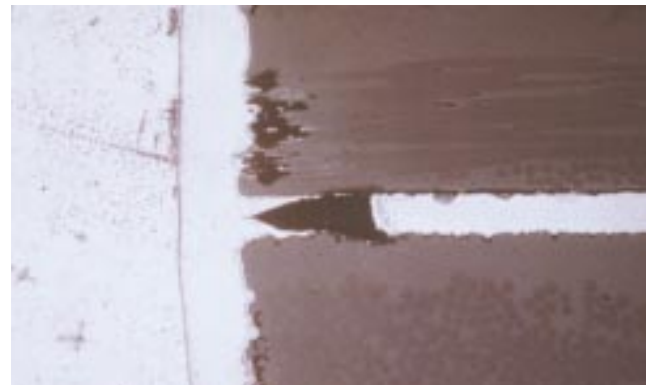
“Negative” or “reverse” etchback (Figure 6–1) refers to the condition where the copper interconnect is recessed into the drilled hole wall. This condition occurs because of the greater removal of copper (during the preplate copper etch cycle) than the depth of resin removal during the desmearing operation.

Figure 6–1 Negative etchback

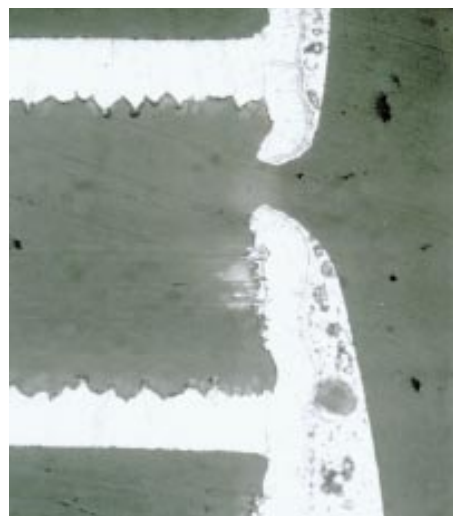
Figure 7-1 Void in hole

A	PROBLEM	CAUSE	ACTION
<p>Voids on both glass and resin areas. (See Figure 7-1.)</p>		Incompatibility of cleaner/conditioner/catalyst/accelerator/copper combination.	Ensure compatibility by lab testing, or preferably by using a single supplier's PTH line.
		Insufficient catalyzation.	Check preceding processing solutions on the line for conformance to operating parameters. Increase catalyst strength or temperature within supplier's recommended limits. Inadequate or excessive acceleration.
		Improper bath parameters.	Analyze copper bath for all constituents; replenish if necessary. Ensure correct temperature. Check specific gravity.
		Insufficient agitation in any or all process tanks.	Ensure adequate agitation.
		Bath is sluggish due to inactivity.	Run dummy racks, if needed, to increase bath activity prior to processing work.
		Chrome residues from desmear line have prevented proper catalyzation.	Improve chrome neutralization. (See 6.2.4.C.)

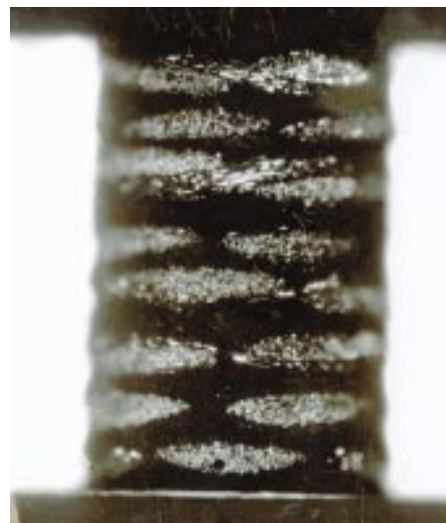
Figure 7-2 Glass voiding as seen using backlighting technique

B	PROBLEM	CAUSE	ACTION
	Voids on glass areas only. (See Figure 7-2.)	Insufficient conditioning.	Check operating parameters of cleaner/conditioner solution. Conditioner solution may be incompatible with rest of process. (See 7.3.2.A.)
		Insufficient or improper glass etching in desmear line.	Ensure correct glass etch solution parameters and etch time. Be sure to remove porous calcium sheath formed after typical glass etch processes. (See Section 6.2.5.A and 6.2.6.C.)
		Excessive etchback of resin.	If all resin is removed from glass bundle area, apparent microvoids may occur in glass region. This is best diagnosed by SEM examination.
		Excessive glass etch.	If glass is etched back deeply into the hole wall, apparent and actual glass voids may occur in the recessed area due to solution not penetrating and/or gas entrapment.

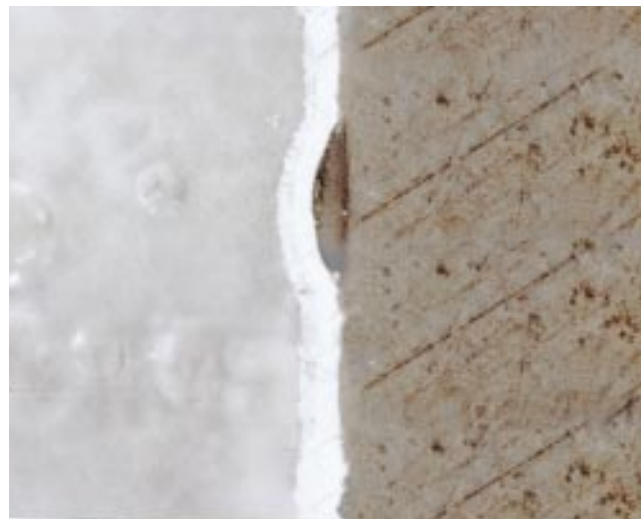
Figure 7-3 Blister in plated through-hole

E	PROBLEM	CAUSE	ACTION
	Blistering or flaking of copper deposit noted after electroless deposition or later, after cross-section of electroplated or thermal-stressed samples. (See Figure 7-3.)	Improper bath parameters.	Ensure correct temperature. Analyze electroless copper bath for all constituents.
		Specific gravity of the electroless copper solution is too high.	Low solution growth can lead to buildup of impurities and by-products in the copper bath. Adhere to recommended bailout schedule.
		Process solution entrapment or humidity absorption by laminate materials.	Check lamination process, laminate storage, dwell time in process solutions.
		Poor copper adhesion can result from improper desmear and PTH process and/or controls.	Review entire process. Enlist chemical supplier's aid.
		Electroless copper deposit is highly stressed.	Review entire process. Check electroless deposit rate panel. Switch to low dep electroless process.

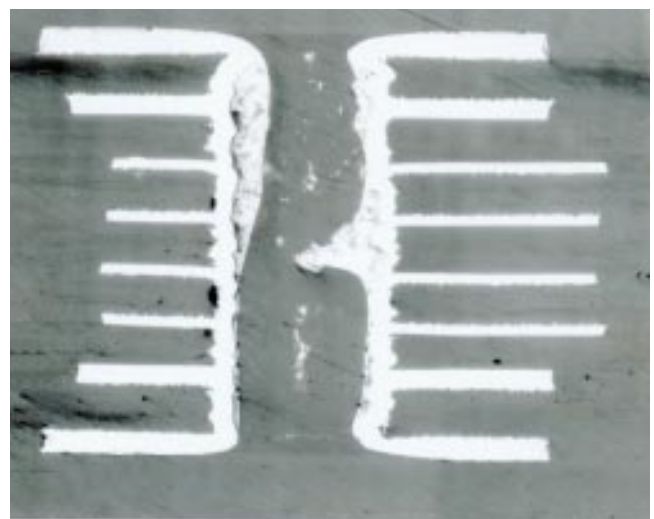
Figure 7-4 Rough hole wall due to poor drilling

F	PROBLEM	CAUSE	ACTION
	Rough (nodular and/or granular) deposit in holes after PTH and/or further plating. (Rough deposits may also be seen on surface.)	Poor drill control—epoxy smear, torn fibers in holes, general poor hole finish (double-sided boards), burring, and undersize holes. (See Figure 7-4.)	Institute proper drill resharpening or replacement cycle. Determine proper feed and speed for drill diameter being used, as well as for type and thickness of substrates being drilled. (See Section 5.1.2.) Assure laminate cure by baking prior to processing. (See Section 1.5.)
		Pumice grit not cleaned from holes and surfaces prior to electroless deposition.	Vapor blast, rinse with good agitation or use more vigorous (perhaps ultrasonic) cleaning to remove pumice prior to electroless processing.
		Glass fibers protruding into holes after resin etchback.	Balance desmear/etchback with glass etch so that an even hole wall surface results. SEM after hole preparation may be the best diagnostic tool. (See Section 6.)

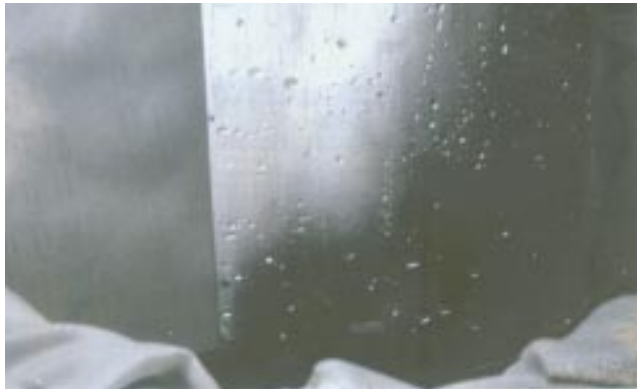
Figure 8-1 Water-break test.

C	PROBLEM	CAUSE	ACTION
	Scrubber not cleaning properly, as evidenced by no scrubbing, poor resist adhesion, step plating, or poor plating adhesion. (See Figure 8-1.) A clean, well-scrubbed panel should hold a continuous film of water for 15-25 seconds.	Bristle brushes not properly trimmed.	Brushes should be pre-trimmed at factory to expose abrasive, but it is possible to get one improperly trimmed or not trimmed at all. Running brush on copper over full width of conveyor for 20 to 30 minutes will usually expose abrasive.
		Too much brush pressure.	Adjust brushes to give 6.35 mm wide stripe on full width panel. (In the case of bristle brushes, too much pressure can bend bristles so abrasive doesn't contact board. Also high pressure can smear nylon from brush onto board surface.)
		Inadequate brush cooling water.	Check cooling water supply and re-expose abrasive as described above. (Overheating the brushes can cause nylon to flow over the abrasive and inhibit scrubbing.)

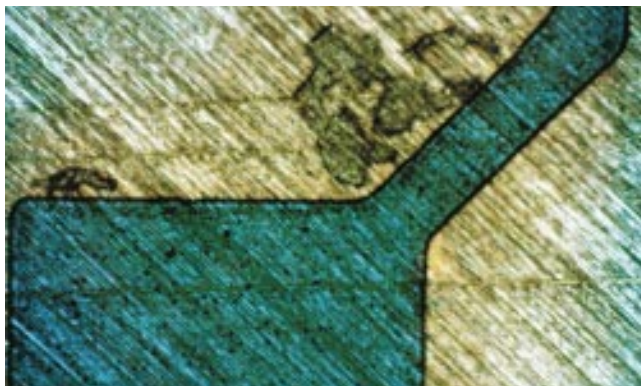
Figure 9-1 Resist scum on panels

A	PROBLEM	CAUSE	ACTION
	Resist scum/ residue on panels after develop- ment. (See Figure 9-1.)	Underdevelopment.	Establish proper development time per supplier's data sheet.
		Phototools with low density in the opaque areas.	Check opaque density of phototools with a densitometer. Check circuit image edge acuity on the phototool.
		Photoresist exposed to white light prior to development.	Store resist-coated panels in non-white-light areas prior to development. Inspect the yellow room for light leaks.
		Redeposition of exposed resist from the panel edge.	Apply an unexposed border around the edge of panels to prevent flaking and chipping of exposed resist during development.
		Insufficient water rinse after development.	Check for plugged spray water rinse nozzles. Maintain a minimum water pressure in the spray rinse chamber of 138 kPa using direct fan spray nozzles. Maintain rinse temperature above 16°C.

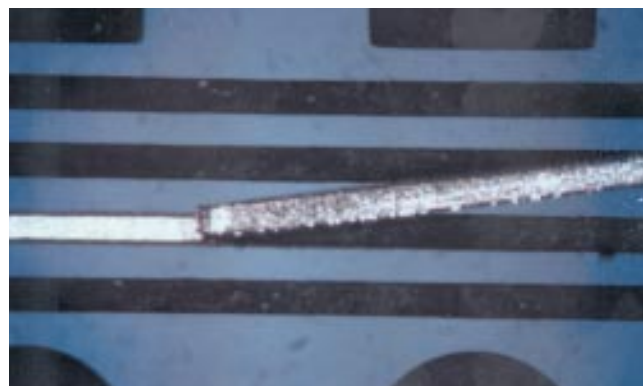
Figure 9-7 Copper-to-copper peelers after pattern plating

G	PROBLEM	CAUSE	ACTION
<p>Copper-to-copper peelers after pattern plating. (See Figure 9-7.)</p>		<p>Inadequate preplate cleaning prior to copper pattern plating.</p>	<p>Establish the proper preplate cleaning process. Dry film suppliers recommend:</p> <ul style="list-style-type: none"> • Hot soak cleaner • Micro-etch • Acid dip <p>The acid dip generally consists of 10% sulfuric acid. Sufficient rinsing is required between each process tank. No rinse is required between the sulfuric acid dip and acid copper sulfate plating bath. Control of the micro-etch is critical in eliminating peelers. This solution is required to provide a virgin copper surface for electroplating. Concentration, temperature and immersion time in the micro-etch bath are critical. (Also see Sections 8.2 and 10.1.1.)</p>
		<p>Electro-cleaning process out-of-control—short immersion time and/or low current density.</p>	<p>Establish proper process conditions per supplier's recommendations. (Monitor the process and train operators in process control.)</p>

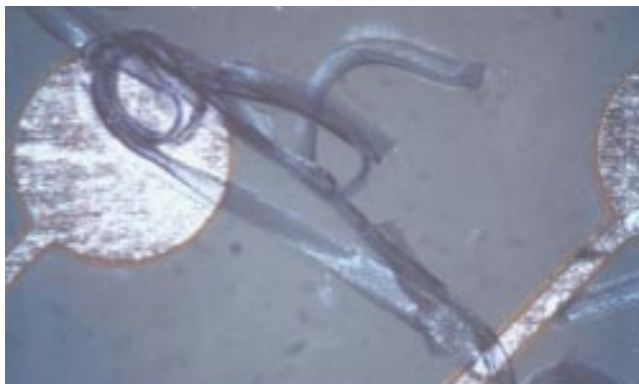
**Figure 9-9 Photoresist residue on board**

J	PROBLEM	CAUSE	ACTION
	Photoresist residue on the board after stripping. (See Figure 9-9.)	Short stripping time.	Establish optimum strip time with boards processed through print-and-etch or pattern plating. (Adjust the strip time with increased loading of the stripper solution. The optimum strip time will generally change with different resist types and thicknesses. Inspect first article for adequate stripping.)
		Over-plating during pattern plating.	Increase thickness of dry film to prevent over-plating. Improve method for controlling current density during pattern plating to prevent over-plating. (See Section 10.0.) Increase time in stripper solution (consider a presoak of boards in stripper prior to a fresh stripper bath). Investigate alternate stripping chemistry.
		Excessive exposure of developed resist to white lights.	Store panels in yellow- light areas prior to pattern plating. Minimize hold time between pattern plating and stripping. Increase strip time.

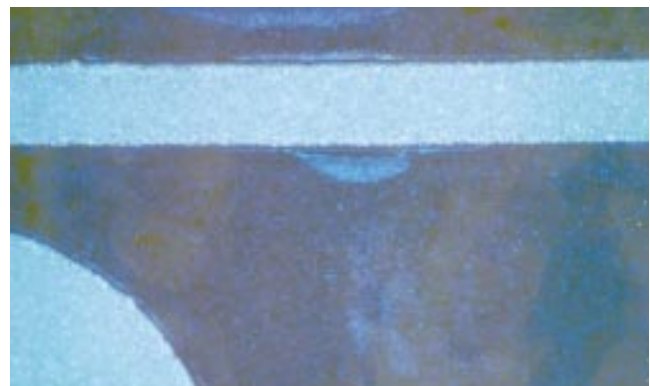
Figure 9-11 Resist breakdown during pattern plating

C	PROBLEM	CAUSE	ACTION
	Resist breakdown during pattern plating. (See Figure 9-11.)	Hot, mildly alkaline soak cleaner in the pre-plate cleaning line.	Replace with recommended acid cleaner per dry film supplier's recommendation. (Also see Section 9.2.3.3.)
		Long immersion time, high concentration and/or high temperature of the hot soak cleaner in the pre-plate cleaning line.	Obtain the recommended list of cleaners and operating conditions for use with the total aqueous dry films from supplier. (Hot acid cleaners are preferable.)
		Out of control electro-cleaner in the pre-plate cleaning line: high temperature, high current density, high concentration, and/or long immersion time.	Control electro-cleaner for proper activation of the exposed copper surface without stripping the resist image. (Aqueous resists have a narrow process window in this cleaning solution.) Establish operating conditions per the supplier's data sheet.

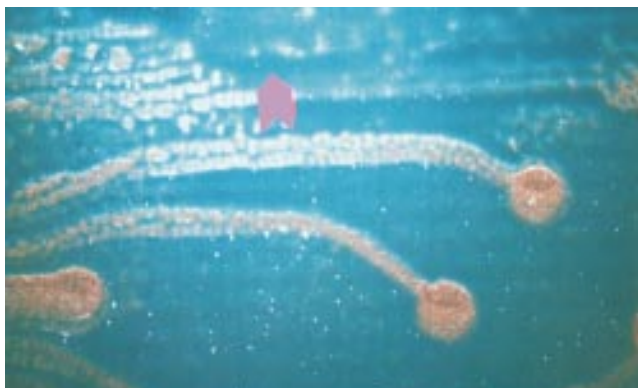
Figure 9-17 Ink runs through screen

E	PROBLEM	CAUSE	ACTION
	Ink runs through screen. (See Figure 9-17.)	Screen fabric too coarse.	Use supplier recommended fabric.
		Screen left flooded for long periods of time.	See supplier's recommendation in data sheet for maximum flood period.

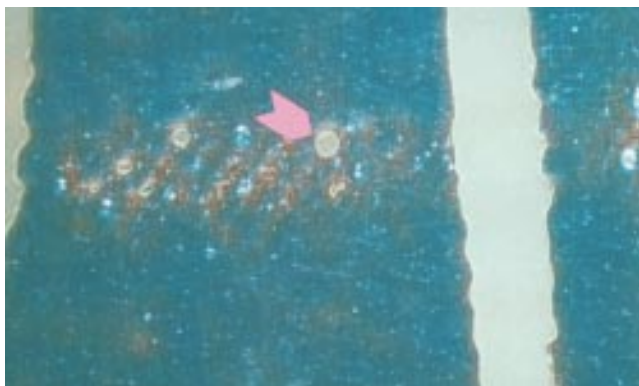
Figure 9-21 Very small voids

J	PROBLEM	CAUSE	ACTION
	Very small voids in conductor patterns, going through copper foil to substrate. (See Figure 9-21.)	Small unwashed spots on screen which produce voids in the screened image, thus allowing etch out of copper.	Clean screen. Verify screen prior to release over light table. Verify each screen setup by screening on white paper and inspecting over a light table.

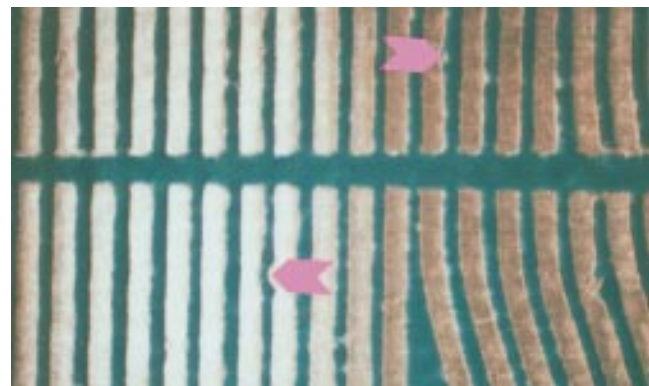
Figure 9-22 Ragged line definition

K	PROBLEM	CAUSE	ACTION
	Ragged line definition. (See Figure 9-22.)	Poor stencil image, worn or improperly made.	Fabricate new screen using direct/indirect combination.
		Poor line definition in the original artwork.	Correct artwork and remake screen.

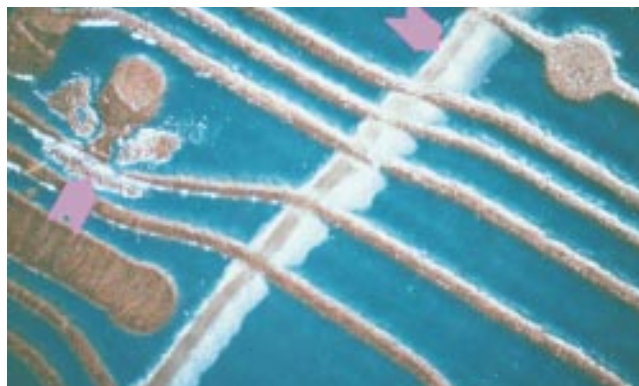
Figure 9–23 Ink soft and easily marred

L	PROBLEM	CAUSE	ACTION
	Ink soft and easily marred. (See Figure 9–23.)	Improper curing.	Adjust oven temperature or UV cure speed per supplier’s recommendations.
		Too heavy ink deposit.	Reduce thickness as required.
		Poor surface preparation (poor image adhesion).	Review surface preparation method and handling prior to screen printing.

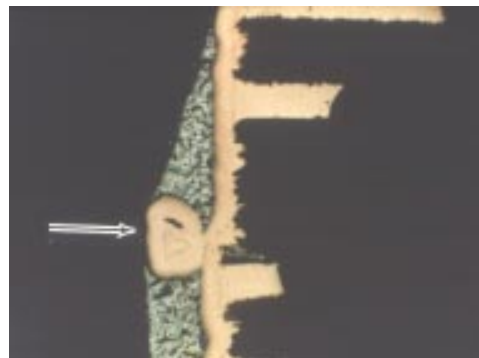
Figure 10-1.
Nodules from copper plating.

D	PROBLEM	CAUSE	ACTION
	Pitted copper plating. (See Figure 10-1; also see Section 10.2.1C.)	Small, fine air bubbles in tank (especially if pitting is localized, on a particular area of panels or tank).	Major potential source is an air leak in pump. This is difficult to track down. Do not use air stones or similar to increase air agitation in tank.
		Incomplete resist development, resulting in "mouse bites."	Review photoresist steps in Section 9.0.
		Poor preplate cleaning.	Review acid cleaner and micro-etch steps, and their respective rinses.

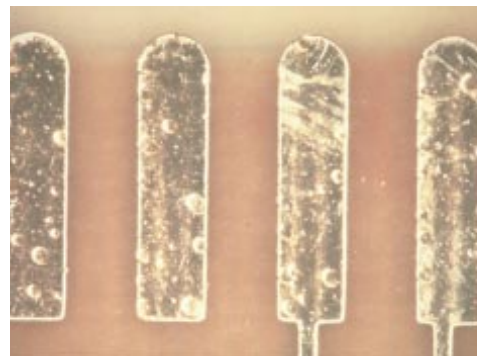
Figure 10-4.
Hard gold pitting.

L	PROBLEM	CAUSE	ACTION
	Pitting. (See Figure 10-4.)	Pitted nickel underplate.	Follow action items in 10.5.3C on pitting of nickel.

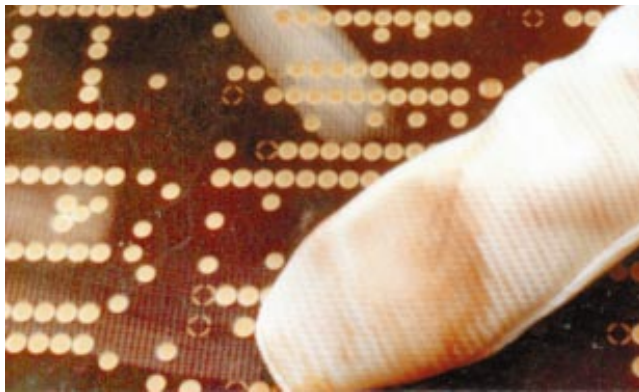
Figure 12-3 Loose black oxide crystals

B	PROBLEM	CAUSE	ACTION
	Improper development of oxide.	Black oxide crystals too long causing fracturing. (See Figure 12-3).	Shorten dwell time, concentration or temperature in oxide. Investigate alternate bath chemistry.
		Inadequate surface area produced by process.	Increase micro-etch rate or improve etch topography on copper innerlayer surface.
		Inadequate surface treatment.	Follow action items detailed in 12.4.2.A for oxide coatings.

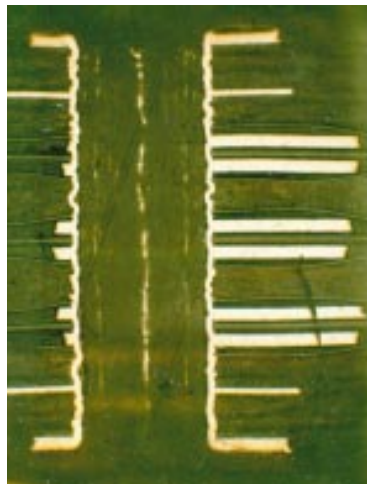
Figure 13-1.
Misregistration of innerlayers as evidenced by shifted lands.

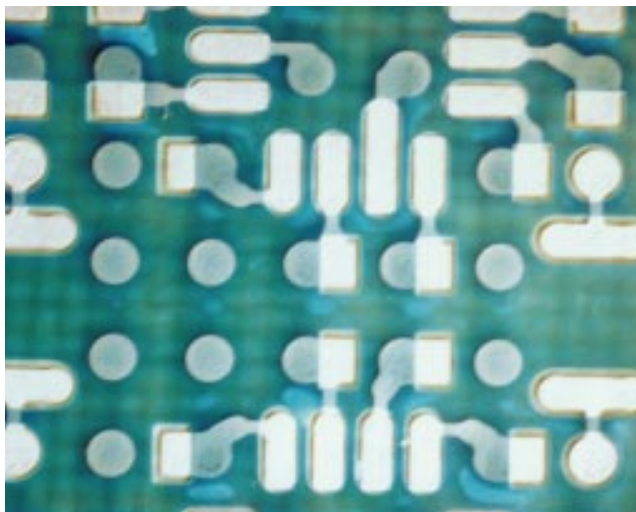
Figure 15-2 Air entrapment

A	PROBLEM	CAUSE	ACTION
	Air entrapment during lamination. (See Figure 15-2.)	Board design is too complex for hot roll lamination.	Use vacuum lamination.
		Insufficient vacuum caused by faulty pump.	Fix pump or replace oil.
		Insufficient vacuum caused by clogged vacuum lines or sticking solenoids.	Clean residues from vacuum lines and solenoids.
		Warped boards.	Place board with warped bow side up. Refer to Section 4.0 on Base Materials and Section 13.0 on Lamination to address bow and twist (warpage) problem.
		Platen temperature is too low.	Raise platen temperature to increase film flow.
		Cycle time is too short.	Lengthen cycle time to achieve higher board temperature and more film flow.
		Clearance inside vacuum chamber is too great.	Use shims to decrease clearance (total clearance inside chamber should be 40-80 mils).
		Circuit traces are too high for the thickness of the mask being used.	See Section 10.2 to address excessive copper thickness on traces. NOTE: A 3-mil thick mask will typically conform to a 4-mil high circuit line. A 4-mil mask will typically conform to a 5-mil high circuit line.

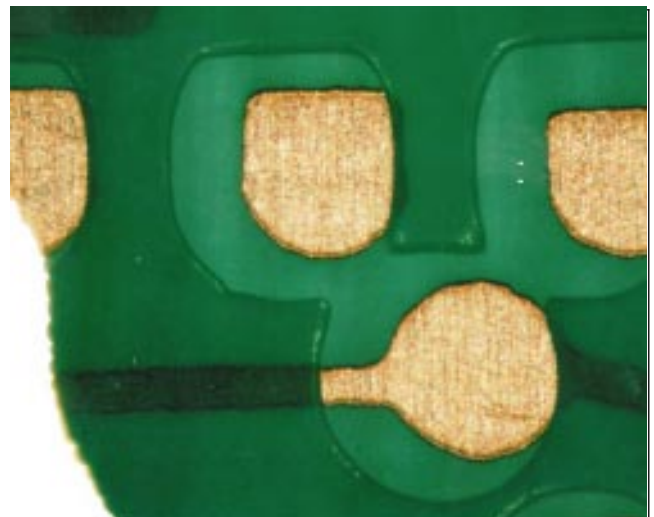
Figure 15-5 Development time too long

E	PROBLEM	CAUSE	ACTION
	Development time too long. (See Figure 15-5.)	Dry film solder resist has partially polymerized during lamination step.	Reduce platen temperatures. Reduce cycle time. Check board exit temperature just out of vacuum chamber (for best results, it should be between 60-65.6°C).
		Dry film solder resist is exposed to white light or sunlight, causing partial polymerization.	Keep boards in yellow light environment or shrouded.
		Low spray pressure, typically caused by plugged filter or cone nozzles rather than high pressure fan nozzles.	Change filter. Replace cone nozzles with high pressure direct fan spray nozzles.
		During exposure, light has scattered through transparent laminate, causing partial polymerization (“shoot-thru” or “ghosting”) in pad area on reverse side.	Reduce exposure time.
		Developing solution is spent or too low in temperature.	Check developer solution; raise temperature, if necessary.

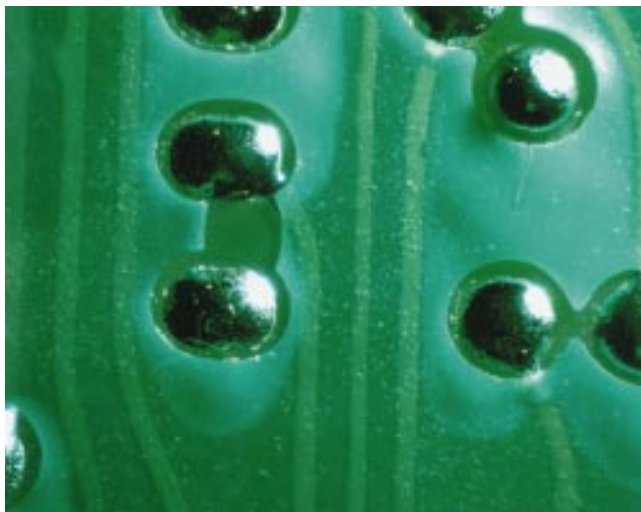
Figure 15-6 Solder resist breakdown

F	PROBLEM	CAUSE	ACTION
	Solder resist breakdown during post soldering operations. (See Figure 15-6.)	Dirt, oxides, grease, water on board surface prior to solder mask application.	Make sure boards are clean and dry prior to solder resist application.
		Flux is too aggressive.	Use less activated flux.
		Preheat of solder temperature is too high.	Reduce preheat and/or solder temperature. (Also see Section 14.0.)
		Residual moisture in solder mask prior to soldering.	Bake boards for 1 hour at 121°C.
		Defluxing medium is attacking solder resist.	Do not use defluxing media containing methylene chloride; also, reduce time in defluxing medium.

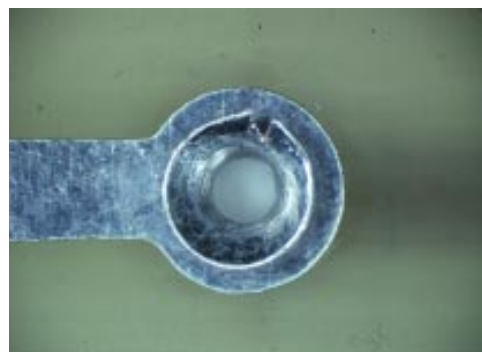
Figure 16-1.
Split terminal.

A	PROBLEM	CAUSE	ACTION
	Terminals and eyelets, swaged base split. (See Figure 16-1.)	Terminal/eyelet material is too hard.	Terminals/eyelets must be annealed.
		Tooling is incorrect for particular hardware.	Check supplier's literature for correct tooling.
		Board is delaminated around plated-through hole.	Install proper length hardware.

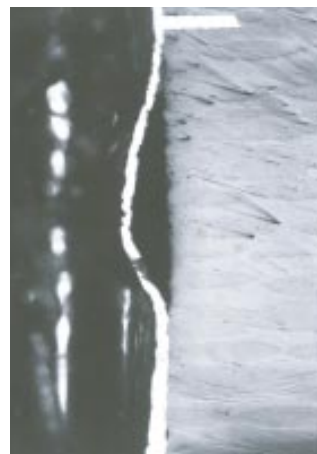
Figure 20-2.
Plating torn away during microsection preparation because of potting compound void in hole.

B	PROBLEM	CAUSE	ACTION
	Voids in potting compound in the holes of mounted coupon, causing poor edge retention of hole walls. (See Figures 20-1 and 20-2.)	Voids in potting compound from not enough flow of compound through holes.	Increase flow of potting compound by using a vacuum or pressure encapsulation. Investigate alternate types of compound. Consult metallographic equipment supplier for assistance. Pour compound from one side and let flow through holes. If using two coupons in mount, pour compound between them.
		Incorrect epoxy resin/hardener ratio.	Carefully mix potting compound per supplier's recommendations.

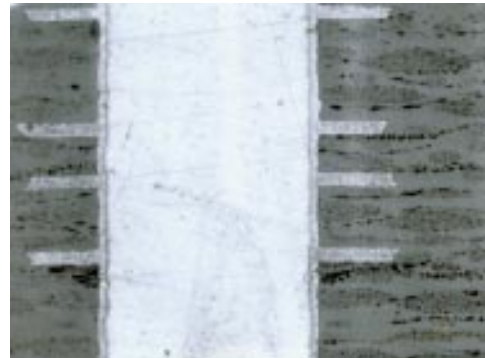
Figure 20-4.
Scratches on mount surface.

D	PROBLEM	CAUSE	ACTION
	Scratches on surface of mount that won't polish out. (See Figure 20-4.)	Grinding too heavy with coarse grit paper.	Use successively finer grit paper as the centers of the holes are approached.
		Polishing cloth is contaminated (scratches appear during the polishing steps).	Clean or replace polishing cloth. Prevent contamination from previous steps by cleaning thoroughly between sequential grinding/polishing operations. Always rinse the mount thoroughly and dry between each grinding/polishing step.
		Improper handling or storage of prepared mount.	Ensure proper storage and handling that avoids scratching the polished mount.
		Unfiltered water being used on polishing steps, contaminating the polishing cloth.	Use filtered or DI water during polishing steps.

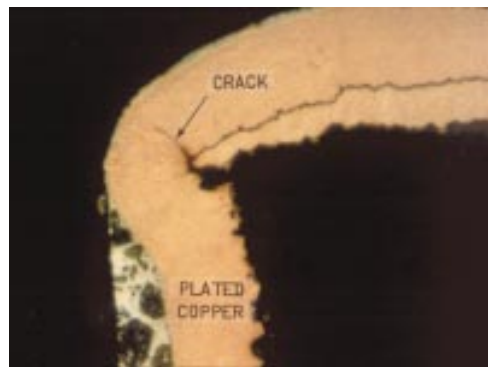
Figure 20-5. Corner crack in copper plating.

A	PROBLEM	CAUSE	ACTION
	Cracks in copper plating after thermal stress test. (See Figure 20-5.)	Insufficient polishing of mount; scratches or smeared tin-lead.	Re-polish mount.
		Solder temperature too high during test, or excessive float time.	Review thermal stress test procedure. (See IPC-TM-650, Test Method 2.6.8.)

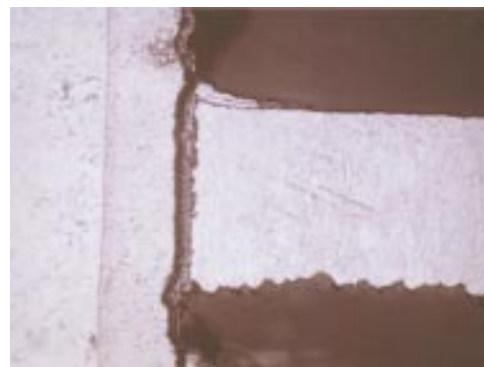
Figure 20-6. Innerlayer pull-away from barrel.

B	PROBLEM	CAUSE	ACTION
	Innerlayer pull-away from barrel after thermal stress test. (See Figure 20-6.)	Copper smeared or pulled during grinding of microsection.	Grind mounts with even, steady pressure; do not use excessive force.
		Coupons not baked prior to thermal stress test.	Coupons should be baked to remove moisture. (See IPC-TM-650, Test Method 2.6.8.)
		Incorrect solder temperature during thermal stress.	Confirm solder temperature with high-temperature thermometer (do not use alcohol thermometer).
