**WATER RESOURCES ENGINEERING, Inc.**

**DAM BREAK STUDY  
MOCCASIN RESERVOIR  
TUOLUMNE COUNTY, CALIFORNIA**

UTILITIES ENGINEERING BUREAU  
CITY AND COUNTY OF SAN FRANCISCO

MAY 1989

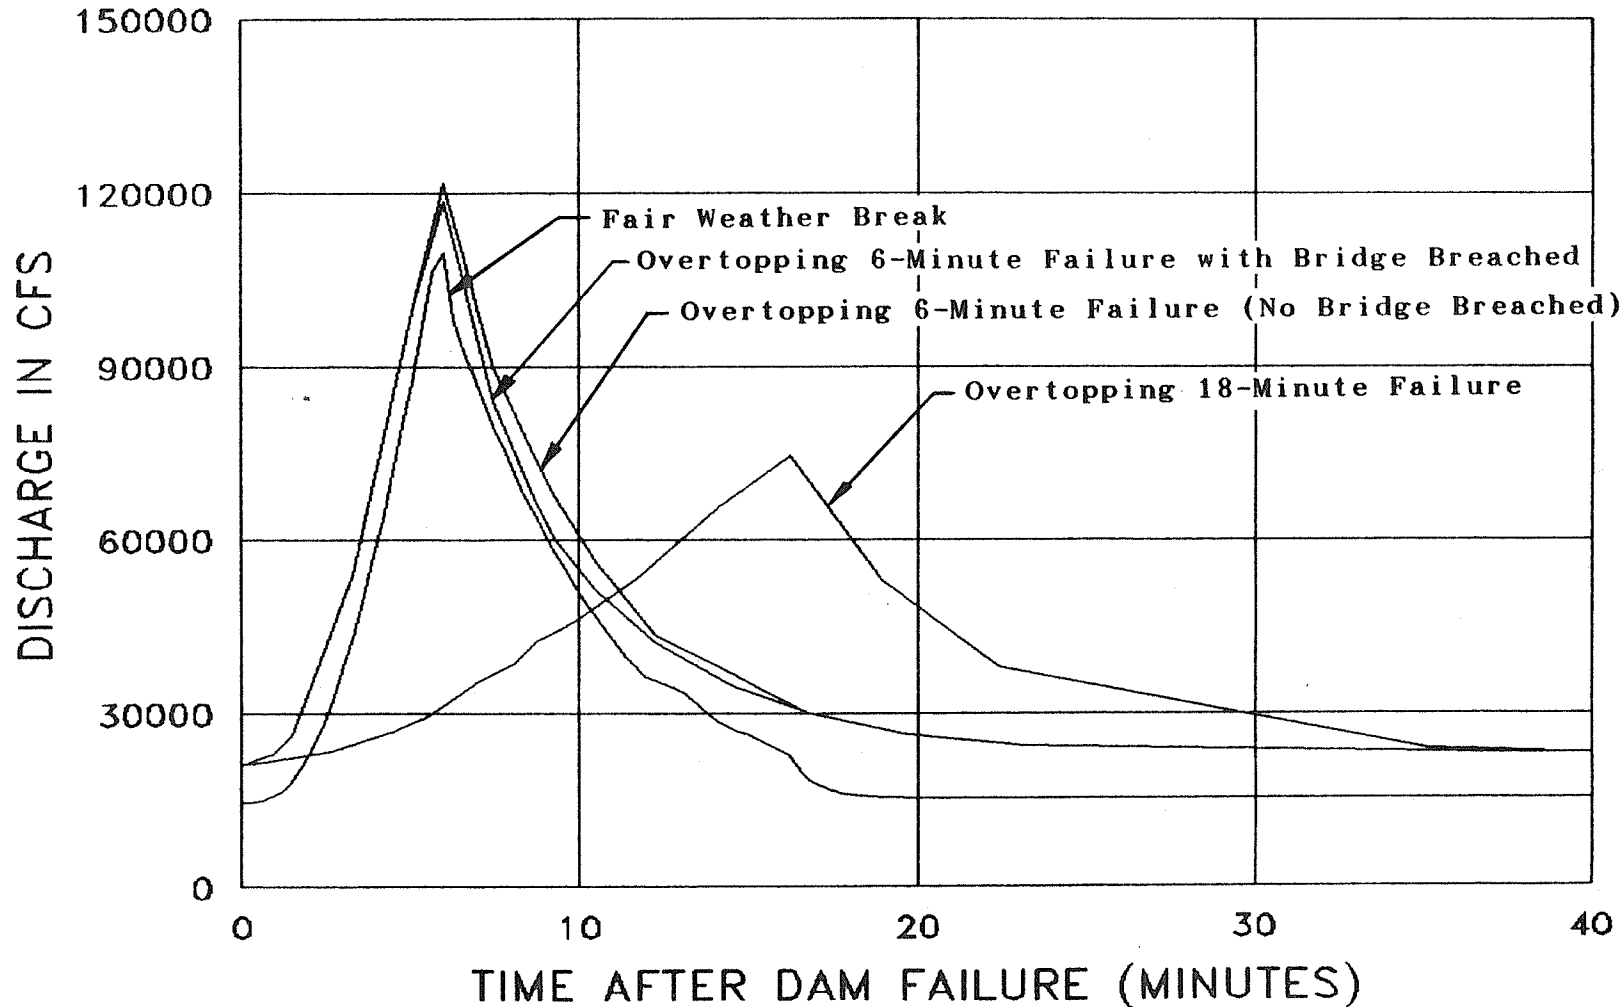
Fig. 6

## OUTFLOWS FROM BREACHED DAM

Table 1 summarizes the sensitivity of peak outflows to different variables. Figure 6 illustrates the outflow hydrographs for four basic conditions: a "fair weather" dam break occurring in six minutes, an overtopping failure occurring in six minutes, an overtopping failure occurring in 18 minutes, and a six-minute overtopping failure with breaching of the downstream road embankments. As the graph in Figure 6 indicates, the highest peak discharges were recorded for six-minute failures.

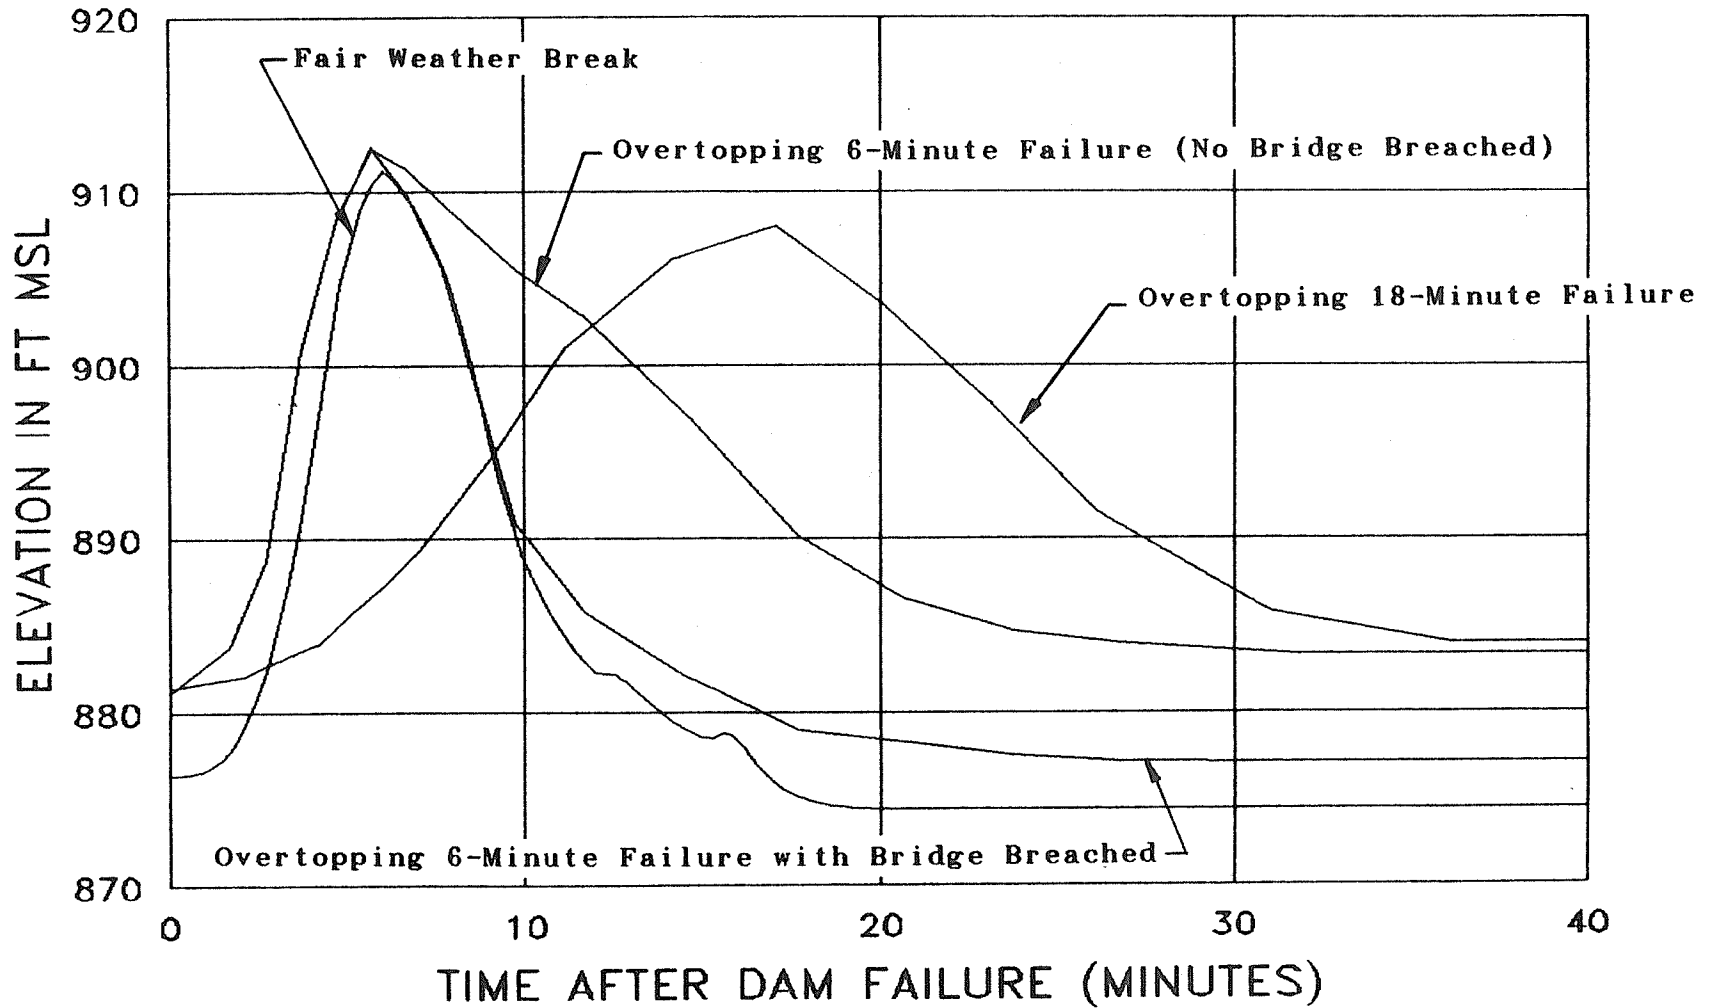
Fig. 7

## FLOOD LEVELS BETWEEN DAM AND HWY 120 BRIDGE

Flood levels varied depending on the assumptions made, but in all cases were high between the dam and Highway 120 and almost imperceptible once in the Don Pedro Reservoir pool. Due to the constriction at the Highway 120 bridge, the flood wave raised water levels above the 900-foot elevation for most of the conditions tested, thus overtopping the road embankments at the intersection of Highways 49 and 120. Figure 7 shows the resulting flood stages between the dam and the road embankments for the same four sets of assumptions listed in the previous report section. The highest flood stages were reached for the six-minute failures, with overtopping failures showing peak elevations about two feet higher than fair weather break failure. The breaching of the road embankments is shown to have little effect on peak stages; the breach at the road embankment does allow the flood levels to recede more rapidly.

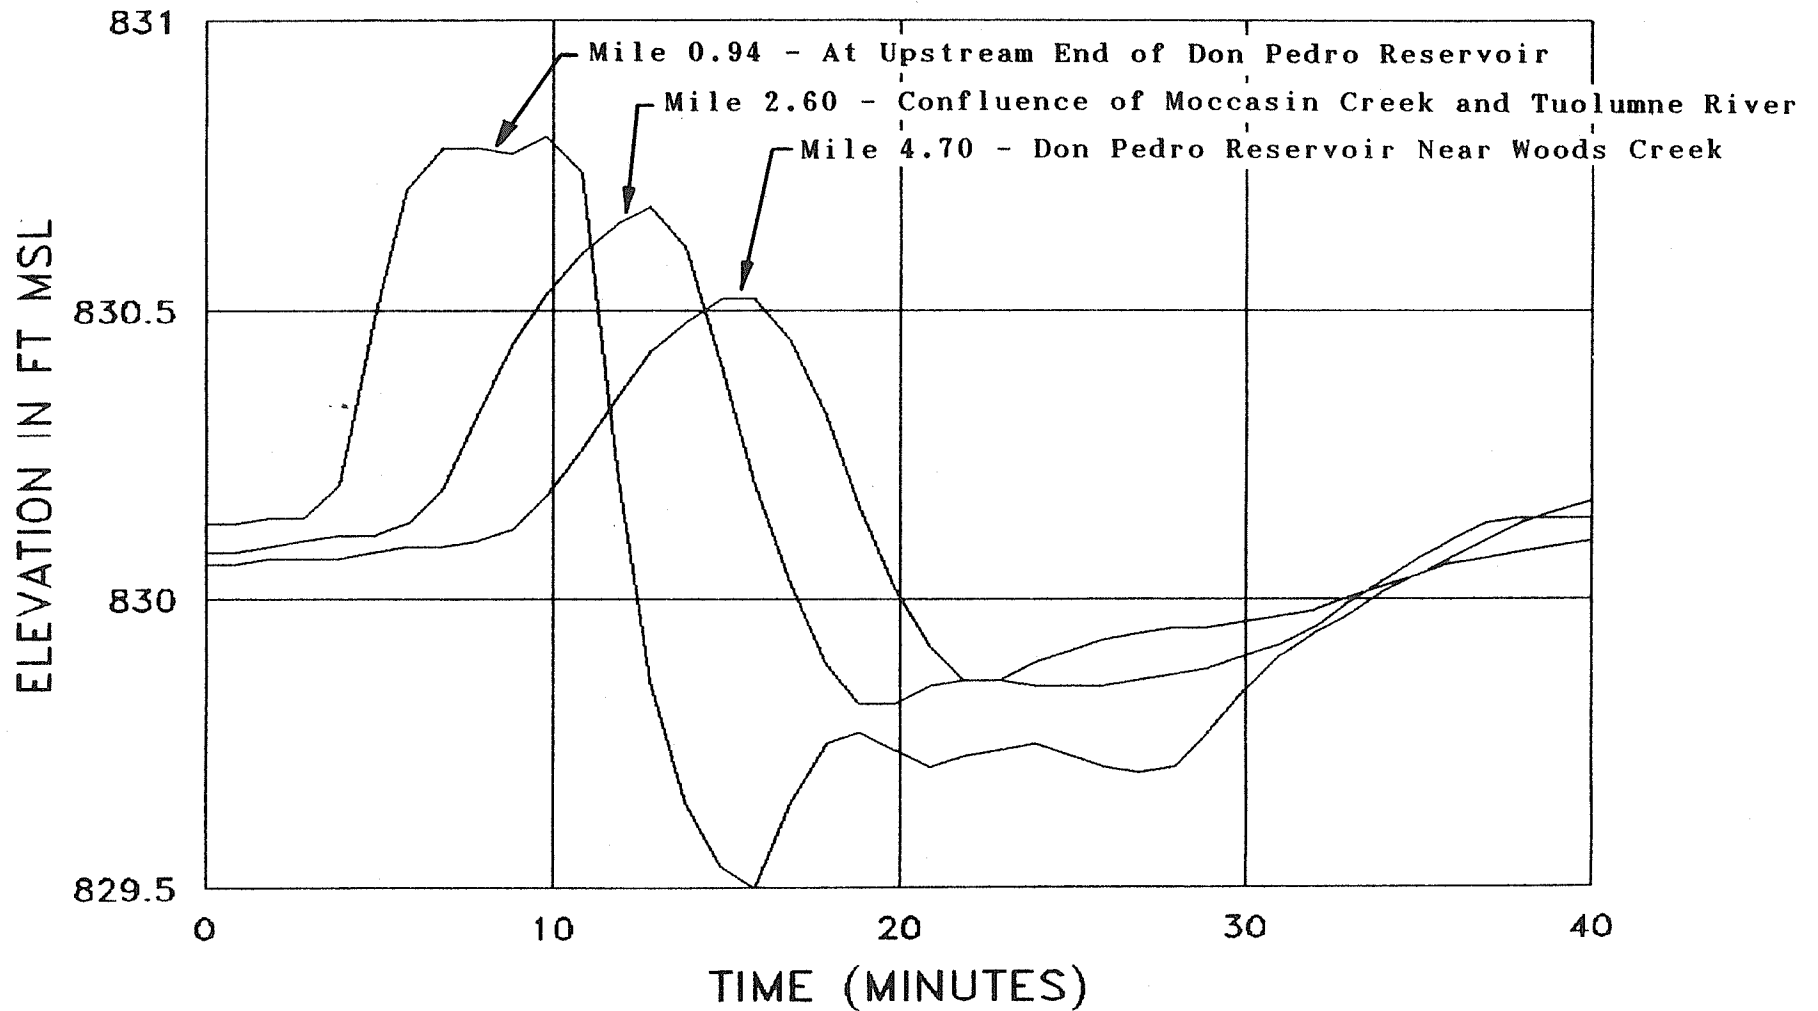
Fig. 9

## LEVEL FLUCTUATIONS IN THE DON PEDRO RESERVOIR

The magnitude of the flood wave decreased in intensity as it moved downstream of the bridge. Figure 8 shows water surface elevations at four different locations, from the dam to the beginning of the Don Pedro Reservoir pool; the elevations plotted correspond to the worst-case scenario tested (six-minute overtopping failure). Figure 9 shows the small fluctuations in level experienced in the Don Pedro Reservoir due to the dam break

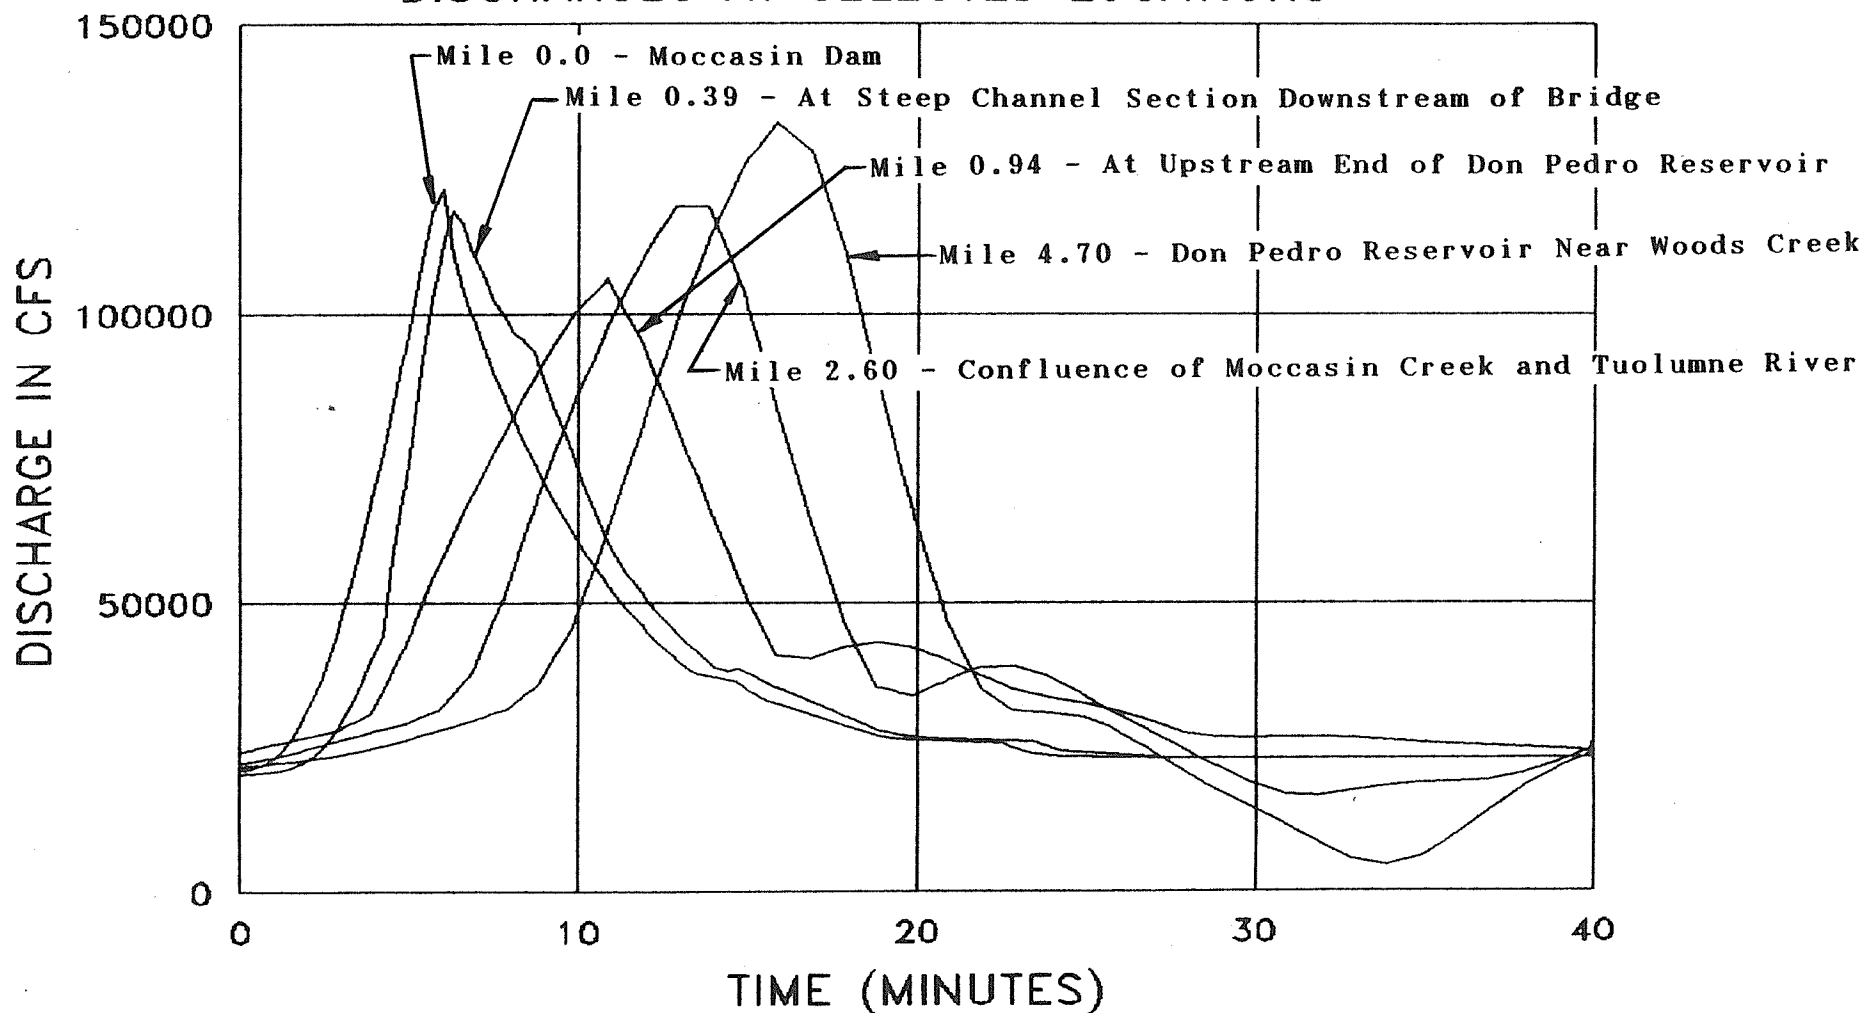
Fig. 10

## DISCHARGES AT SELECTED LOCATIONS

The flood wave for a six-minute dam failure would reach the upstream end of Don Pedro Reservoir within five minutes. Figure 10 shows the movement of the wave from the dam to a point 4.7 miles downstream.

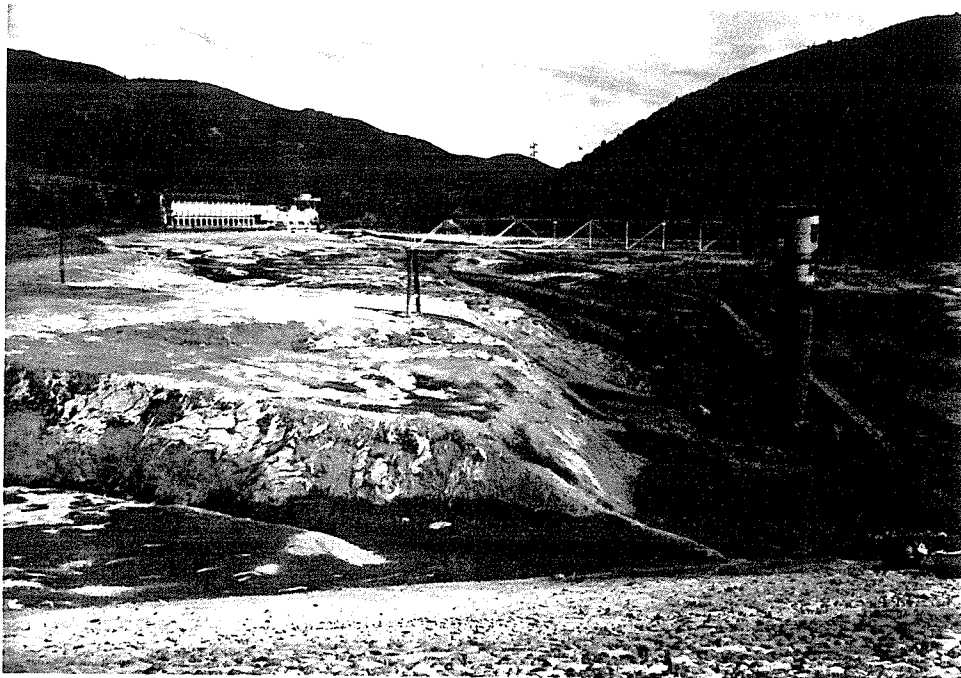
PHOTOGRAPH No. 1

MOCCASIN RESERVOIR: View of empty reservoir, looking upstream from the crest of the dam; auxiliary outlet tower and Moccasin Creek Diversion conduit in foreground; Moccasin Power Plant in background.

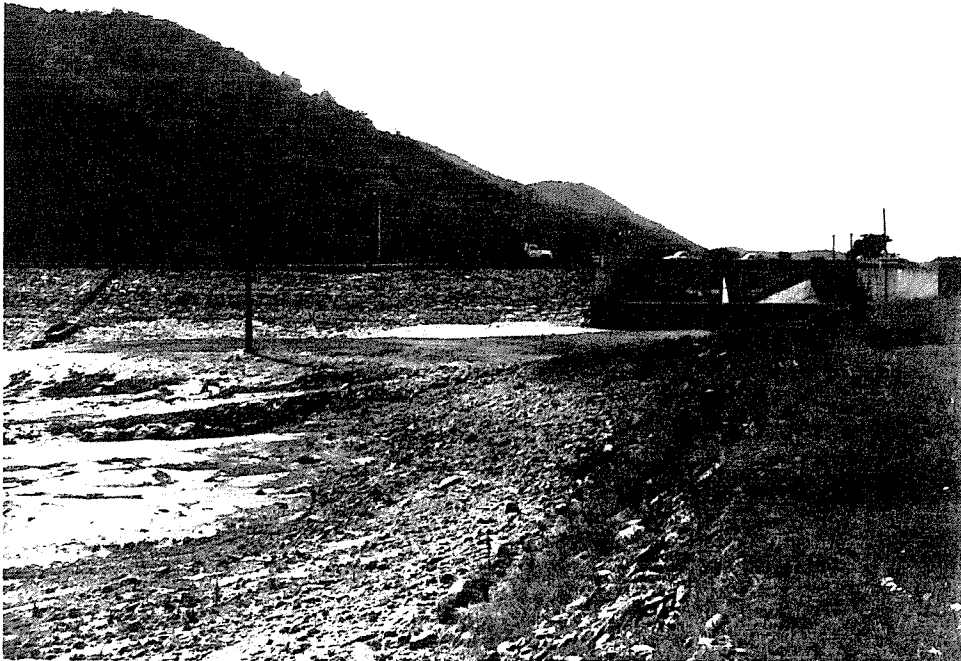
PHOTOGRAPH No. 2

MOCCASIN DAM AND PRIMARY SPILLWAY: View of upstream face of dam and spillway; dam crest at elevation 929 ft MSL; spillway weir crest at elevation 918.29 ft MSL. Low Head Plant intake (not on picture) is located to the right of the primary spillway.

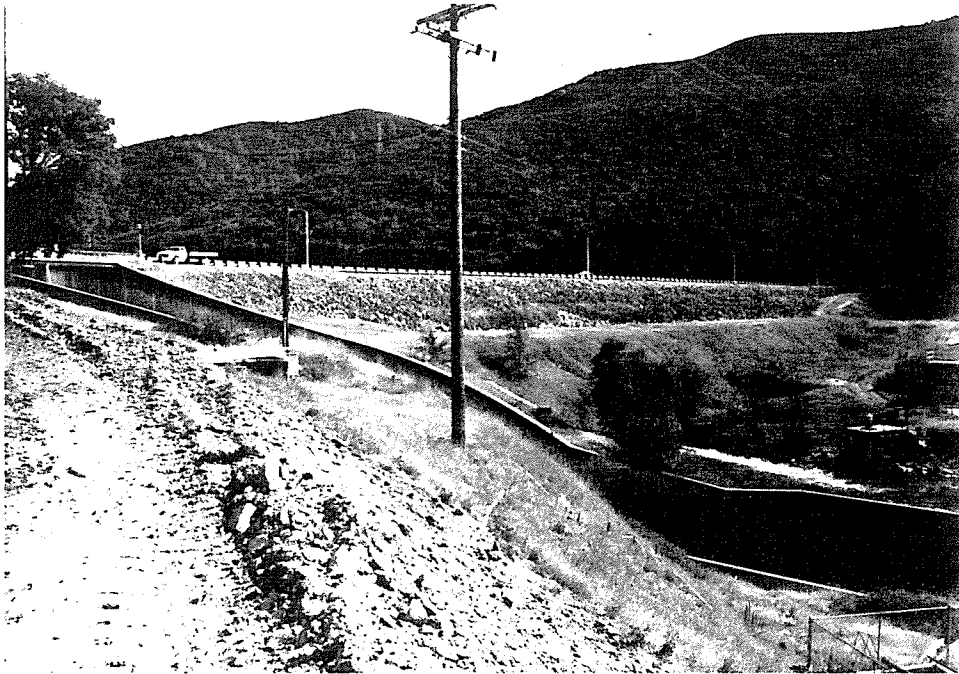
PHOTOGRAPH No. 4

MOCCASIN DAM, SPILLWAY AND OUTLET CONDUIT:  
View of downstream face of dam with spillway  
on foreground, outlet conduit discharging in  
the middle, Highway 49 in background.
