REAR COMBINATION LAMP ASSY LH REPLACEMENT

650GW-01

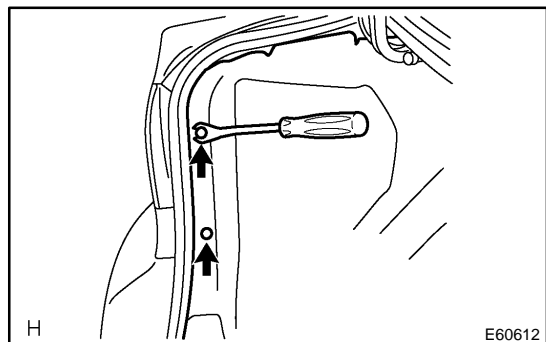
- (a) Using a clipremover, remove the 2 clips and disconnect the luggage compartment trim cover LH.

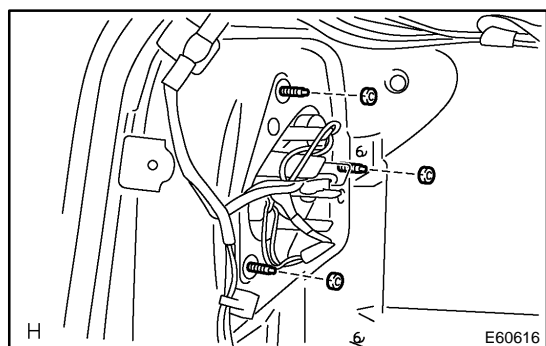
- (b) Disconnect the connector and remove the 3 nuts.

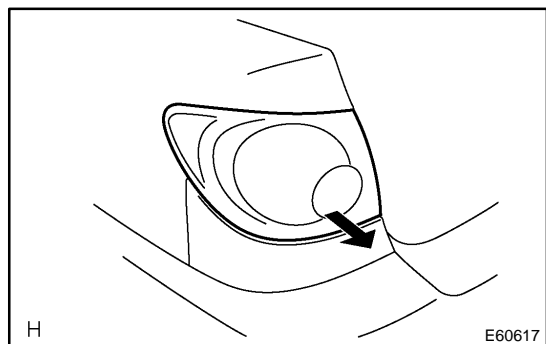
- (c) Pull out the rear combination light assy LH to the back of the vehicle, and remove.
