LUGGAGE COMPARTMENT DOOR

ADJUSTMENT

2004 COROLLA (RM1037U)

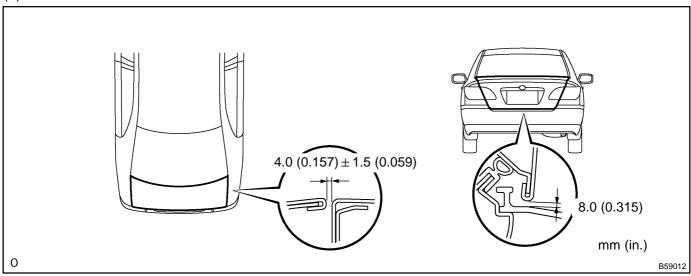
1. INSPECT LUGGAGE COMPARTMENT DOOR PANEL SUB-ASSY

(a) Check that the clearance is within the standard value.
